TECHNICAL INSTRUCTIONS
FOR
VOULANTARY SAFETY RECALL CAMPAIGN SET-16B
SEAT HEATER RECALL

CERTAIN Toyota 2005-2011 4Runner, 2005-2010 Avalon, 1988-1990, 2005-2010 Camry, 1989, 2009-2010 Corolla, 2007-2010 FJ Cruiser, 2005-2011 Highlander, 2010-2012 Prius, 2006-2011 Rav4, 2005-2011 Sequoia, 2005-2011 Sienna, 2006-2008 Solara, 2006-2011 Tacoma, 2005-2010 Tundra, and 2009-2010 Venza

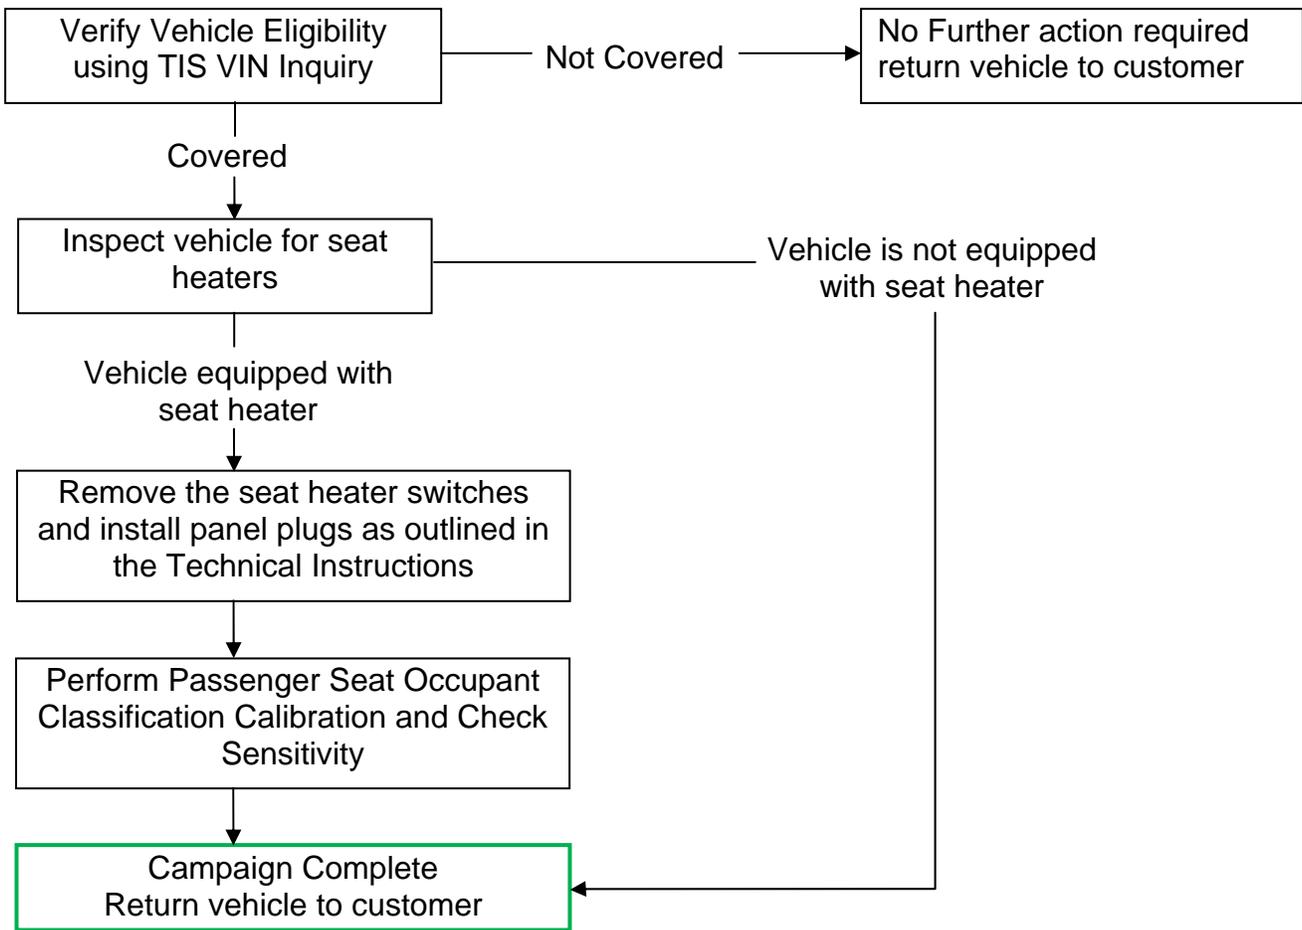
I. OPERATION FLOW CHART

- Inspect the vehicle for seat heater switches and location
 - If the vehicle is equipped with seat heater switches on the seat side panel follow **Procedure A.**
 - See page 3
 - If the vehicle is equipped with seat heater switches in the center console or center dash location follow **Procedure B.**
 - See page 4
 - If vehicle is not equipped with seat heaters. Campaign is complete.

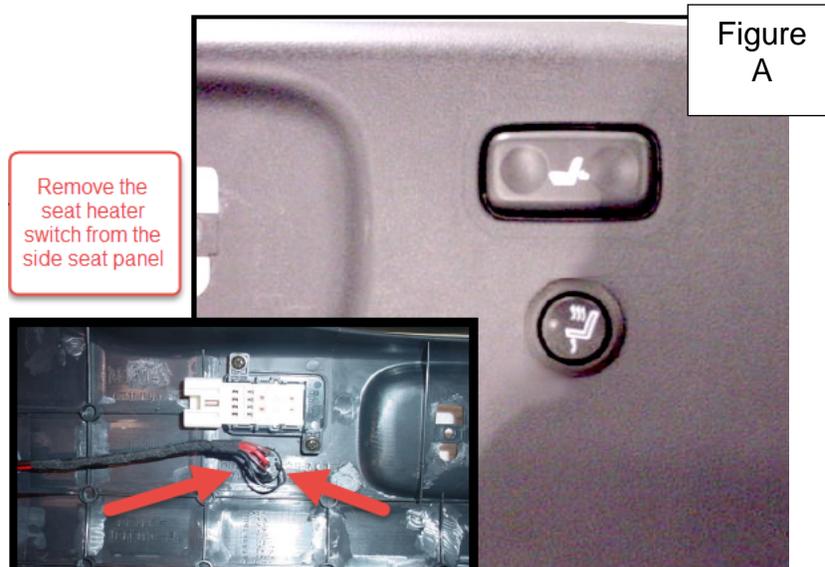
1. Place protective covering on vehicle.
2. **CAUTION: Disconnect the negative battery cable for 3 minutes before beginning repair.**
3. Remove the 4 seat anchor bolts for the drivers and passengers side seat. *(To allow access under the seat assembly)*
4. Remove the drivers and passenger side outboard seat panel. *(refer to TIS for model specific removal instructions)*
5. Disconnect the seat heater switch connector on the drivers and passenger side seat.
6. Remove the seat heater switch on the drivers and passengers side seat panel by squeezing the 2 locking tabs of the switch on the back side of the panel. Figure A

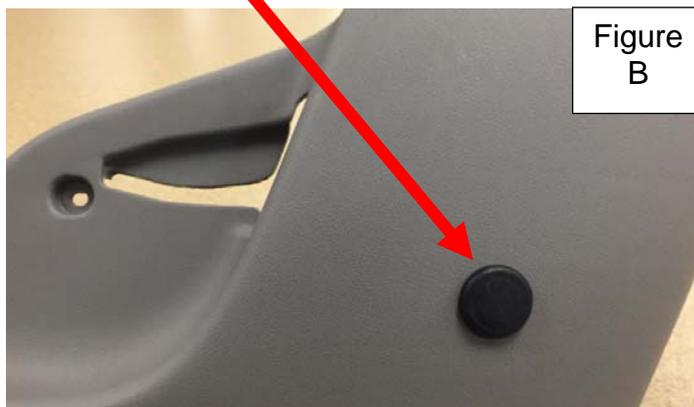
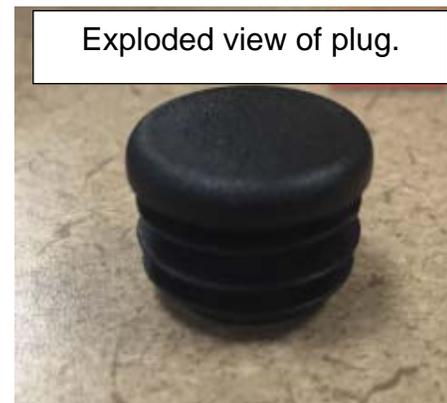
7. Reinstall the seat side panels and seat assemblies with the 4 removed anchor bolts. *(Refer to TIS for torque specifications by model)*
8. Using the supplied 20mm hole plug, install in the side panel until flush and fully seated against the trim panel face. Figure B

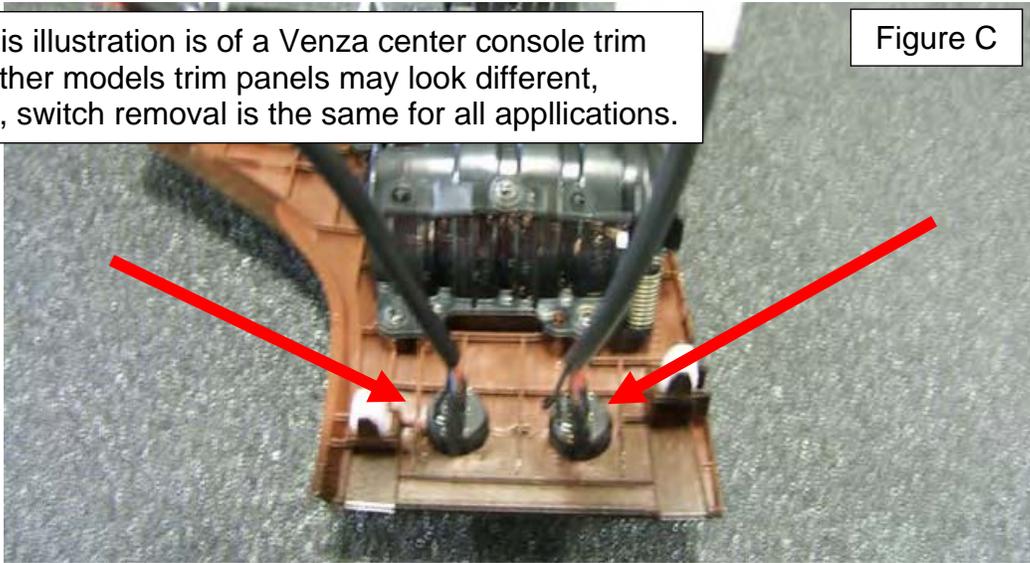
1. Place protective covering on vehicle.
2. **CAUTION: Disconnect the negative battery cable for 3 minutes before beginning repair.**
3. Remove the center console trim panel (s) that retains the seat heater switches. (refer to TIS for model specific removal instructions)
4. Disconnect the seat heater switch connector.
5. Remove the seat heater switches from the center console trim panel by squeezing the 2 locking tabs of the switch on the back side of the panel. Figure C

Note: This illustration is of a Venza center console trim panel. Other models trim panels may look different, however, switch removal is the same for all applications.

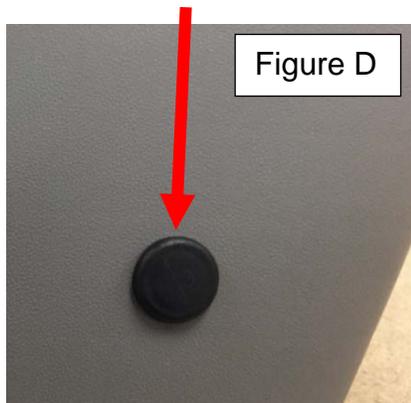
6. Reinstall the center console trim panel (Refer to TIS for torque specifications by model)
7. Using the supplied 20mm hole plug, install it in the center console trim panel until flush and fully seated against the trim panel face. Figure D

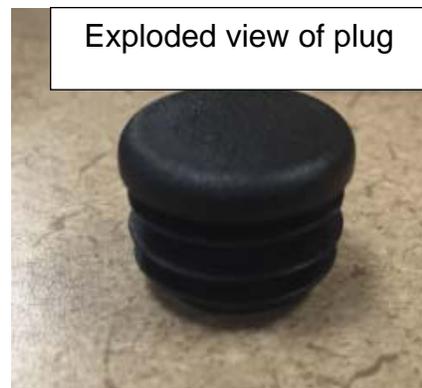
Figure D

Exploded view of plug
