# Safety Recall

## Code: 60C3

<b>Subject</b>	<b>Sunroof Glass Adhesive</b>
<b>Release Date</b>	January 18, 2018
<b>Revision Summary</b>	<b>Updated primer part number and increased primer drying/flash off time.</b>
<b>Affected Vehicles</b>	<b>U.S.A.: 2007-2009 MY Audi A8/S8</b> <b>CANADA: 2008-2009 MY Audi A8/S8</b>  <i>Check Campaigns/Actions screen in Elsa on the day of repair to verify that a VIN qualifies for repair under this action. Elsa is the <u>only</u> valid campaign inquiry &amp; verification source.</i> <ul style="list-style-type: none"><li>✓ Campaign status must show "open."</li><li>✓ If Elsa shows other open action(s), inform your customer so that the work can also be completed at the same time the vehicle is in the workshop for this campaign.</li></ul>
<b>Problem Description</b>	On certain vehicles, the glass panel of the sunroof may not have been properly bonded to the sunroof frame. This could allow the glass panel to separate from the vehicle while driving, creating a road hazard which could increase the risk of a crash causing injury and/or damage to property.

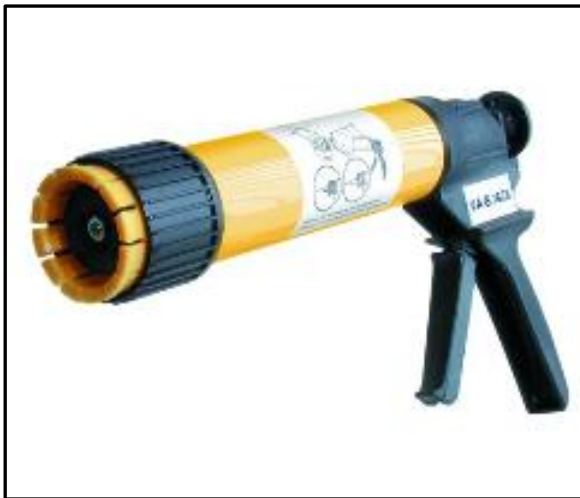
- Cartridge gun <VAG1628>

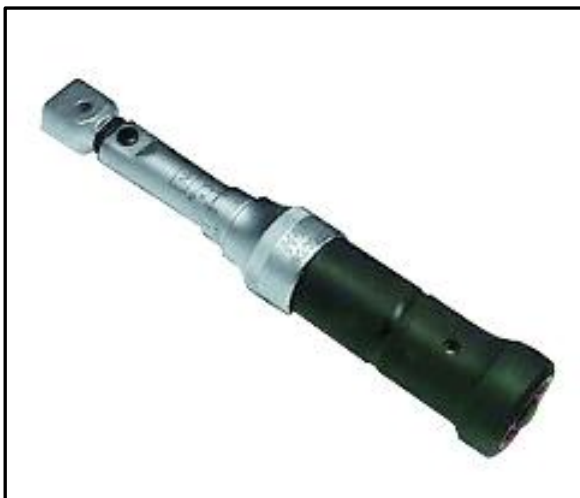
- Torque wrench <VAG1783> or equivalent

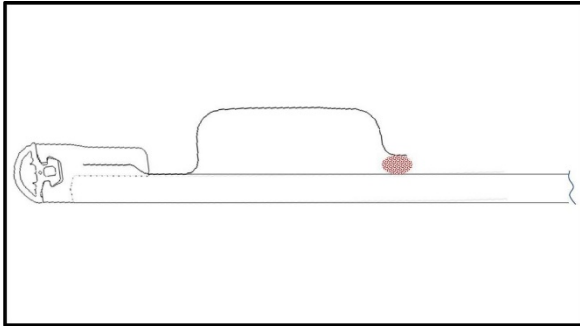
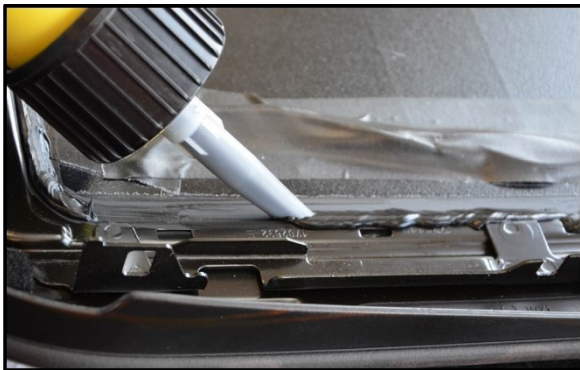
#### Apply Second Bead of Adhesive

- Cut a larger opening in the cartridge nozzle.
- Apply wide bead of adhesive to the glass frame and glass <red area>.

Allow 3 hours for the adhesive to cure prior to reinstalling glass assembly to the vehicle.
