RECALL CAMPAIGN BULLETIN

NTB16-069a

VOLUNTARY SAFETY RECALL CAMPAIGN 2016 SENTRA; ENGINE ROOM HARNESS

CAMPAIGN ID #: PM658

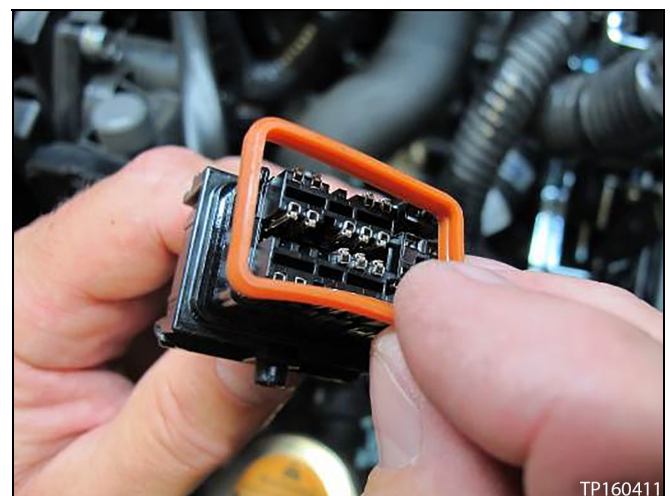
Figure 9

8. Carefully remove the orange weather seal (see Figure 9).

NOTE: This part will be reused.

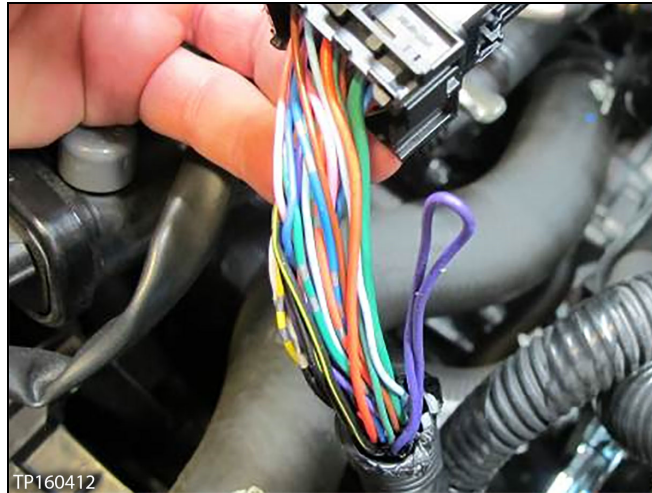
Figure 10

- Carefully remove the tape from the connector body to the corrugated conduit (see Figure 10).

CAUTION: Be careful NOT to damage any wiring during tape removal.

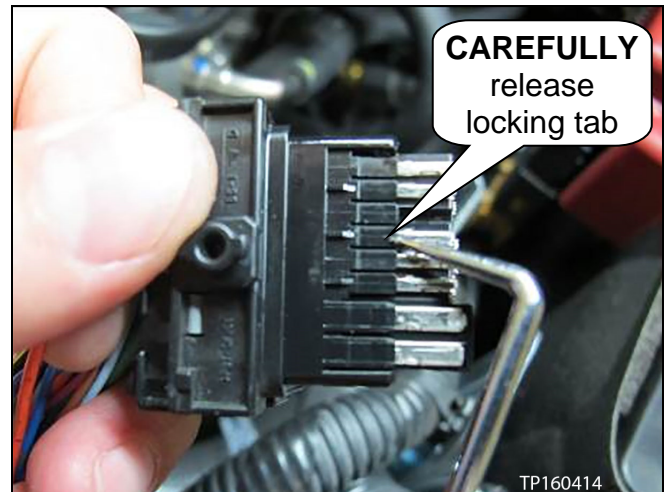
Figure 12

- a. Using a suitable tool, carefully release the terminal from the locking tab (see Figure 12).

CAUTION: Be careful when working with the locking tab. If forced too hard, it may break.

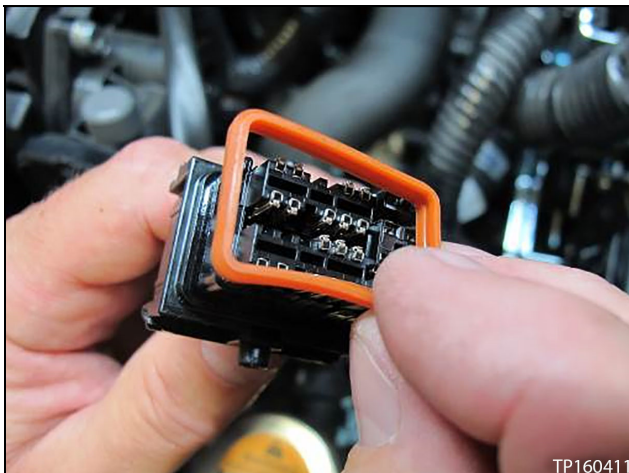
Figure 23

21. Reinstall the orange weather seal to the ECM connector (see Figure 23).
