**TECHNICAL INSTRUCTIONS
FOR
SAFETY RECALL GLJ
CURTAIN SHIELD AIRBAG
CERTAIN 2011 –2012 MODEL YEAR CT200h**

I. OPERATION FLOW CHART

II. BACKGROUND

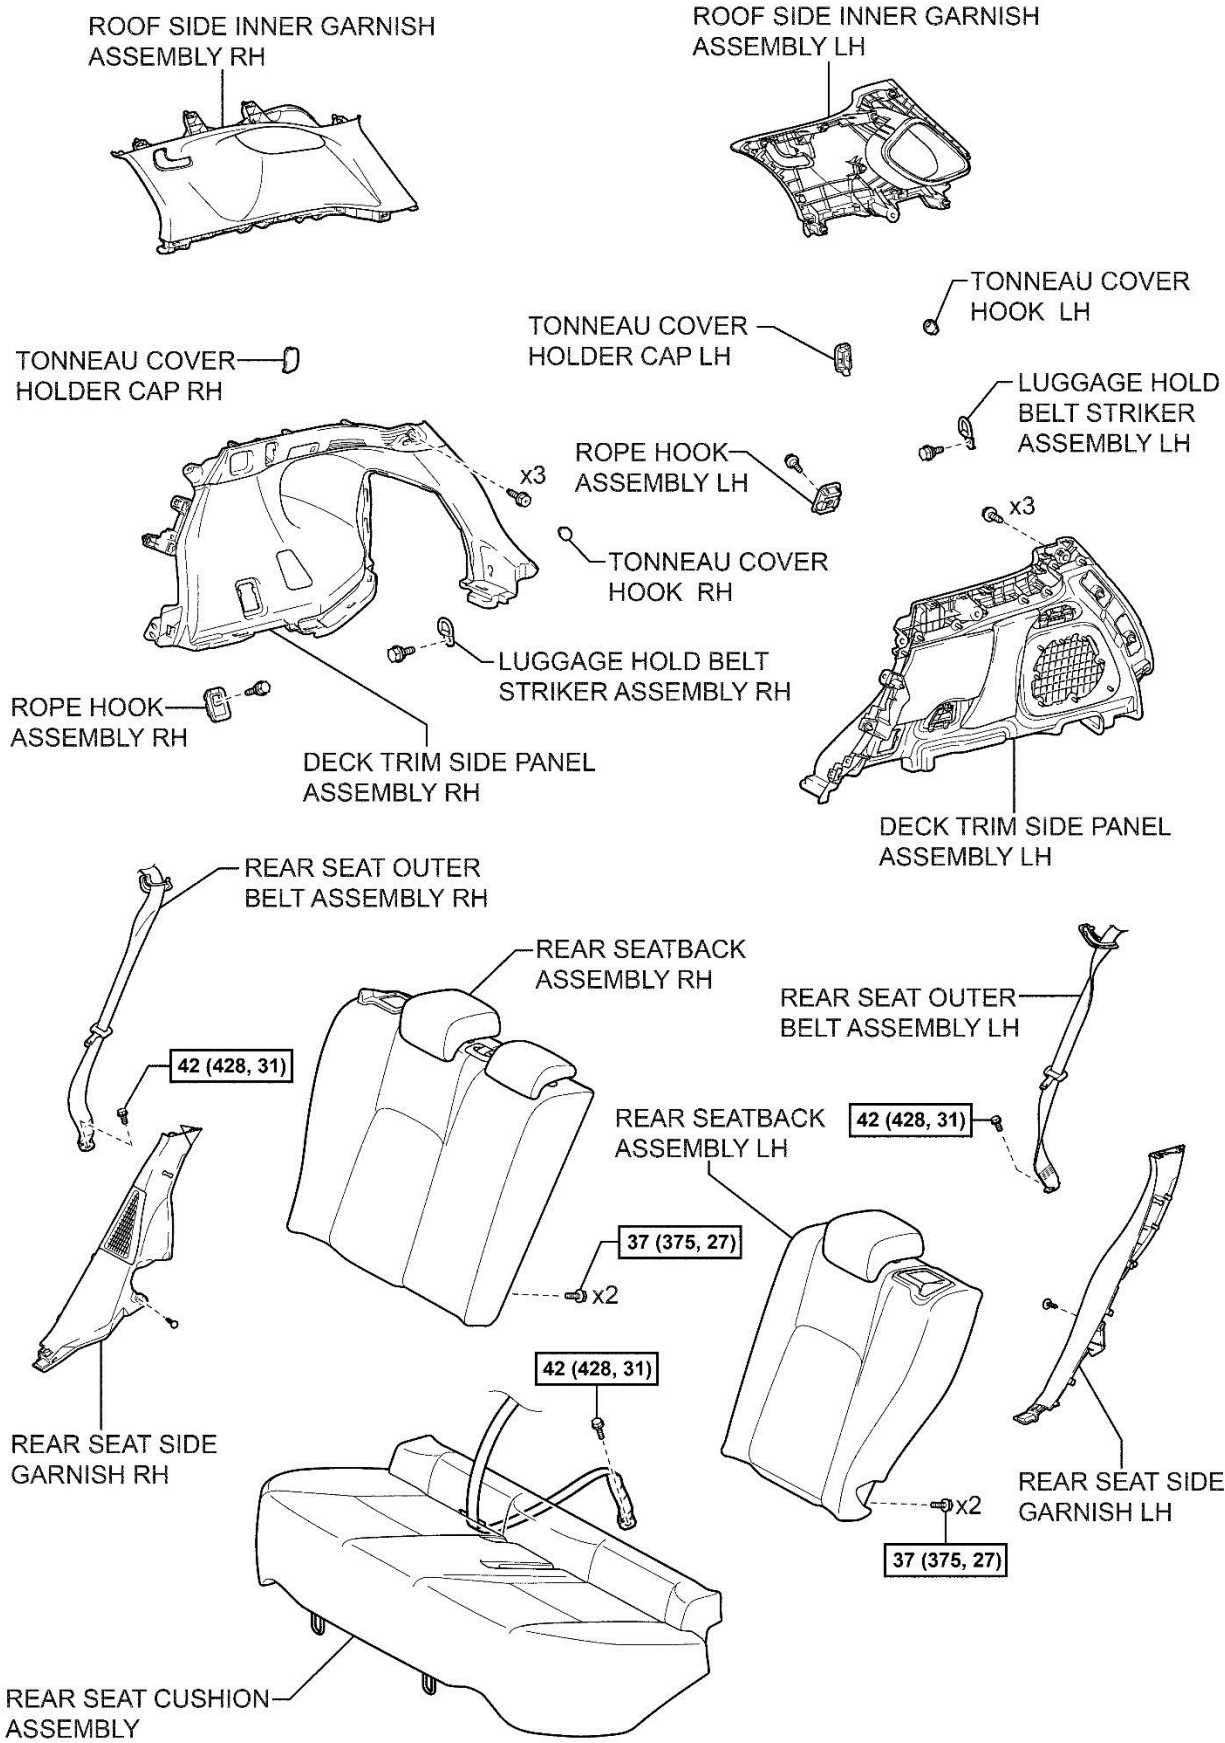
Component Removal Continued...

N*m (kgf*cm, ft.*lbf) : Specified torque

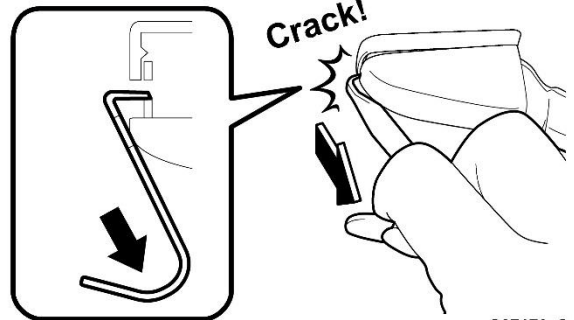
NG

- **DO NOT pull the assist grip remover at an angle or it can disengage and damage the cover.**
- **DO NOT forcefully pry the assist grip cover or they will be damaged.**

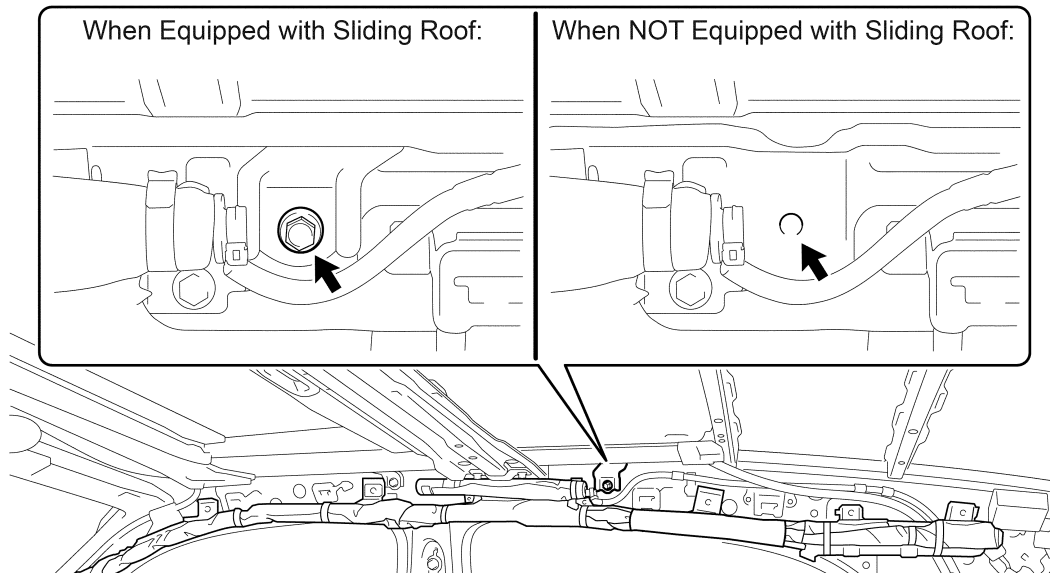
- a) Remove the bolt from the curtain shield airbag. (**Only if Equipped with Sliding Roof**)
- b) Mark the bolt removed from the vehicle to ensure it does not get reused. (**If equipped**)

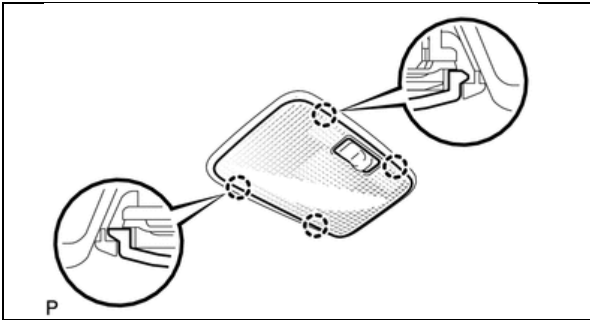
- a) Reengage the 2 claws guides as shown.
- b) Engage the 3 claws as shown.
