July 2016

Safety Recall S42 / NHTSA 16V-490 Center Seatbelt Bezels

2017 (RU) Chrysler Pacifica

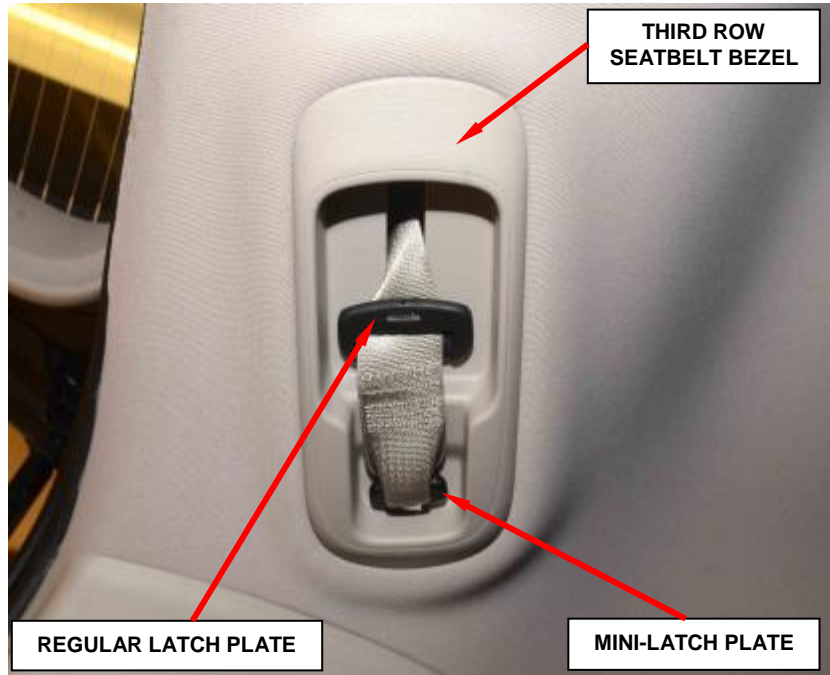
Figure 1 – Third Row Seatbelt Bezel

2. **If the latch plates are in the stowed position,** remove the mini-latch plate and regular latch plate from their stowed position in the third row seatbelt bezel (Figure 1).

8. Install the third row seatbelt bezel to the headliner fully engaging all four corners (Figure 1).

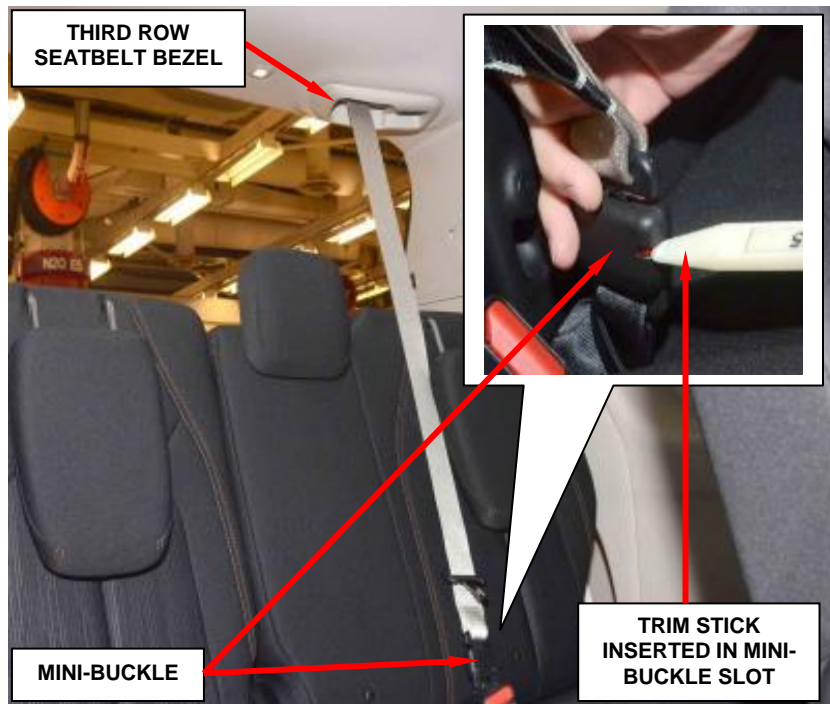
Figure 2 – Mini-Latch Plate Buckled

3. **If the mini-latch plate is in the the buckled position,** insert a trim stick or equivalent into the center red slot on the mini-buckle. The seatbelt will automatically release and retract. If necessary, slide the regular latch plate down the webbing to allow the seatbelt to retract fully (Figure 2).

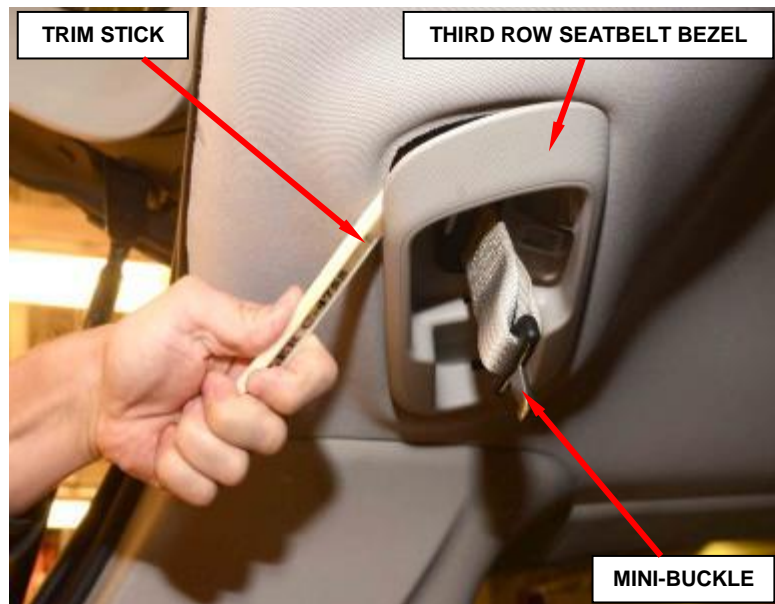
Figure 3 – Remove Seatbelt Bezel

4. Use a trim stick to disengage all four corners of the third row seatbelt bezel (Figure 3).

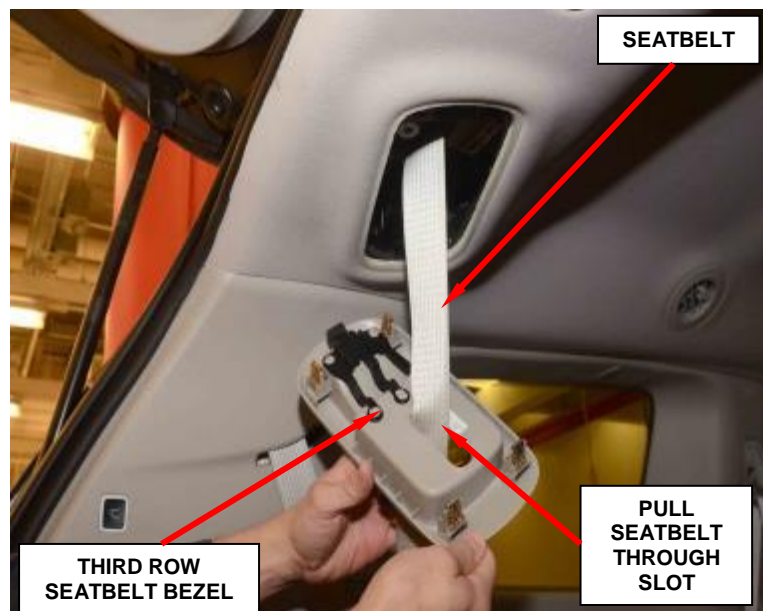
Figure 4 – Remove Seatbelt

6. Remove the seatbelt from the third row seat belt bezel (Figure 4).

7. Route the seatbelt through the **NEW** third row seatbelt bezel (Figure 4).

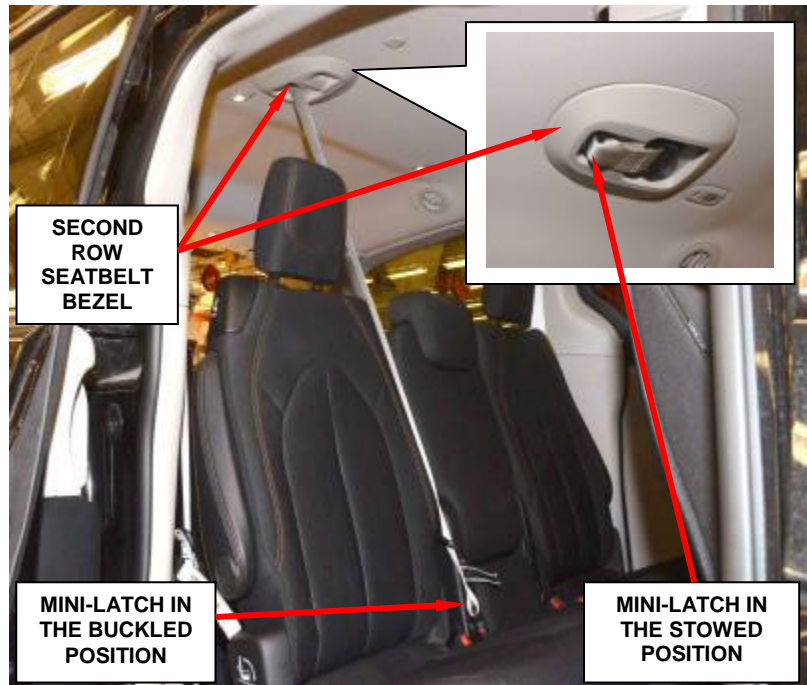
Figure 5 – Second Row Seat Bezel Location

11. Repeat steps 2 through 10 for the second row seatbelt bezel, **if equipped** (Location shown in Figure 5).
