Revised January 2017

Dealer Service Instructions for:

## **Safety Recall S48 / NHTSA 16V-495 Transfer Case Rear Output Shaft**

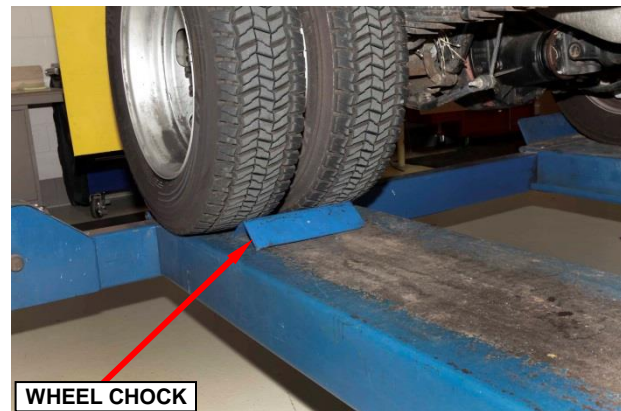
**Figure 1 – Chock Rear Wheels**

**WARNING:** If the vehicle is placed on a drive-on type hoist, apply the park brake and chock the rear wheels to prevent unintended vehicle movement (Figure 1).

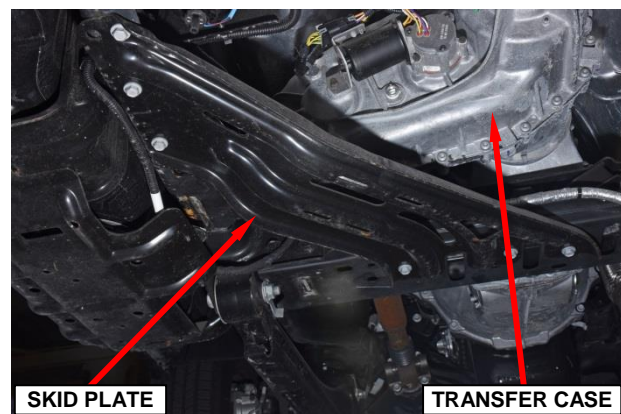
**Figure 2 – Transfer Case Skid Plate**

2. Remove and save the transfer case skid plate (Figure 2).

- c. Install the fill plug. Tighten the plug to 15 - 22 ft. lbs. (19 - 30 N·m) (Figure 3).
  - d. Wipe away any excess fluid that may have spilled.
37. Install the transfer case skid plate and bolts. Tighten the bolts to 27 ft. lbs. (37 N·m) (Figure 2).

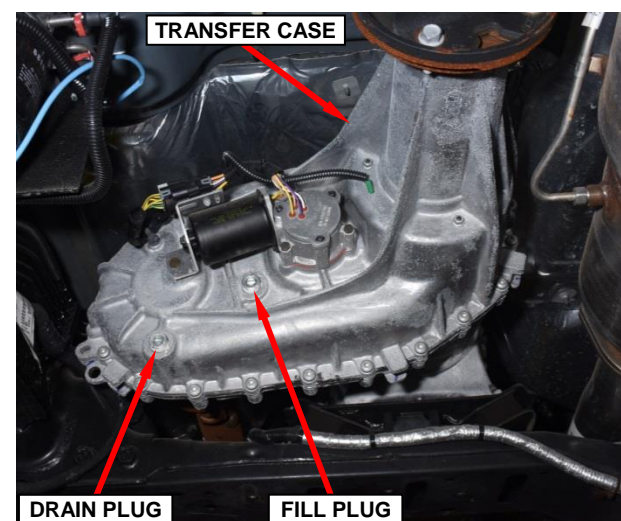
**Figure 3 – Lubricant Drain/Fill Plugs**

3. Drain the transfer case lubricant:
  - a. Position a drain pan under the transfer case (Figure 3).
  - b. Remove the drain plug and allow the lubricant to drain completely (Figure 3).
  - c. Install the drain plug. Tighten the drain plug to 15 - 22 ft. lbs. (19 - 30 N·m) (Figure 3).
  - d. Remove the drain pan.

36. Fill the transfer case with lubricant:
  - a. Remove the fill plug (Figure 3).
  - b. Fill the transfer case with the correct fluid to the bottom edge of fill plug opening (Figure 3).

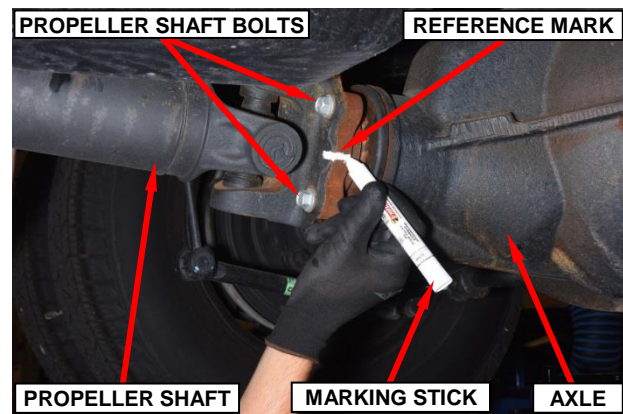
**Figure 4 – Driveline Alignment Mark**

4. Place alignment marks on the front and rear propeller shafts and the axle companion flanges for assembly alignment (Figure 4).

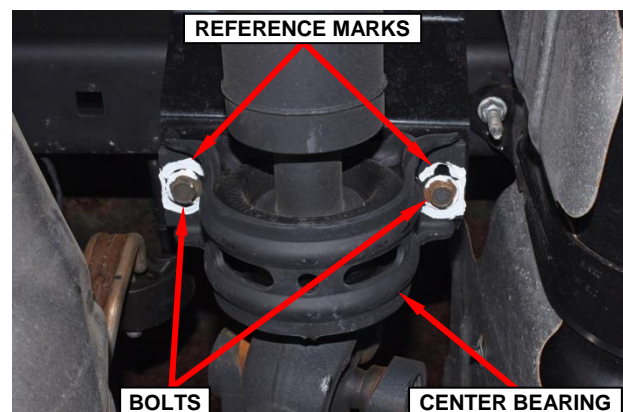
**Figure 5 – Rear Propeller Shaft Center Bearing Alignment Mark**

5. Remove and discard the companion flange-to-propeller shaft bolts from the front axle and transfer case.
6. Remove and save the front propeller shaft.
7. **Two and three piece rear propeller shafts only:** Mark the position of the center bearing for installation reference. Support the propeller shaft then remove and discard the center bearing bolts (Figure 5).

33. Align the rear axle flange-to-propeller shaft reference marks made prior to removal. Install the rear propeller shaft using new bolts. Tighten the transfer case companion flange-to-propeller shaft bolts to 55 ft. lbs. (75 N·m). Tighten the axle flange-to-propeller shaft bolts to: (DD, DF models) 89 ft. lbs. (120 N·m) / (DP models) 55 ft. lbs. (75 N·m) (Figure 4).
34. **Two and three piece rear propeller shafts only:** Align the propeller shaft center bearing bracket to the outline reference mark made prior to removal. Install new center bearing bolts. Tighten the bolts to 40 ft. lbs. (54 N·m) (Figure 5).

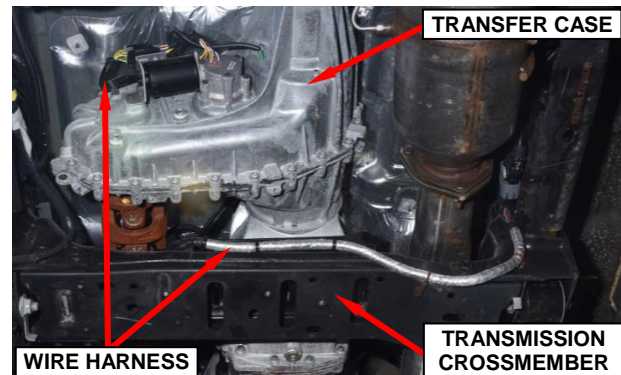
**Figure 6 – Electrical Wire Harness**

10. Disconnect the transfer case electrical wire connectors and release the wire harness retainers from the transfer case (Figure 6).
11. Release the electrical wire harness retainers from the transmission crossmember (Figure 6).

29. Connect the transfer case vent hose to the top of the transfer case.
30. Connect the transfer case electrical connectors and secure the wire harness retainers to the transference case (Figure 6).

31. Secure the electrical wire harness retainers to the transmission crossmember (Figure 6).
32. **Manual shift transfer case only:** Connect the transfer case shift linkage.

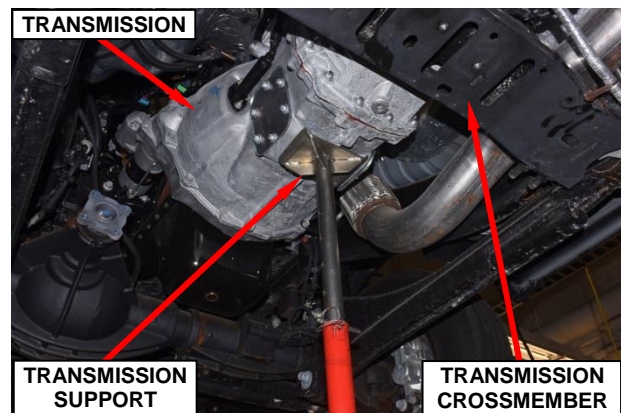
**Figure 7 – Support Transmission**

14. Support the transmission with an appropriate transmission jack (Figure 7).
15. Remove and save the transmission mount-to-transmission crossmember nuts (Figure 8).

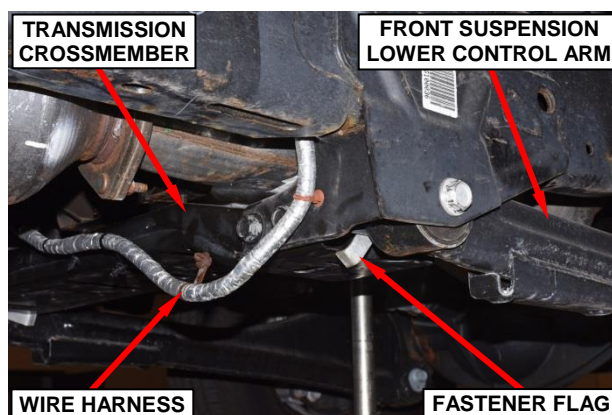
**Figure 9 – Fastener Flag Interference**

16. For transmission crossmember removal clearance, the right side front suspension lower control arm fastener flag (Figure 9) must be positioned out of the way by following these steps:

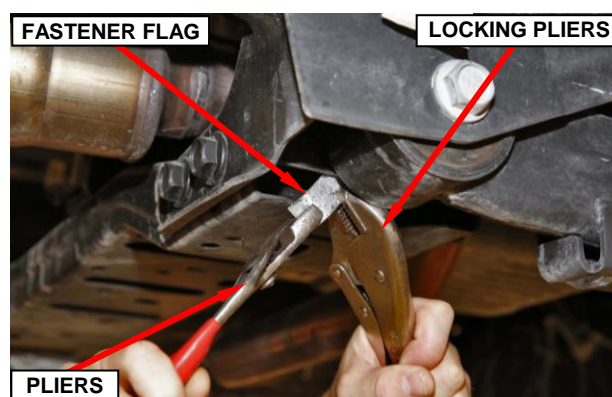
**Figure 10 – Bend Fastener Flag**

- a. Use locking pliers to clamp the fastener flag in position relative to the vehicle frame to prevent fastener flag rotation while bending the flag (Figure 10).
- b. While the fastener flag is clamped to prevent rotation, use pliers to bend the flag end away from the crossmember until adequate clearance is achieved to allow for crossmember removal (Figures 10 and 11).

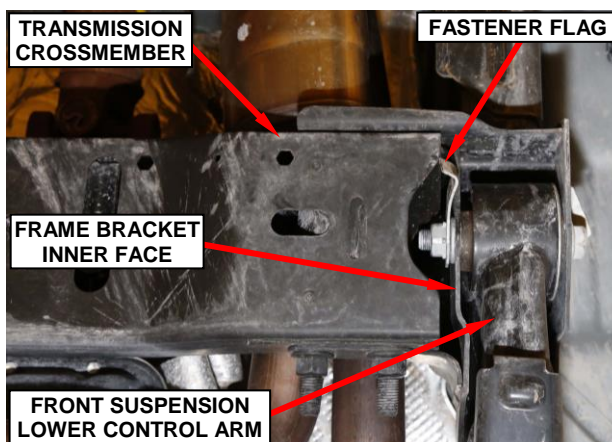
**Figure 11 – Fastener Flag Clearance**

**NOTE:** Ensure that the fastener flag does not extend beyond the inner face of the frame bracket in order to prevent possible contact with the front suspension lower control arm (Figure 11).

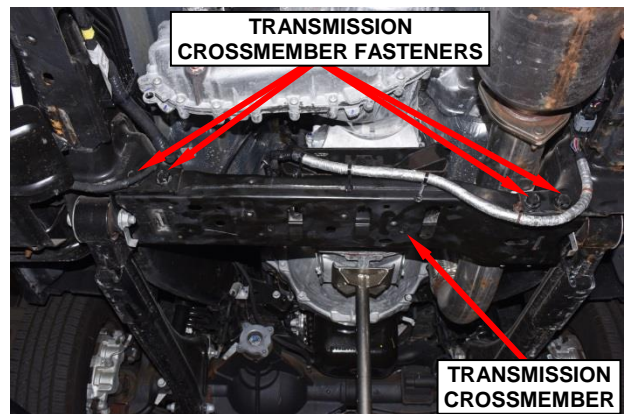
Figure 12 – Crossmember Fasteners

17. Remove and save the four transmission crossmember-to-frame fasteners (Figure 12).

27. Install the transmission crossmember and the crossmember-to-frame fasteners. Tighten the fasteners to: (DD, DF models) 177 ft. lbs. (240 N·m) / (DP models) 94 ft. lbs. (127 N·m) (Figures 12 and 13).

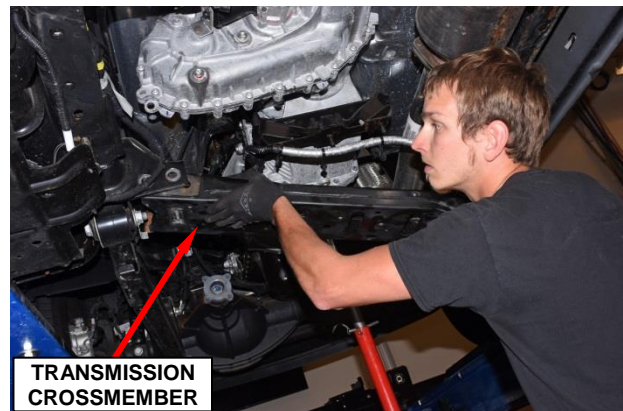
Figure 13 – Transmission Crossmember

18. Remove the transmission crossmember (Figure 13).

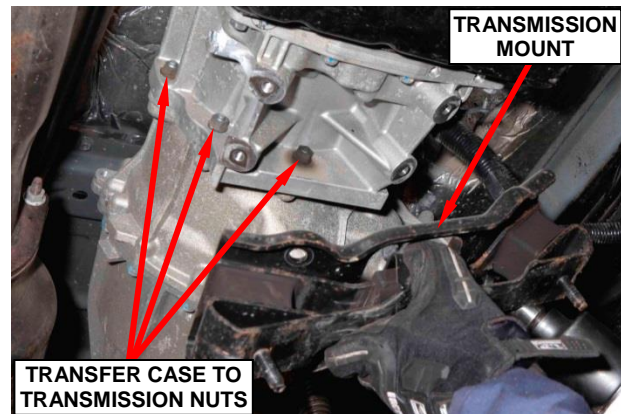
Figure 14 – Transmission Mount

19. **Automatic transmission only:** In order to access the transfer case lower fastening nut, remove and save the transmission mount-to-transmission bolts and mount (Figure 14).

26. **Automatic transmission only:** Install the transmission mount and mount-to-transmission bolts. Tighten the bolts to 45 ft. lbs. (61 N·m) (Figure 14).

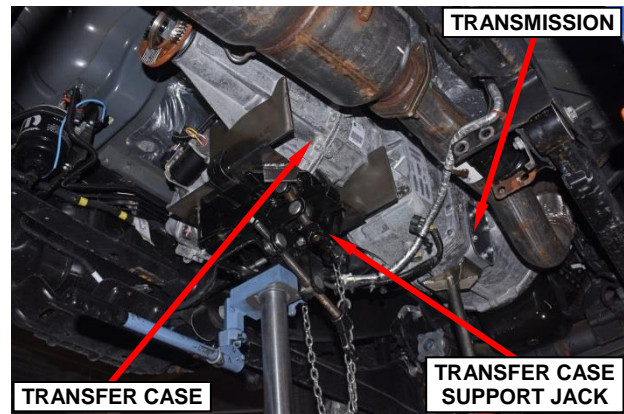
**Figure 15 – Support Transfer Case**

20. Support the transfer case with a transmission jack and secure the transfer case to the transmission jack with straps or chains (Figure 15).
21. Remove and discard the transfer case-to-transmission nuts (Figure 16).

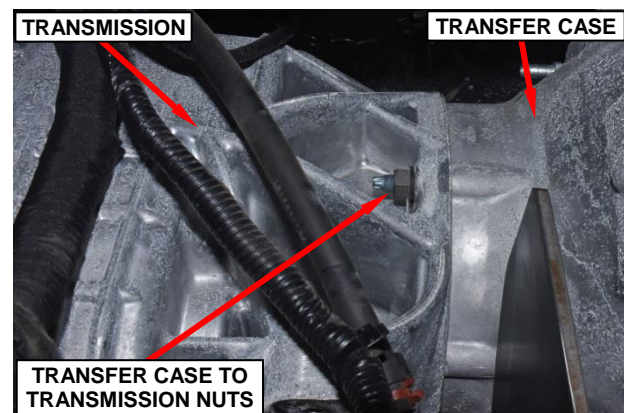
**Figure 16 – Transfer Case Fastening**

22. Pull the transfer case and jack rearward to disengage the transfer case from the transmission. Then remove the transfer case from under the vehicle.
23. Remove the old transfer case from the jack. Then install the new transfer case onto the jack.
24. Lift the transfer case into position and place the transfer case against the back of the transmission (Figure 15).
25. Install the new transfer case-to-transmission nuts. Tighten the nuts to 30 ft. lbs. (41 N·m) (Figure 16).
