04427 Version 2

Safety Recall: Rear Side Marker Light Is Not Working

Year	Model	Trim	VIN Range
2016	Civic	2-Door	Check the VIN status inquiry

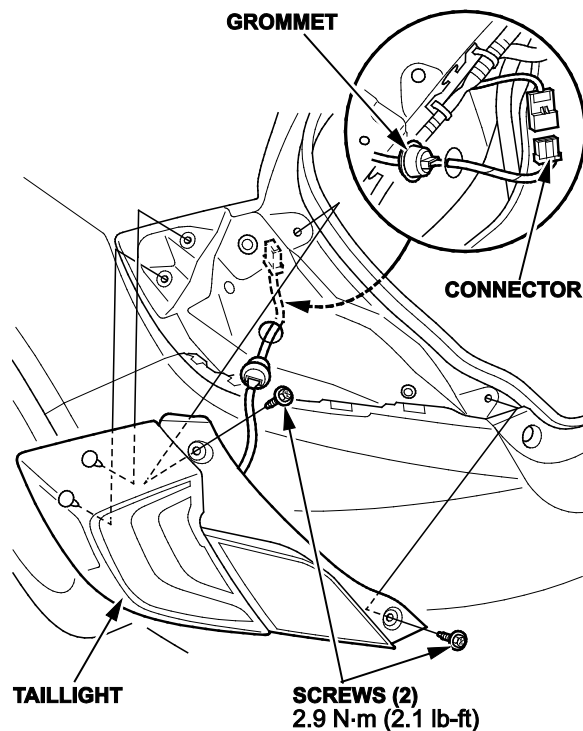
1. Remove the trunk rear side trim panel.
2. Disconnect the connector.

3. Remove the grommet.
4. Remove the taillight.
5. Install the grommet and connect the connector.
6. Install a new taillight, then torque the screws to **2.9 N-m (2.1 lb-ft)**.

7. Install the trunk rear side trim panel.
8. If necessary, repeat steps 1 thru 7 for the opposite side.
