Recall Service Bulletin

APPLIES TO: This recall service bulletin applies to transit bus chassis cabs altered by Spartan Motors, USA Inc. between January 29, 2014 and December 1, 2014.

NHTSA/TC Id: 16V-537

CONDITION: Altered chassis frame may crack

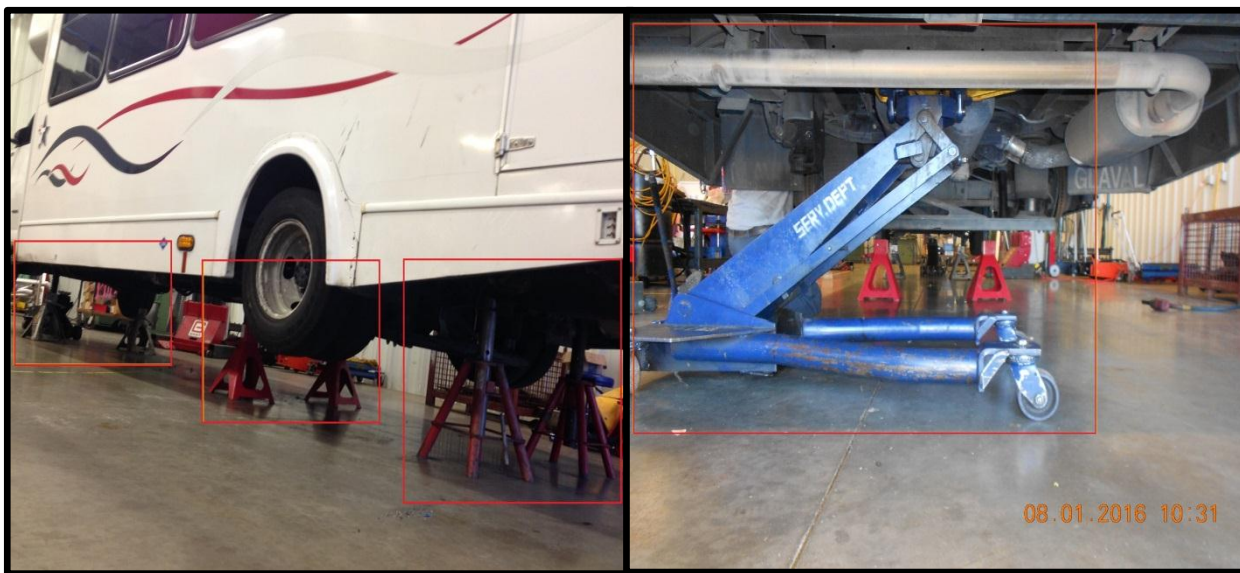
FIG. 2-2

1. Raise vehicle to desired working height and securely place on jack stands. Use at least seven (7) jack stands to support truck under frame rail. Locate jack stands in the following places: two (2) in front, two (2) in middle, and two (2) just behind rear axle, and use a jack at very rear of bus cross member for support. Refer to FIG. 2-2.

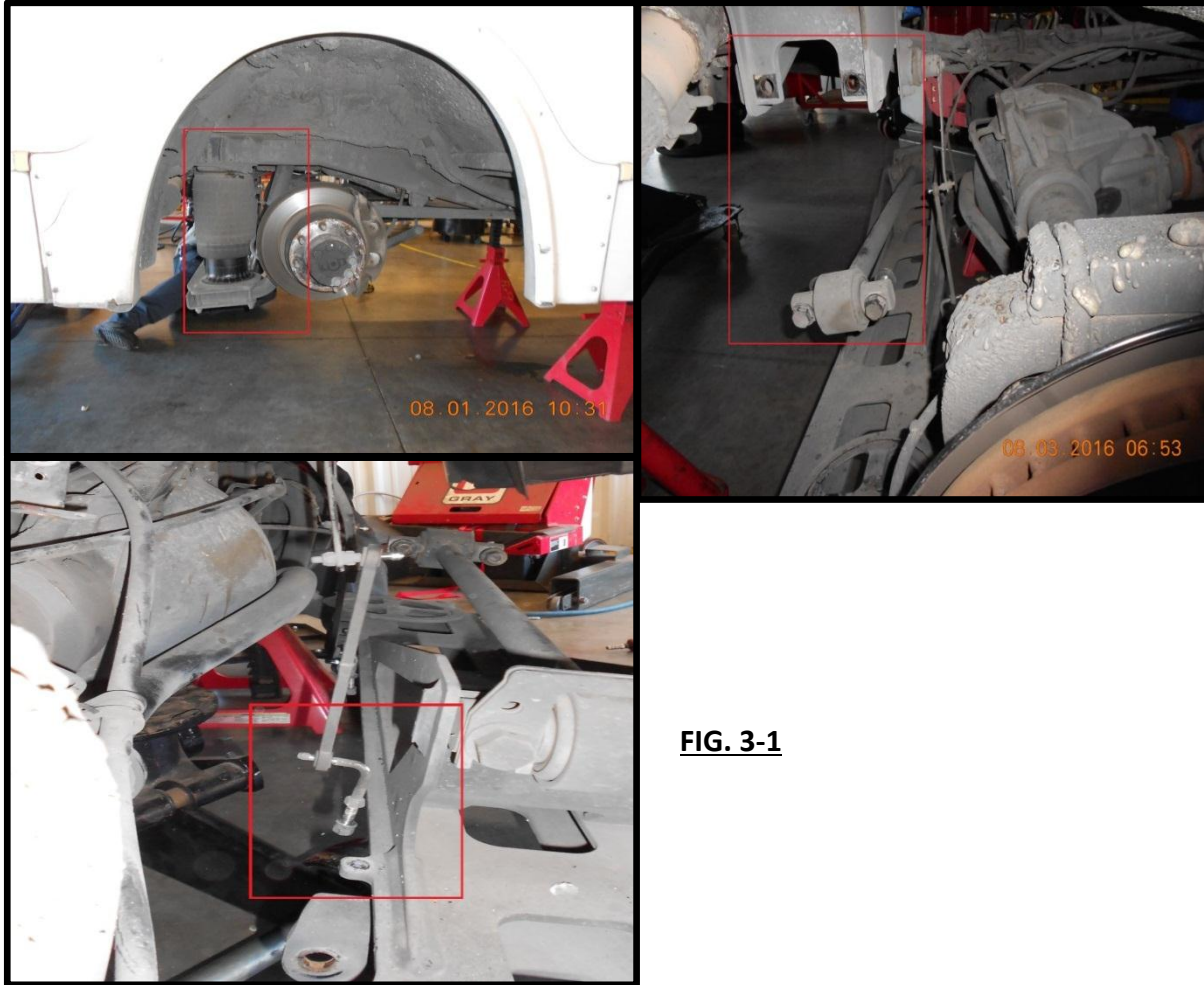
FIG. 3-1

3. Remove sway bar end links, rear shocks, air springs, track rod at cross member, and disconnect height control valve linkages. Retain for re-install. Refer to FIG. 3-1.

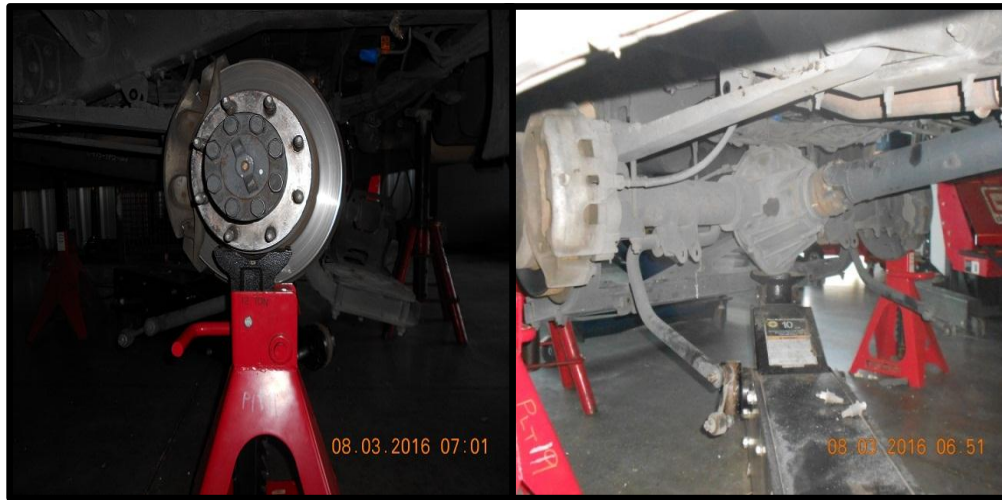
FIG. 4-1

4. Support rear axle on jack stands. Refer to FIG. 4-1.

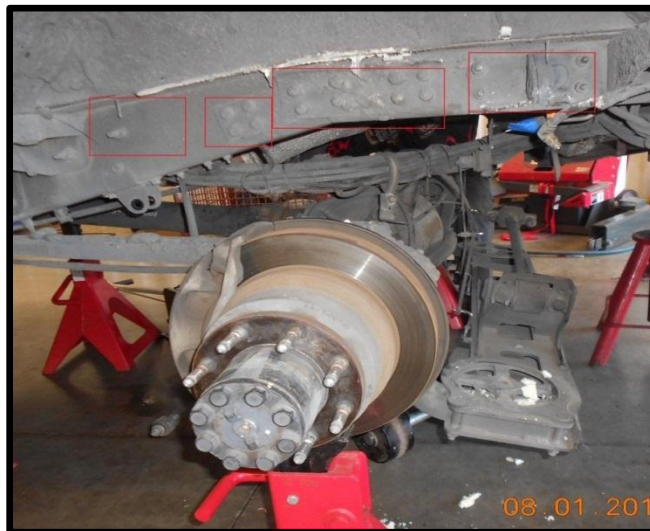
FIG. 4-2

5. Cut and remove seventeen (17) huck bolts from frame. Properly dispose of hardware. Refer to FIG. 4-2.

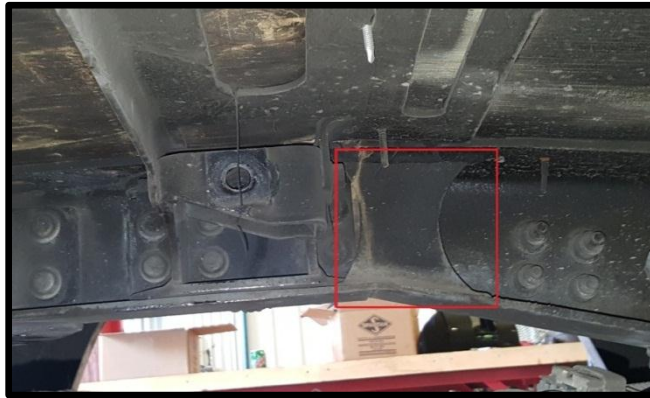
FIG. 5-1

6. Cut out old support bracket and grind down weld as close to frame rail as possible. Properly dispose of support bracket. Refer to FIG. 5-1.

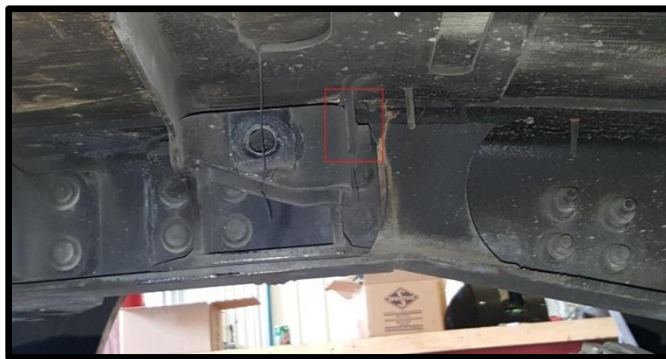
FIG. 5-2

7. Cut off tab connecting cross member to shock mount and **save tab for re-install**. Refer to FIG. 5-2.

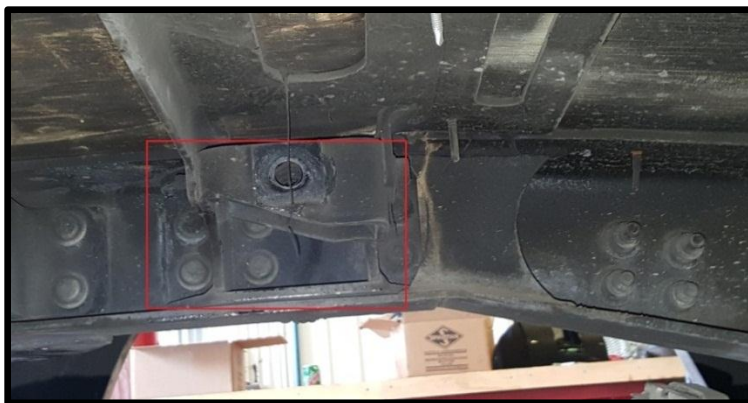
FIG. 5-3

8. Remove old shock mount. Properly dispose shock mount. Refer to FIG. 5-3.

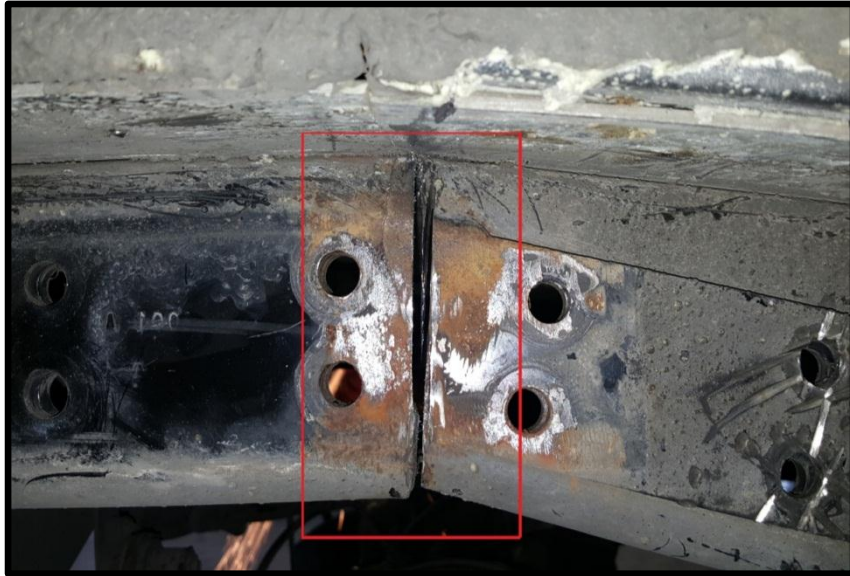
FIG. 6-1

9. Cut frame rail in half along old weld, **do not cut into floor**. Refer to FIG. 6-1.

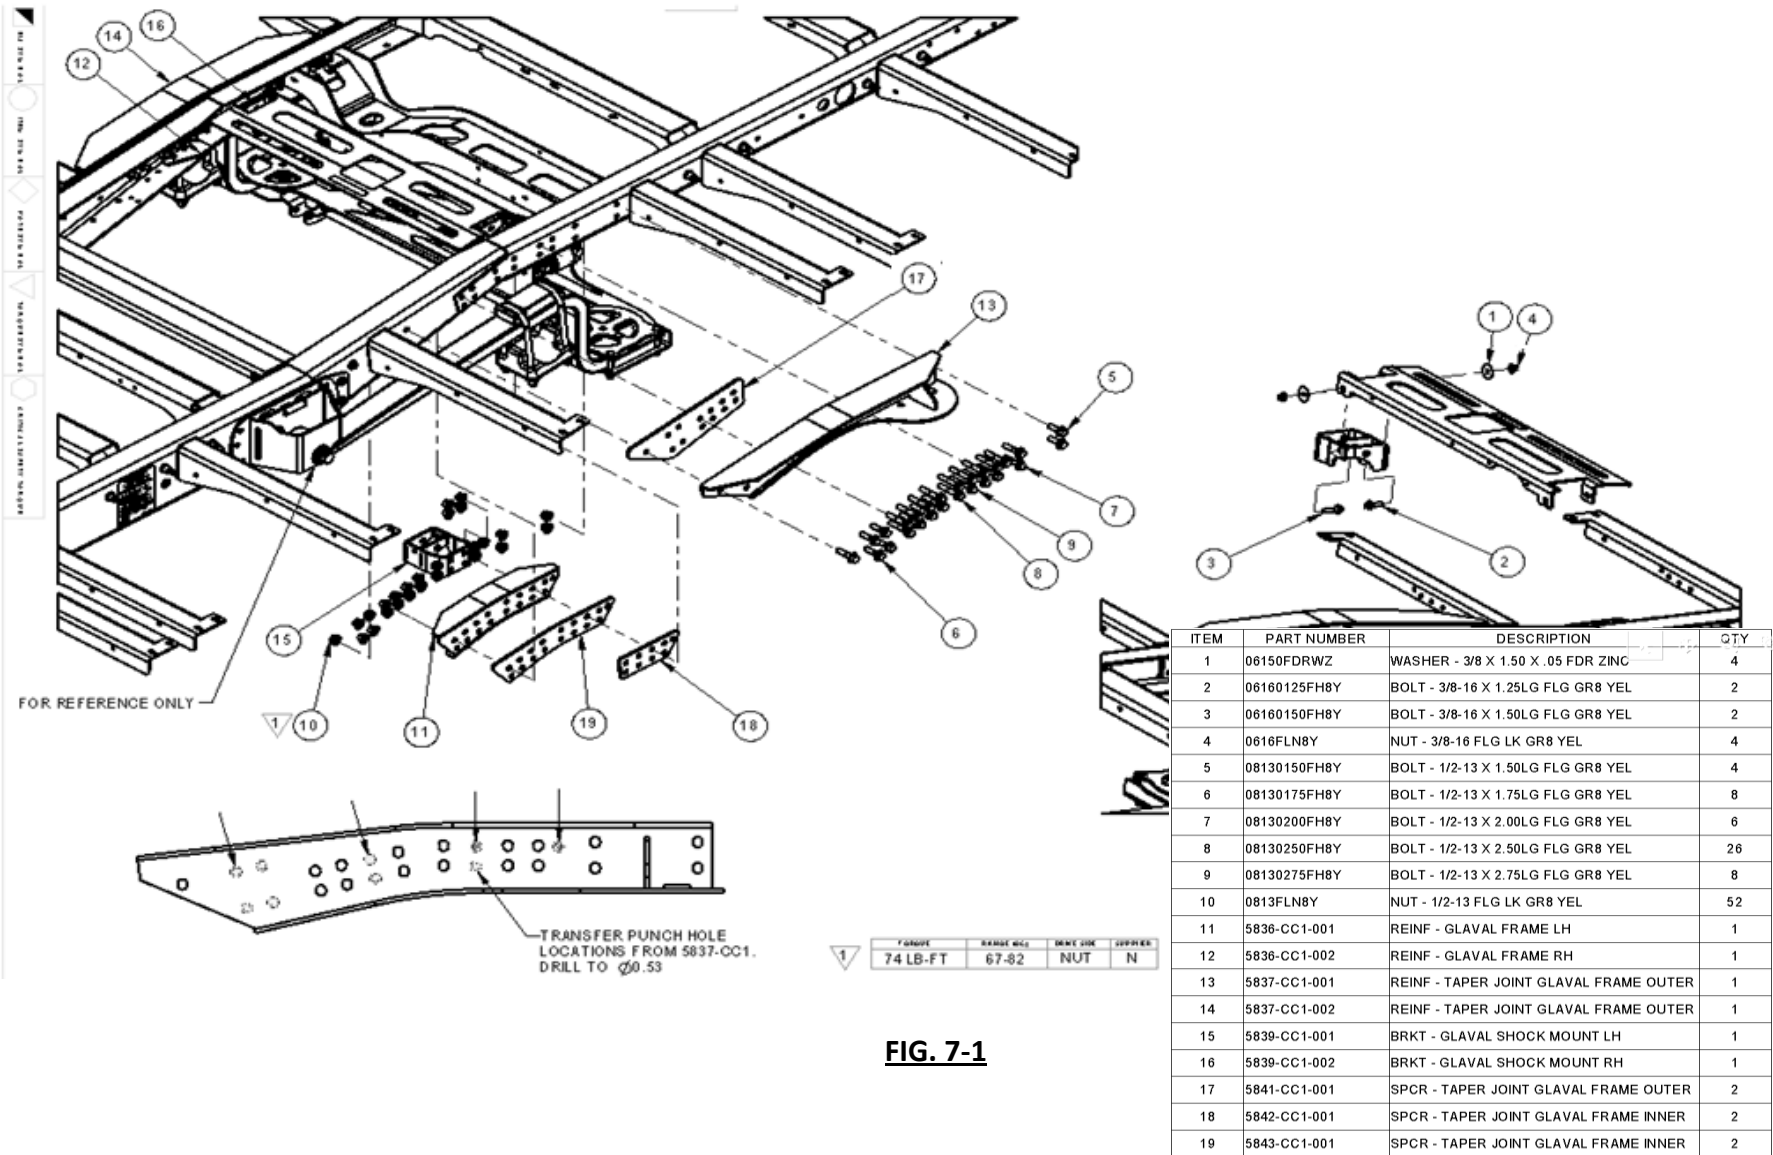
FIG. 7-1

10. Fit 5837-CC1-001 & -002 to match existing holes and transfer punch nine (9) additional hole locations.
11. Drill nine (9) additional .53" diameter holes through frame rail. Use drill fixture 5854-CC1-001 for magnetic drill attachment.
12. Remove drill fixture from vehicle and retain for re-use on other units.
13. Install new frame rail support brackets and shock mount. Refer to FIG. 7-1, FIG. 8-1, and FIG. 9-1. Torque specification is nut side of bolt 74 FT.-LBS. or head side of bolt 94 FT.-LBS.

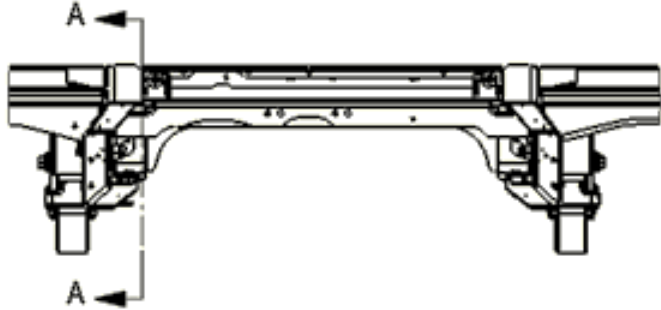
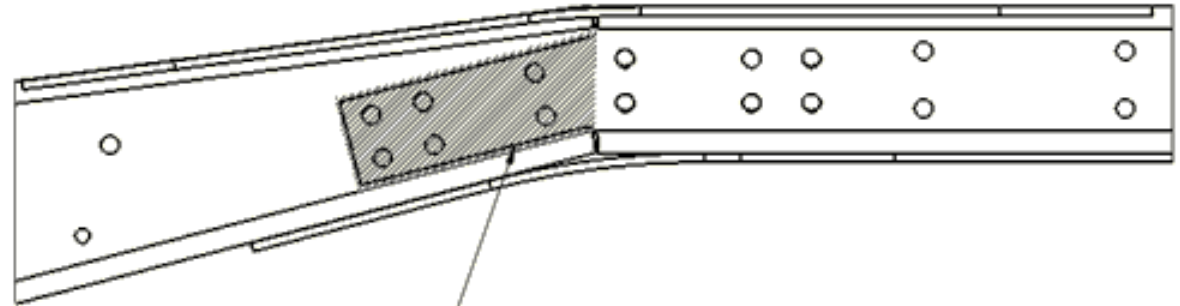
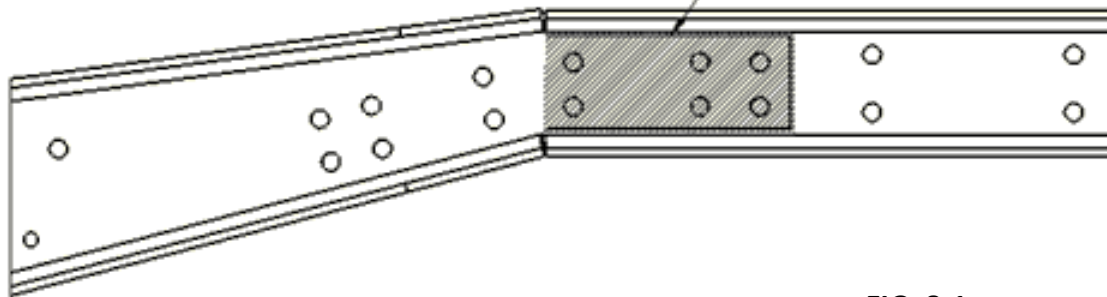
FIG. 8-1

REMOVE "TAB"

SECTION A-A

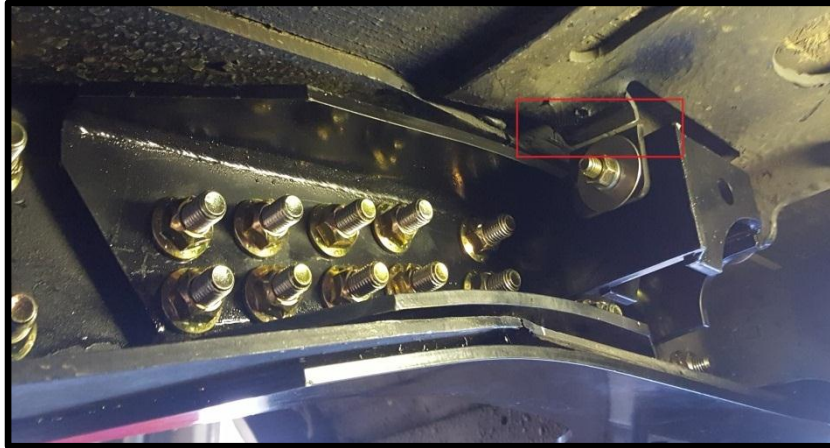
FIG. 10-1

14. Once shock mount bracket and cross member are torqued in place, weld retained tab for cross member back on. Refer to red box within FIG. 10-1.

NOTE: Follow recommended welding procedures per AWS D 1.1 using E70 weld wire.

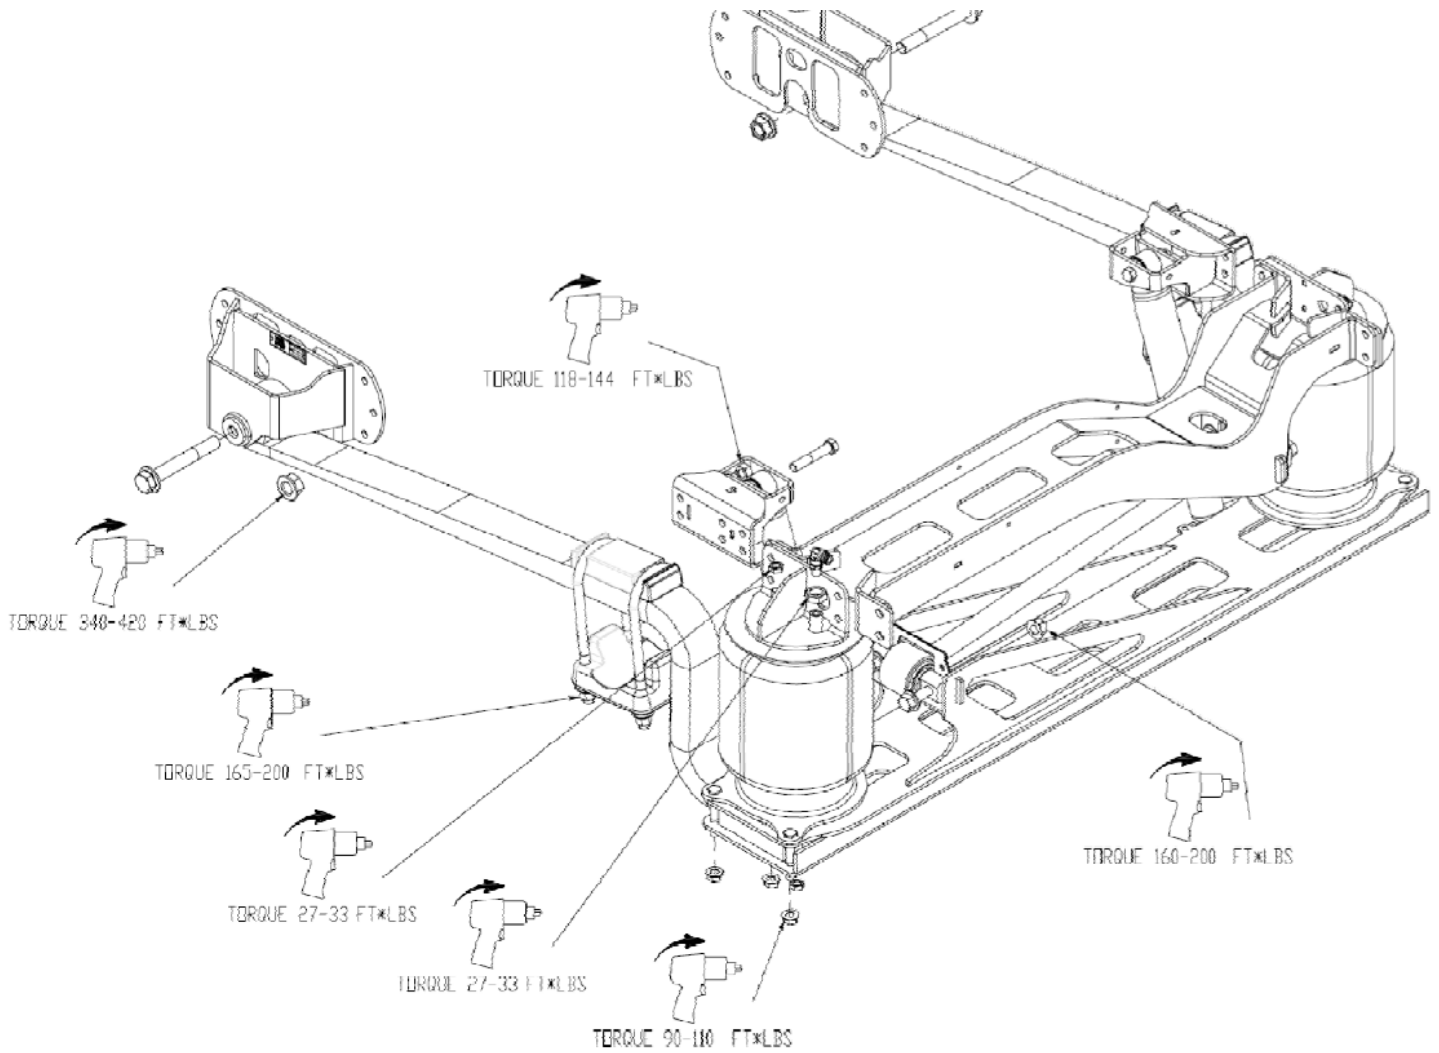
FIG. 11-1

15. Re-install retained shock and torque shock eye bolt nut side. Refer to FIG. 11-1.
16. Re-install retained air spring and torque nuts. Refer to FIG. 11-1.
17. Re-install retained air line for air bag.
18. Re-install retained track rod and torque nut side of bolt. Refer to FIG. 11-1.
19. Re-install retained rear wheels and torque. Refer to FIG. 13-1.
20. Re-install retained CNG line per CNG instructional document attached.
21. Re-install retained Height Control valve linkage. Refer to FIG. 12-1.
 - a. Once wheels are mounted on bus and torqued wheels are complete allow for suspension to be full system air pressure.
 - b. Set ride height to manufacture specification of 11.75 inches from the bottom of the air spring pad to the top of the air spring pad.

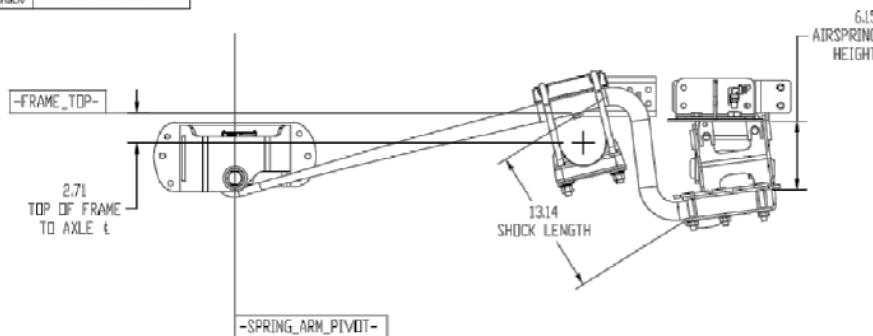
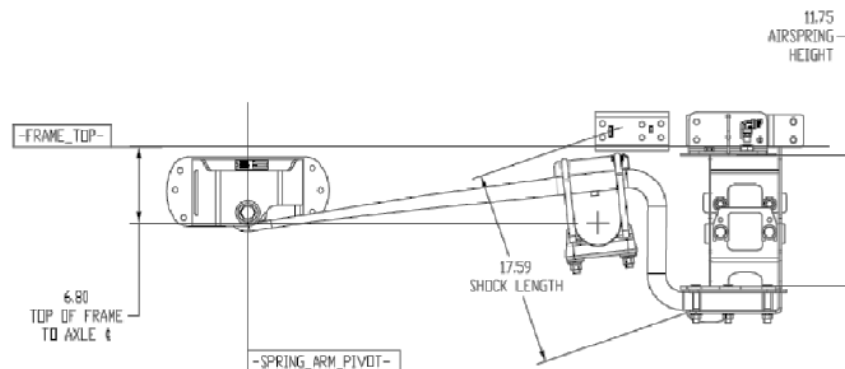
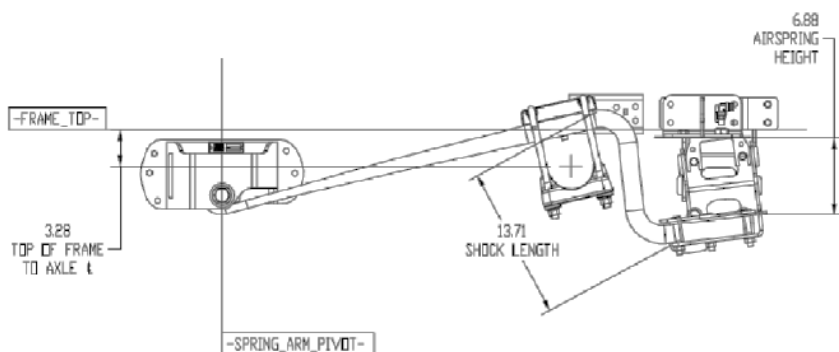
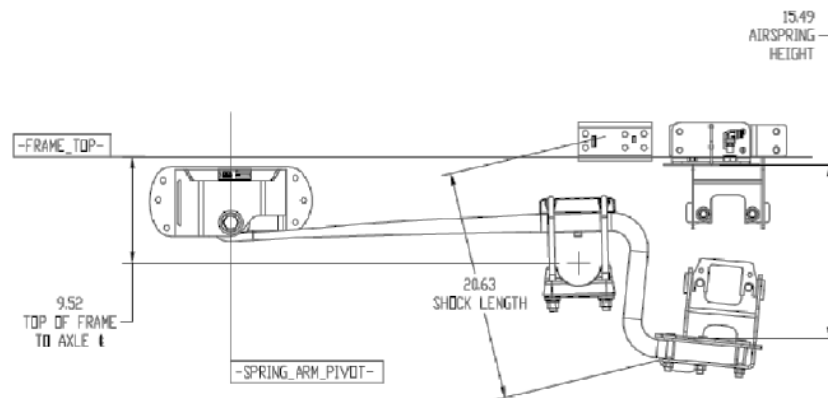
FIG. 12-1

FULL JOUNCE

-4.05° FROM RIDE HEIGHT
LIMITED BY SHOCK COMPRESSION
SHOCKS AND AIRSPRINGS OMITTED FOR CLARITY

RIDE HEIGHT

SHOCKS AND AIRSPRINGS OMITTED FOR CLARITY

JOUNCE/BUMPER CONTACT

-3.51° FROM RIDE HEIGHT
SHOCKS AND AIRSPRINGS OMITTED FOR CLARITY

FULL REBOUND

-2.71° FROM RIDE HEIGHT
LIMITED BY SHOCK EXTENSION
SHOCKS AND AIRSPRINGS OMITTED FOR CLARITY

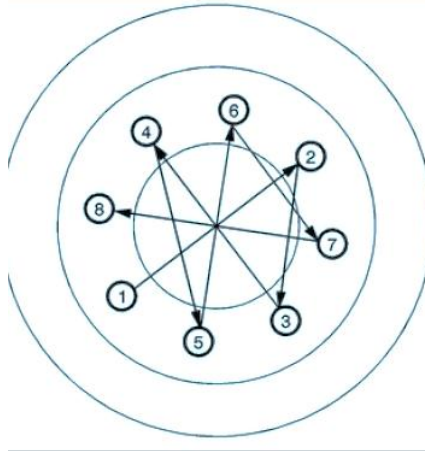
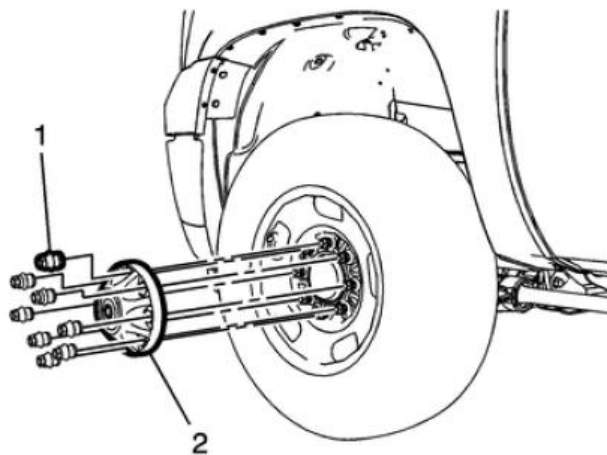
FIG. 13-1

Improperly tightened wheel bolts or nuts can lead to brake pulsation and rotor damage. In order to avoid expensive brake repairs, evenly tighten the wheel bolts or nuts to the proper torque specification.

Using a torque wrench and the appropriate socket, alternately and evenly tighten the wheel nuts to $190\text{ N}\cdot\text{m}$ (140 lb ft) in the sequence illustrated.

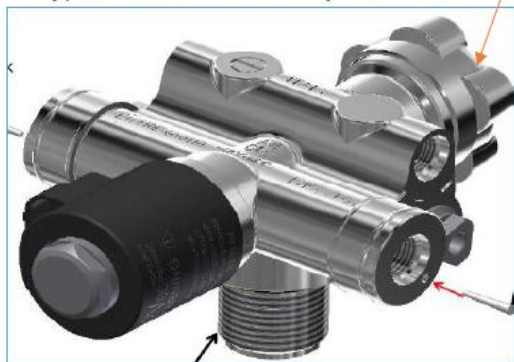
Typical View of the OMB Lyra CV Valve

Open the rear tank access doors and turn off the CNG tank manual valves, this is a clockwise rotation and should be continued until the valve is fully seated. Then turn aft (rear) ¼ turn valve to the off position.

NOTE: ¼ turn valves have an off position that is 90 degrees of the line that they are controlling, a ¼ turn valve that is on will run in the same direction as the line that it is controlling.

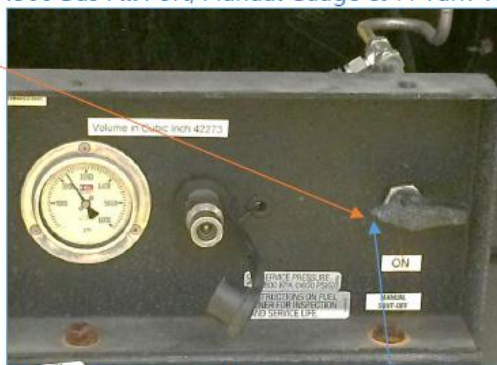
G4500 Bus Fill Port, Manual Gauge & ¼ Turn Valve

Note this view has ¼ turn in the off position

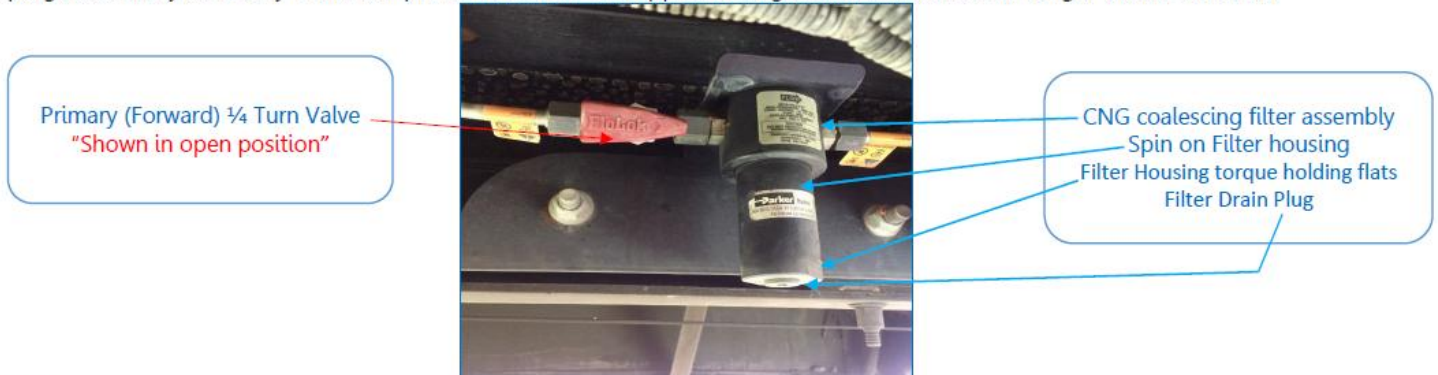
At this time you need to turn off the forward ¼ turn valve located just back of the CNG coalescing filter assembly. Turn valve off so that it is not parallel with the fuel line. Now using an adjustable or suitable size wrench firmly hold the two flats on the filter housing, insert proper size Allen wrench or Allen driver socket (1/4 inch should be correct size) into the drain plug and slowly remove the plug, there may be a very short low pressure release of trapped CNG gas that should not be longer than 2 seconds.

With drain plug removed from filter housing slowly rotate the red primary ¼ turn valve to the open position shown above. Carefully listen for CNG purge, there may be a 1 to 2 second purge of residual gases and then flow should stop. If there is no further CNG flow you have now evacuated the system for line and or filter repairs/maintenance.

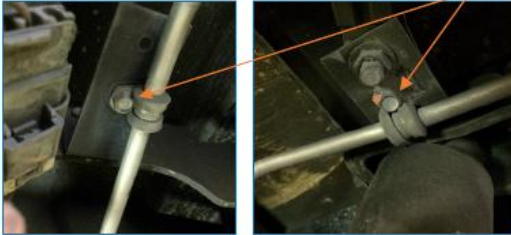
- a) Remove both insulated p-clip line bracket screws

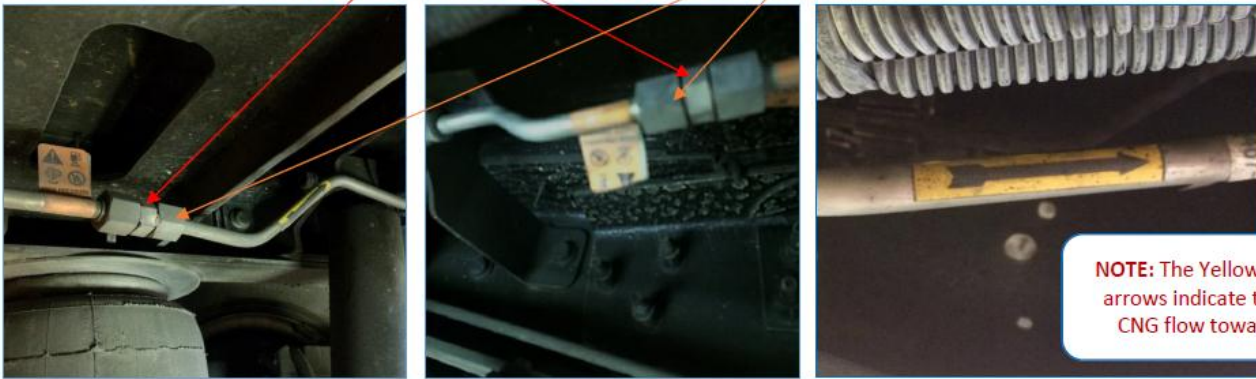
- b) Using the two wrenches grab the center section of the line extension and the nut that holds the line on. Break loose the nut and by hand back nuts off completely, do not force any bending of the line it will be loose enough to be removed when both the front and back section nuts have been backed off. Repeat last procedure for the other end and then gently remove the CNG feed line

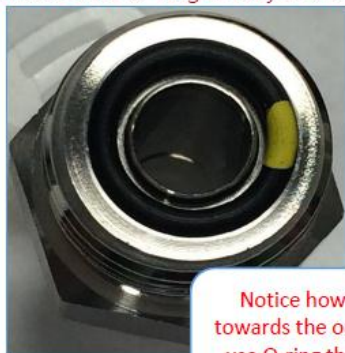
NOTE: make sure O-ring is fully seated in tube groove as not to be pinched (Torque line nuts **31-35 ft-lbs.**)

Notice how the O-ring is pushing towards the out edge of groove, do not use O-ring that is collapsed towards the inner edge of the O-ring groove

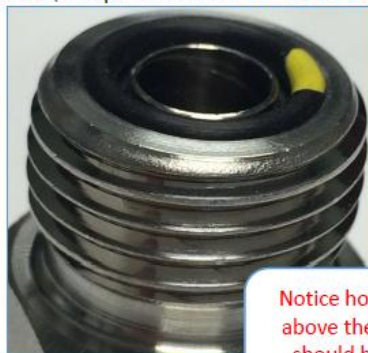
Notice how O-ring just protrudes above the face of the union, this should be uniform around the entire circumference of the union

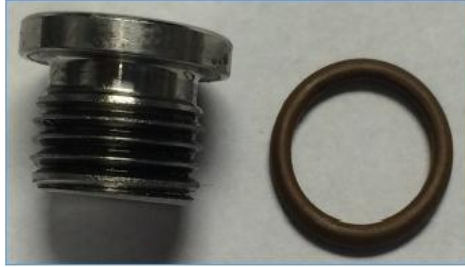
Install new O-ring on filter drain plug using a #8 SAE O-ring & torque to **62 lb in** (7 n-m)

With O-ring removed

With O-ring installed
