Dealer Service Instructions for:

Safety Recall S62 / NHTSA 16V-545 Trailer Hitch

2015-2016 (BU) Jeep® Renegade

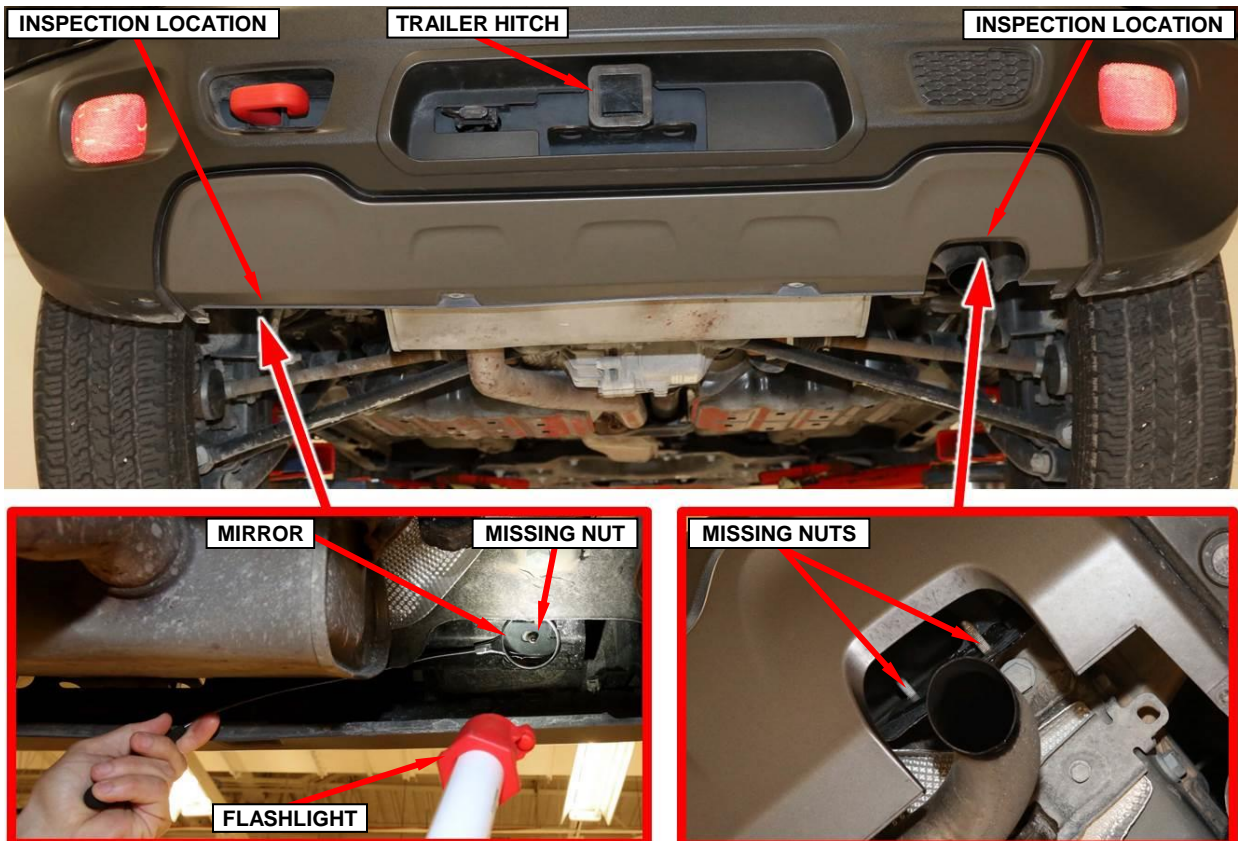
Figure 1 – Inspect Trailer Hitch-to-Body Studs for Missing Nuts

1. Raise the vehicle on an appropriate hoist.
2. Using a flashlight and mirror, inspect for any missing nuts at the trailer hitch-to-body studs on the left and right sides of the vehicle. Three nuts per side, six nuts total should be visible (Figure 1).
3. Are all six nuts installed or are any nuts missing?
 - All six nuts are visible and appear to be fully installed tightly against the trailer hitch. Claim the inspection LOP to complete the recall and return the vehicle to the customer.
 - If any of the six nuts are missing or do not appear to be fully tightened, proceed to **Section B. Install Trailer Hitch-to-Body Attachment Nuts.**

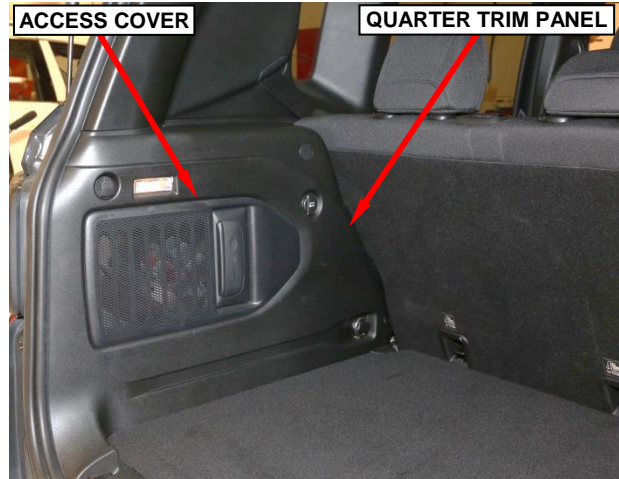
Figure 2 – Quarter Trim Access Cover

2. Using a trim stick or equivalent, remove the inner access covers from the left and right side quarter trim panels (Figure 2).

29. Install the inner access covers to the left and right side quarter trim panels (Figure 2).
30. Connect the negative vehicle battery cable.
31. Check the tail lamps for proper function.

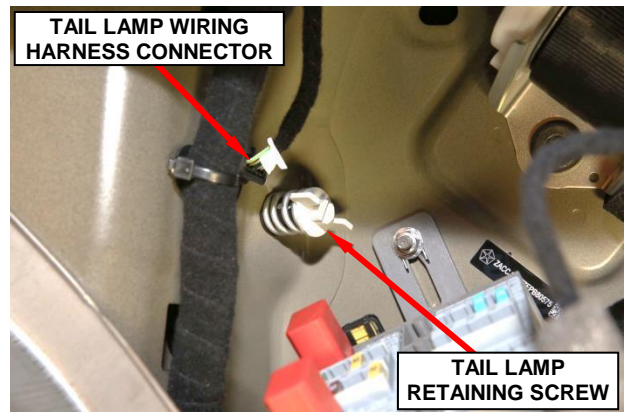
Figure 3 – Tail Lamp retaining screw and Wiring Harness Connector

3. Disconnect the wiring harness connector from the left and right side tail lamps (Figure 3).

4. Remove the tail lamp retaining screw from the left and right side tail lamps (Figure 3).

27. Install the tail lamp retaining screws to the left and right side tail lamps. Tighten the screws securely (Figure 3).
28. Connect the wiring harness connector to the left and right side tail lamps (Figure 3).

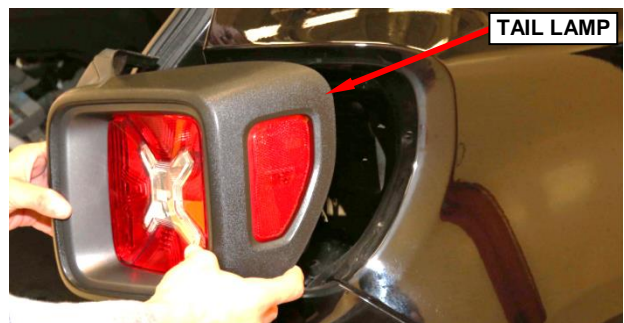
Figure 4 – Tail Lamp

5. Pull the tail lamp from the outboard side in order to remove the tail lamps from the left and right sides of the vehicle (Figure 4).

24. Install the four screws to the lower edge of the rear fascia. Tighten the screws securely (Figure 5).
25. Lower the vehicle.
26. Install the left and right side tail lamps to the vehicle (Figure 4).

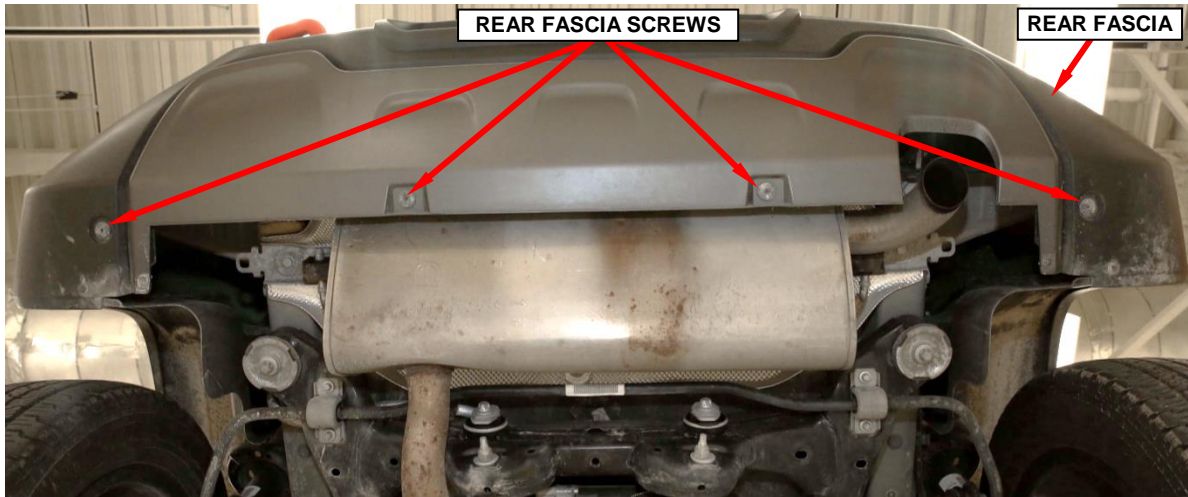
Figure 5 – Rear Fascia Lower Edge Screws

7. Remove the four screws from the lower edge of the rear fascia (Figure 5).

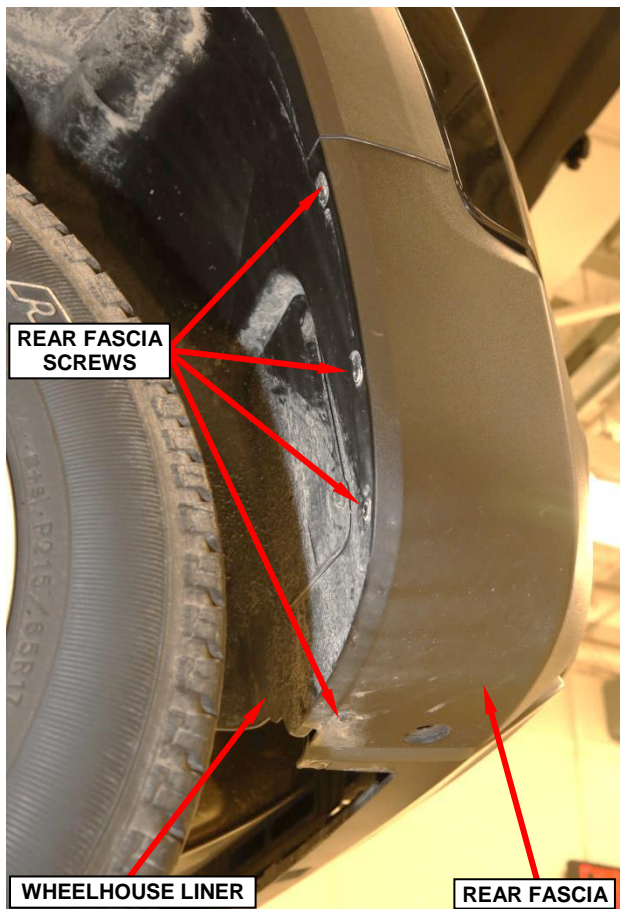
Figure 6 – Wheelhouse Fascia Screws

8. Remove the four screws securing the wheelhouse liner to the rear fascia on the left and right sides of the vehicle (Figure 6).

23. Install the four screws securing the wheelhouse liner to the rear fascia on the left and right sides of the vehicle. Tighten the screws securely (Figure 6).

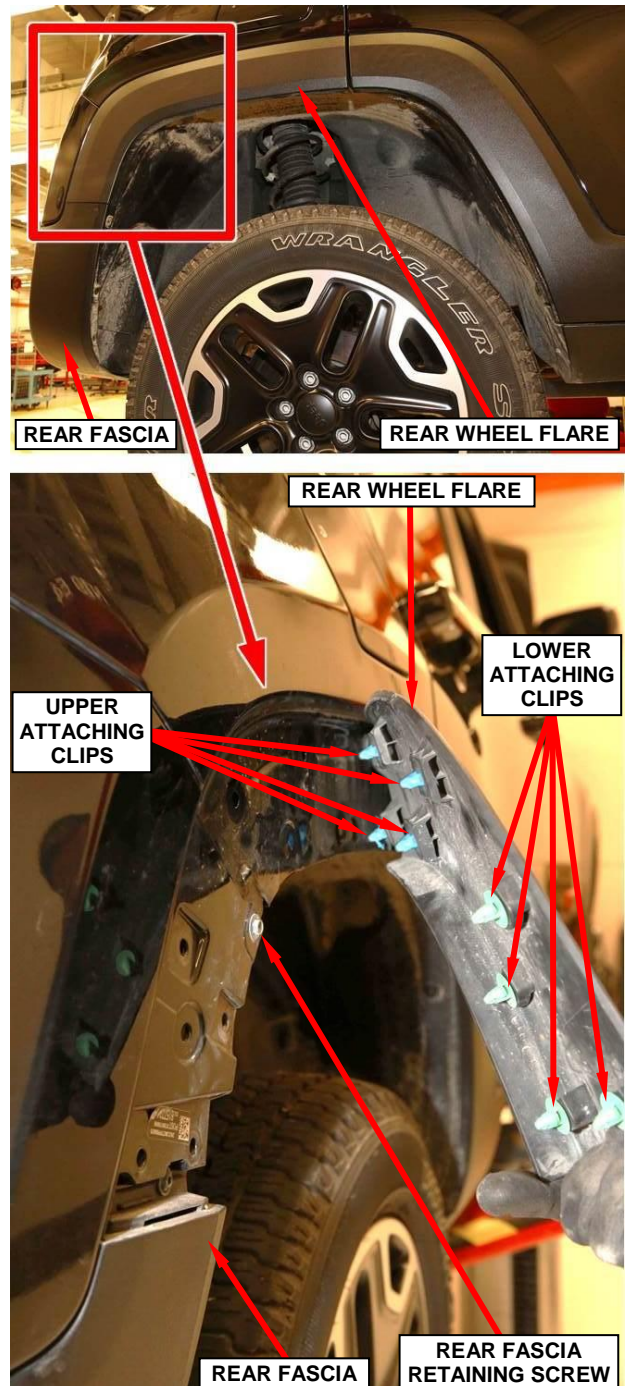
Figure 7 – Rear Wheel Flare

9. Perform the following steps to gain access to the rear fascia retaining screw hidden behind the rear wheel flare on the left and right sides of the vehicle (Figure 7):

- a. Carefully pull back the wheelhouse liner only enough to gain access to the wheel flare lower attaching clips.
- b. Begin with the lowest attaching clip and work upward using a socket of an appropriate size small enough to depress the retaining tabs of the attaching clips. Release the accessible wheel flare lower attaching clips from the rear fascia.
- c. Using a trim stick or equivalent, carefully release only enough of the remaining upper wheel flare attaching clips in order to access the rear fascia retaining screw hidden behind the wheel flare.

10. Remove the rear fascia screw located behind the rear wheel flare on the left and right sides of the vehicle (Figure 7).

21. Install the screws located behind the rear wheel flare on the left and right sides of the vehicle. Tighten the screws securely (Figure 7).

22. Secure the rear wheel flares on the left and right sides of the vehicle by tapping on the wheel flare by hand to engage the attaching clips (Figure 7).

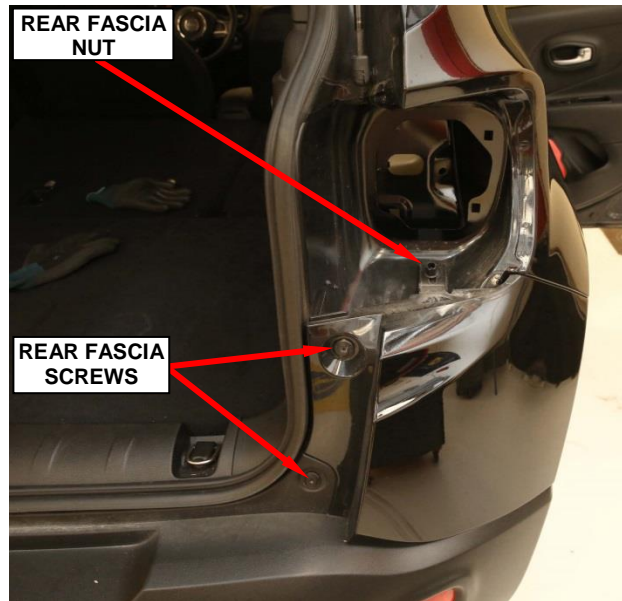
Figure 8 – Rear Fascia Fasteners

11. Remove the rear fascia nut located in the tail lamp bucket on the left and right sides of the vehicle (Figure 8).

12. Remove the rear fascia screws located in the tailgate opening on the left and right sides of the vehicle (Figure 8).

19. Install the screws located in the tailgate opening. Tighten the screws securely (Figure 8).

20. Install the nuts located in the tail lamp bucket on the left and right sides of the vehicle. Tighten the screws securely (Figure 8).

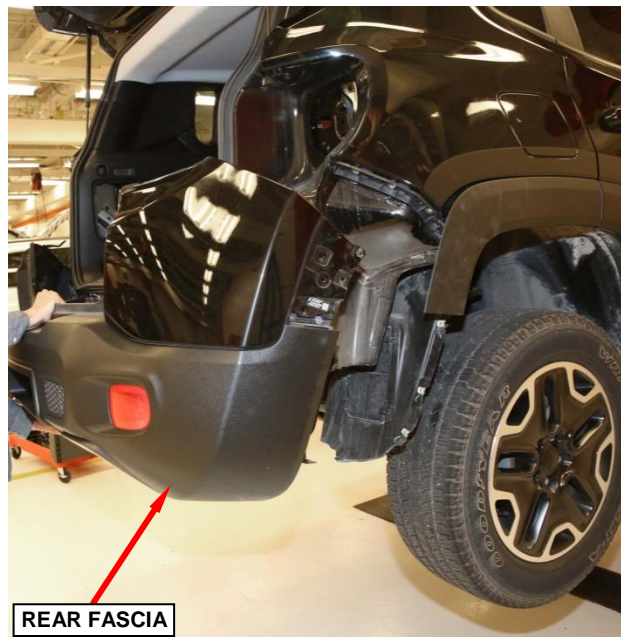
Figure 9 – Rear Fascia

13. Remove the rear fascia from the vehicle and set aside in a safe clean area to prevent scratches (Figure 9).

18. Position the rear fascia to the vehicle (Figure 9).

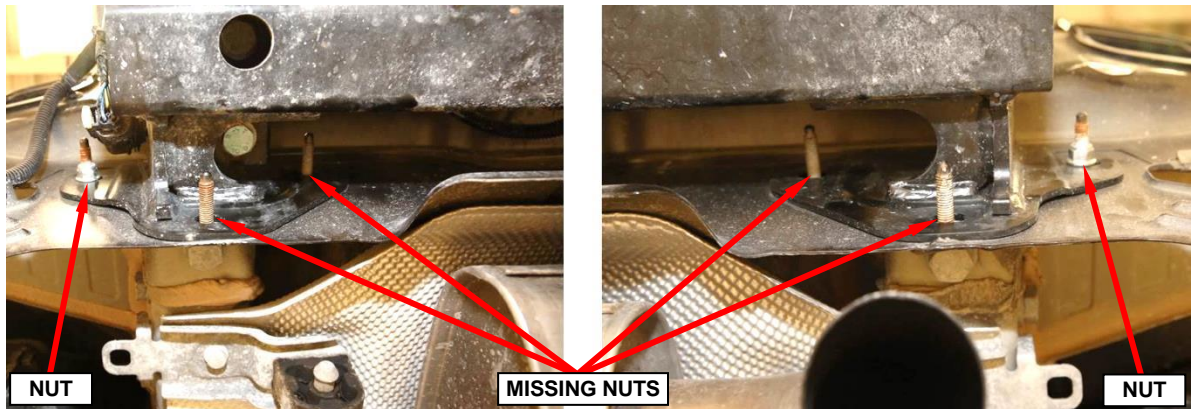
Figure 10 – Trailer Hitch-to-Body Attachment Studs Missing Nuts

14. Clean the trailer hitch-to-body attachment stud threads of any debris before installing any nuts that may be missing (Figures 10 and 11).

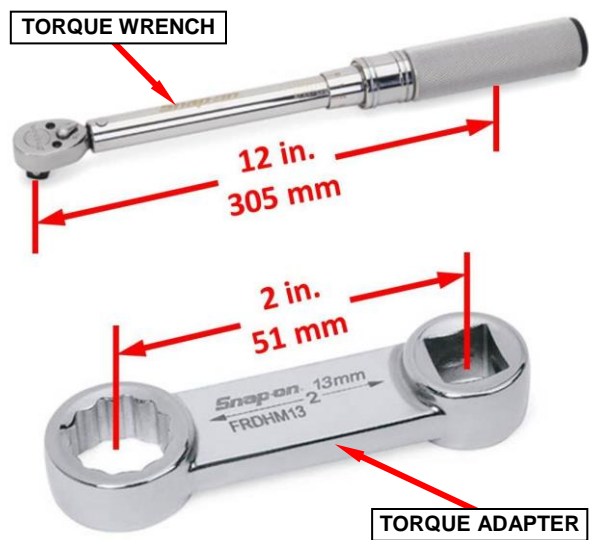
Figure 12 – Required Tools

15. Obtain a Snap-on FRDHM13 or equivalent 13 mm Torque Adapter and a torque wrench with a handle length of approximately 12 in. (305 mm) in order to achieve the proper torque specification while tightening the trailer hitch-to-body attachment nuts (Figure 12).

CAUTION: Using a Torque Adapter or Torque Wrench of longer or shorter dimension may result in trailer hitch-to-body attachment nuts that are either too tight or too loose.

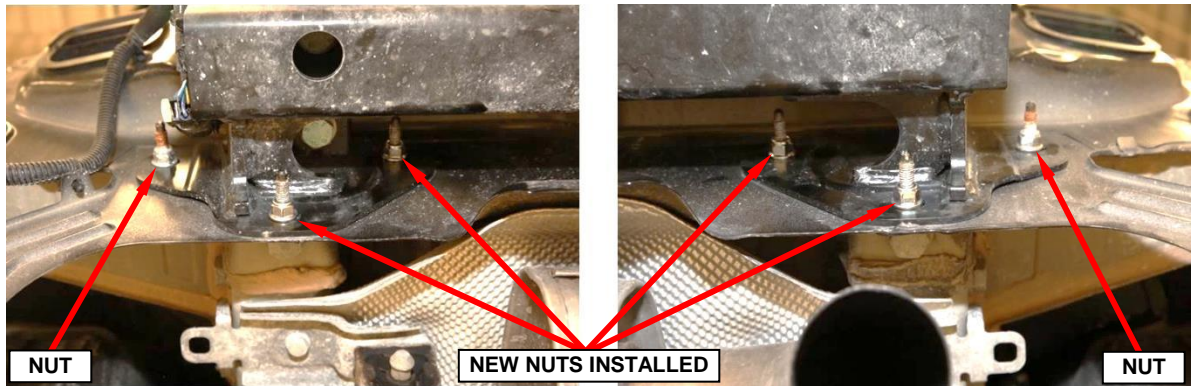
Figure 13 – Trailer Hitch-to-Body Attachment Nuts Installed

16. Install any trailer hitch-to-body attachment nuts that may be missing (Figure 13).

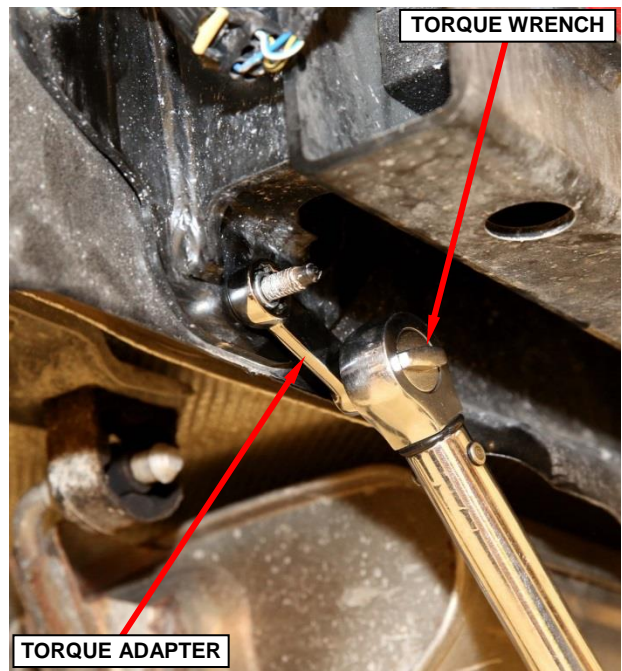
Figure 14 – Tighten Nuts to Proper Torque Specification

17. Using the previously specified torque adapter and torque wrench, tighten all six nuts to 16 ft. lbs. (22 N·m) (Figure 14).
