## RECALL 16V-553: HEAD PROTECTION SYSTEM

F54 MINI Clubman
------------------

The head airbag (side airbag curtain) may not deploy properly in a side crash.

Remove excess wrapper material from around airbag.

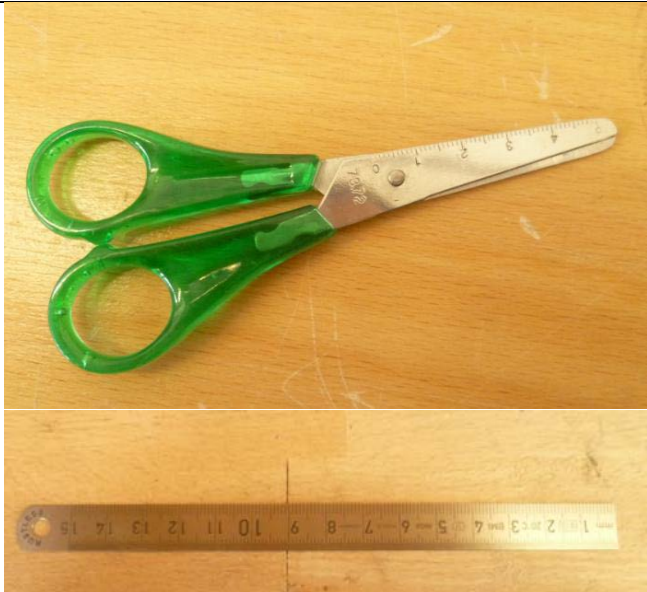
<p><b>Required Tools:</b></p> <ul style="list-style-type: none"><li>• Scissors with round tips</li><li>• Metric ruler</li></ul>
