# Safety Recall Notice

## Service Bulletin

### 503067 Rev. A

Applicable for 2016 Ford MXV

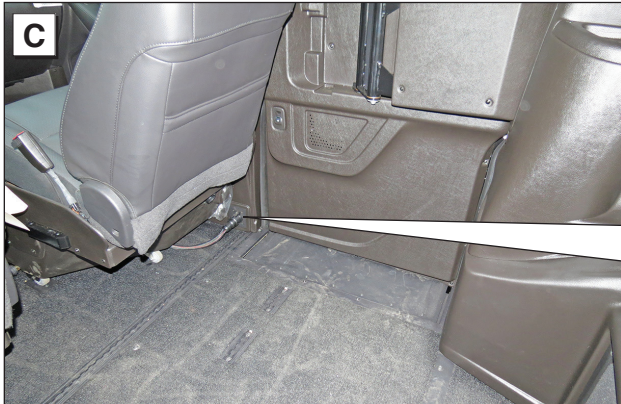
Passenger Seat  
Harness Connector

3. Disconnect front passenger seat harness from B-pillar. See Photos C and D.

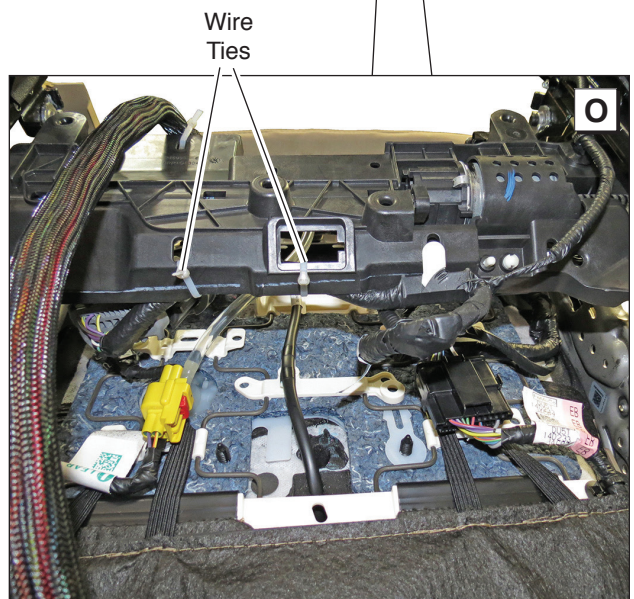
- Secure OEM seat harness to seat cross member with wire ties (2). Ensure proper routing on top of seat cross member. Refer to Photos J, N, and O.
