Southeast Toyota Distributors, LLC

**TECHNICAL INSTRUCTIONS**  
**FOR**  
**VOLANTARY SAFETY RECALL CAMPAIGN SET16D**  
**SET ACCESSORY EXHAUST TIP**  
**CERTAIN 2010-2015 MODEL YEAR 4RUNNER**

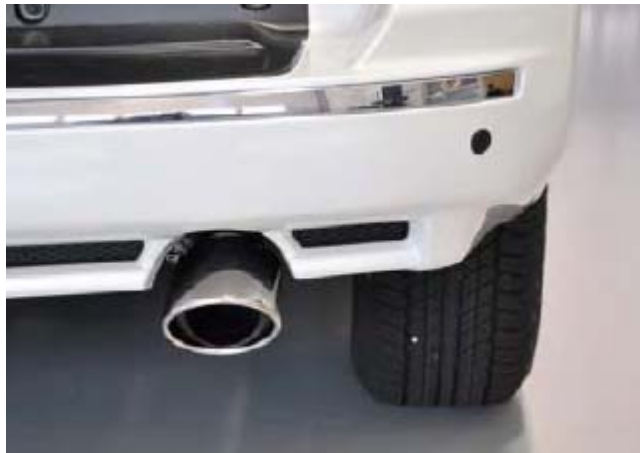
SET Accessory Exhaust Tip

SET either installed, or sold to dealers to install, accessory exhaust tips for 2010 - 2015 Toyota 4Runner. Although the exhaust tip is recessed behind the bumper, SET has determined that the exhaust tip could come into contact with people standing behind and reaching into the rear of the vehicles. A person who comes into contact with an exhaust tip can be burned.

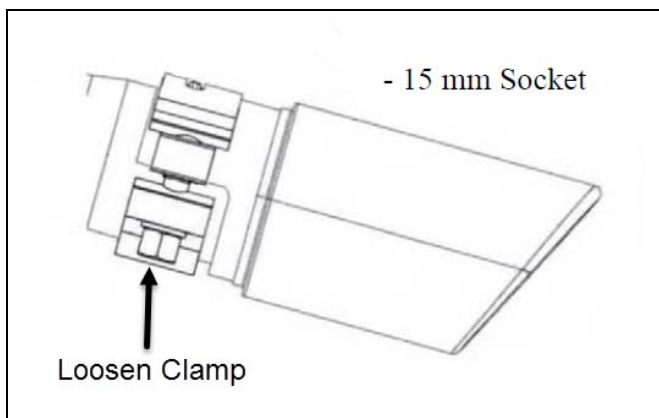
### A. Remove Exhaust Tip

1. Loosen 15mm nut on exhaust tip retaining clamp.
2. Remove the Exhaust Tip

- Click Link below for TIS installation instructions of PT932-89100 exhaust tip.
  - [2010-2016 4Runner Stainless Steel Exhaust Tip PT932-89100](#)
