Revised October 2016

# Safety Recall S63 / NHTSA 16V-590

## Seat Fastener Torque

2014-2016 (KL) Jeep® Cherokee

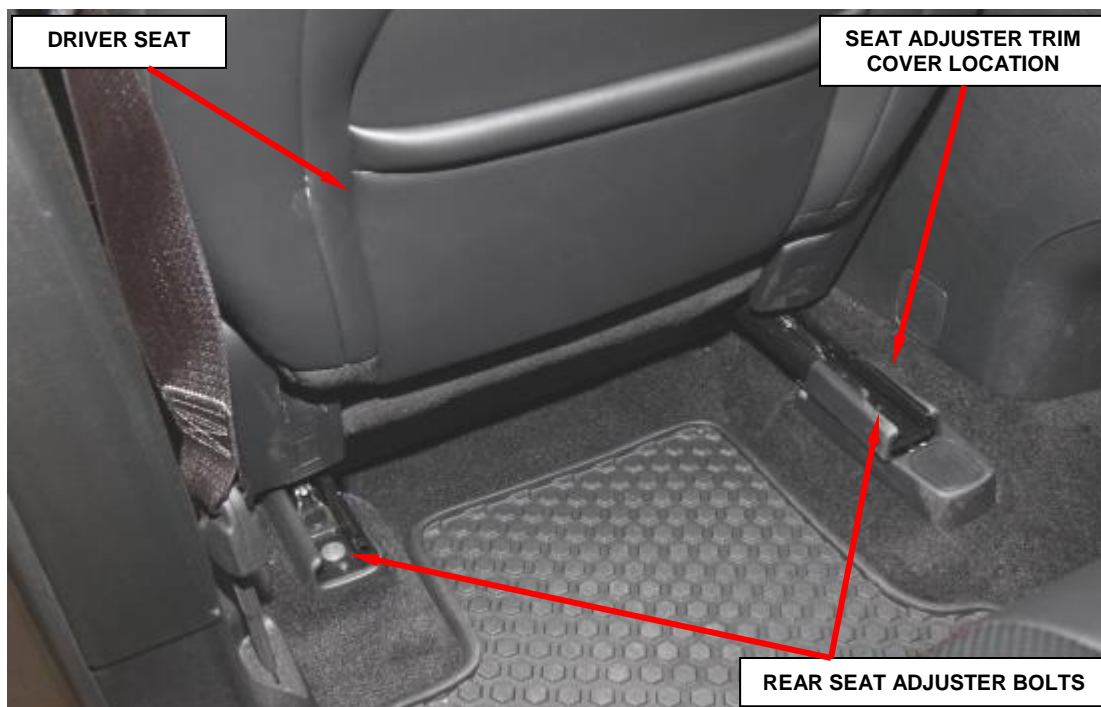
**Figure 1 – Rear Seat Adjuster Bolts**

- If the rear seat assembly is included in this recall, continue with **Section B. Replace Rear Seat Assembly.**
  - If a front seat assembly is included in this recall, continue with **Step 1.**
1. Position the front seat forward.
  2. Using trim stick C-4755 or equivalent, pry open the inboard rear seat adjuster trim cover (Figure 1).
  3. Remove the two rear seat adjuster bolts (Figure 1).

10. If the front seat was replaced, position the seat forward.
11. **Install the two rear seat adjuster bolts. Tighten to 30 ft. lbs. (40 N·m)** (Figure 1).

12. Close the inboard rear seat adjuster cover.
13. If an Electronic Control Unit (ECU) was replaced with a new unit, a diagnostic scan tool **MUST** be used to align the PROXI configuration data into the new ECU. Follow the routine outlined in the diagnostic scan tool for PROXI Configuration Alignment under Body Control Module (BCM) Miscellaneous Functions menu.

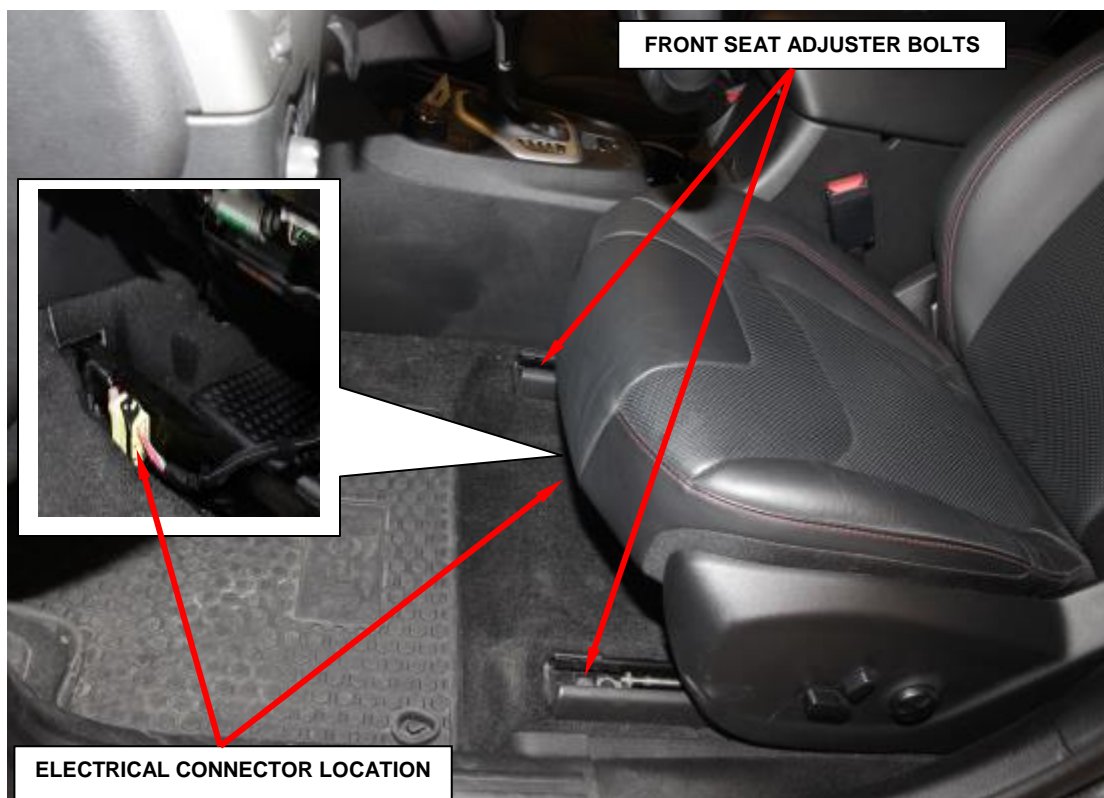
**Figure 2 – Front Seat Adjuster Bolts**

4. Position the front seat rearward.
5. Remove the two front seat adjuster bolts (Figure 2).
6. Open the hood.
7. Disconnect and isolate the negative cable from the battery. If equipped with an Intelligent Battery Sensor (IBS), disconnect the IBS connector before disconnecting the negative cable from the battery. Wait two minutes for the system capacitor to discharge before further service.
8. Disconnect all electrical connectors (Figure 2).

11. Connect all electrical connectors (Figure 2).

12. Install the two front seat adjuster bolts. Tighten to 30 ft. lbs. (40 N·m) (Figure 2).

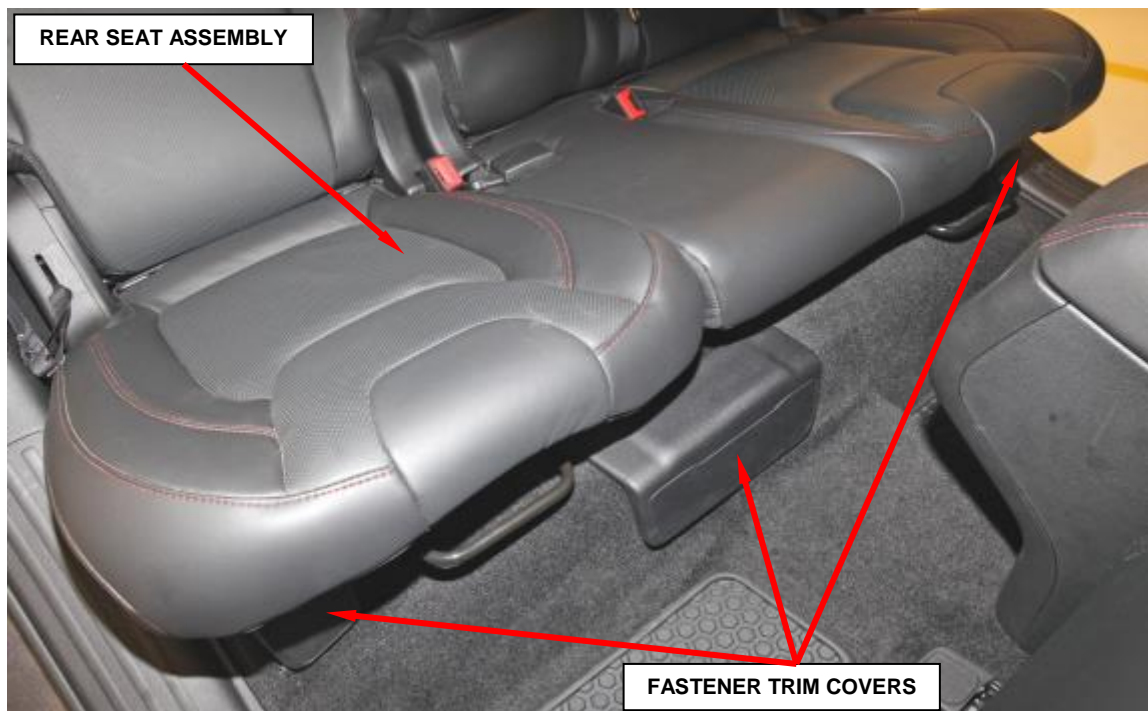
**Figure 3 – Fastener Trim Covers**

1. Move the front seats to their full forward position.
2. Disconnect and isolate the negative cable from the battery. If equipped with an Intelligent Battery Sensor (IBS), disconnect the IBS connector before disconnecting the negative cable from the battery. Wait two minutes for the system capacitor to discharge before further service.
3. Open the three fastener trim covers (Figure 3).

11. Install the three trim covers and seat fully (Figure 3).

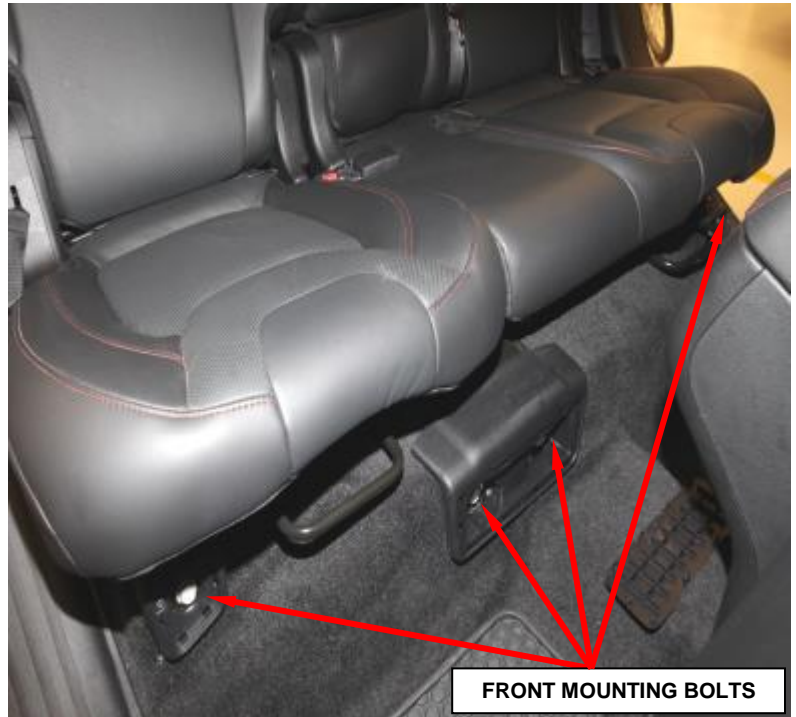
**Figure 4 – Front Mounting Bolts**

4. Remove the four front mounting bolts (Figure 4).
5. Fold the rear seat backs down and position the rear seats full forward.
6. Remove the four rear mounting nuts (Figure 5).
7. Disconnect the two electrical connectors and clips, if equipped (Figure 5).

10. Install the four front mounting bolts and tighten to 63 ft. lbs. (85 N·m) (Figure 4).
