October 2016

Dealer Service Instructions for:

## **Safety Recall S63 / NHTSA 16V-590 Seat Fastener Torque**

**2014-2016 (KL) Jeep® Cherokee**

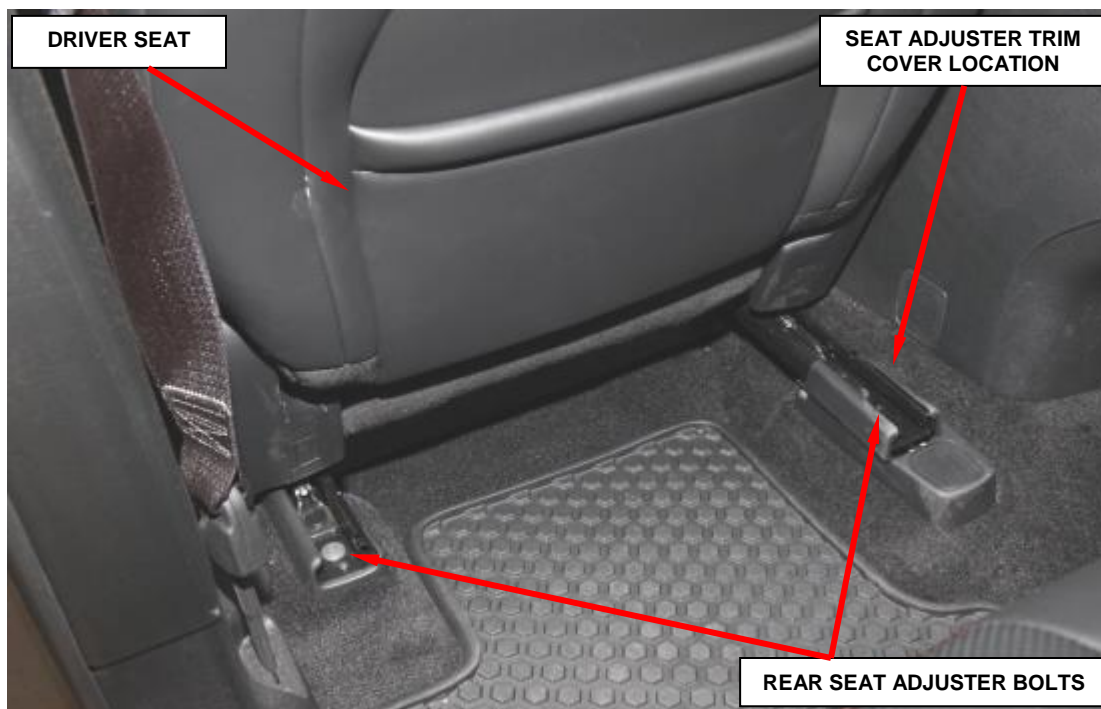
**Figure 1 – Rear Seat Adjuster Bolts**

- If the rear seat assembly is included in this recall, continue with **Section B. Replace Rear Seat Assembly.**
  - If a front seat assembly is included in this recall, continue with **Step 1.**
1. Position the front seat forward.
  2. Using trim stick C-4755 or equivalent, pry open the inboard rear seat adjuster trim cover (Figure 1).
  3. Remove the two rear seat adjuster bolts (Figure 1).

10. If the front seat was replaced, position the seat forward.
11. **Install the two rear seat adjuster bolts. Tighten to 30 ft. lbs. (40 N·m)** (Figure 1).

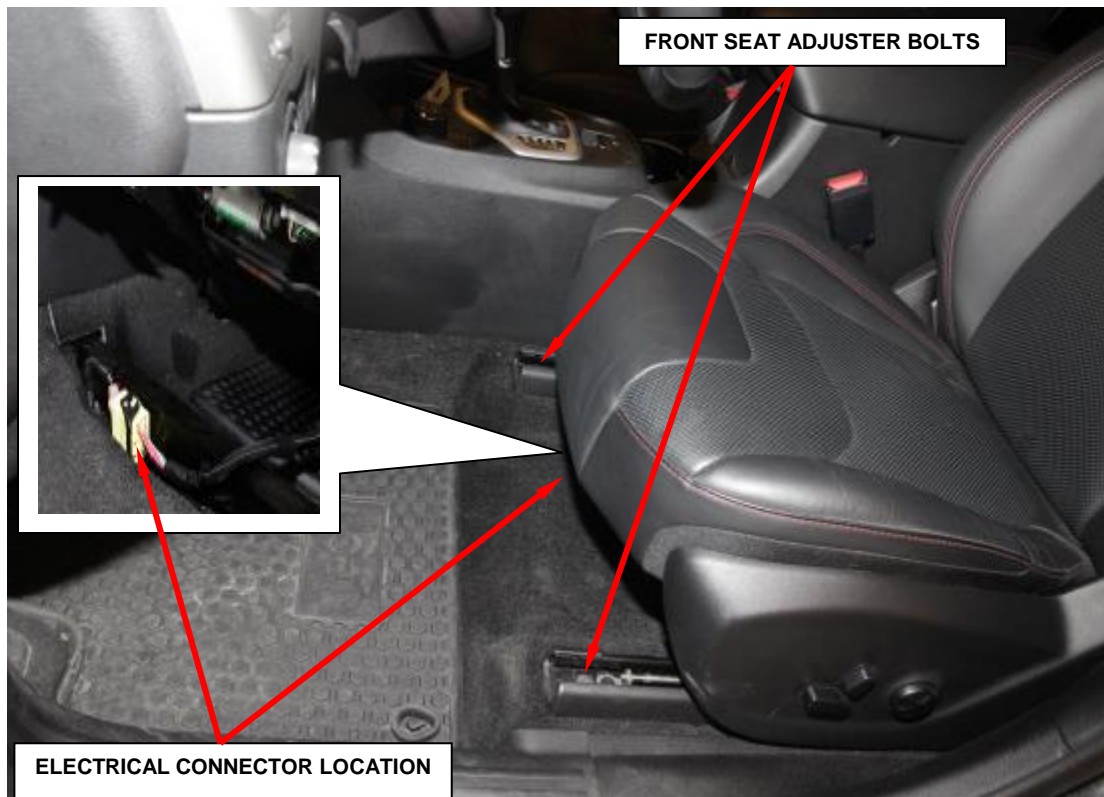
**Figure 2 – Front Seat Adjuster Bolts**

4. Position the front seat rearward.
5. Remove the two front seat adjuster bolts (Figure 2).
6. Open the hood.
7. Disconnect and isolate the negative cable from the battery. If equipped with an Intelligent Battery Sensor (IBS), disconnect the IBS connector before disconnecting the negative cable from the battery. Wait two minutes for the system capacitor to discharge before further service.
8. Disconnect all electrical connectors (Figure 2).

11. Connect all electrical connectors (Figure 2).

12. Install the two front seat adjuster bolts. Tighten to 30 ft. lbs. (40 N·m) (Figure 2).
