2007-2012 CX-7 - FRONT LOWER CONTROL ARMS - SAFETY RECALL 9716H

A. VEHICLE INSPECTION PROCEDURE

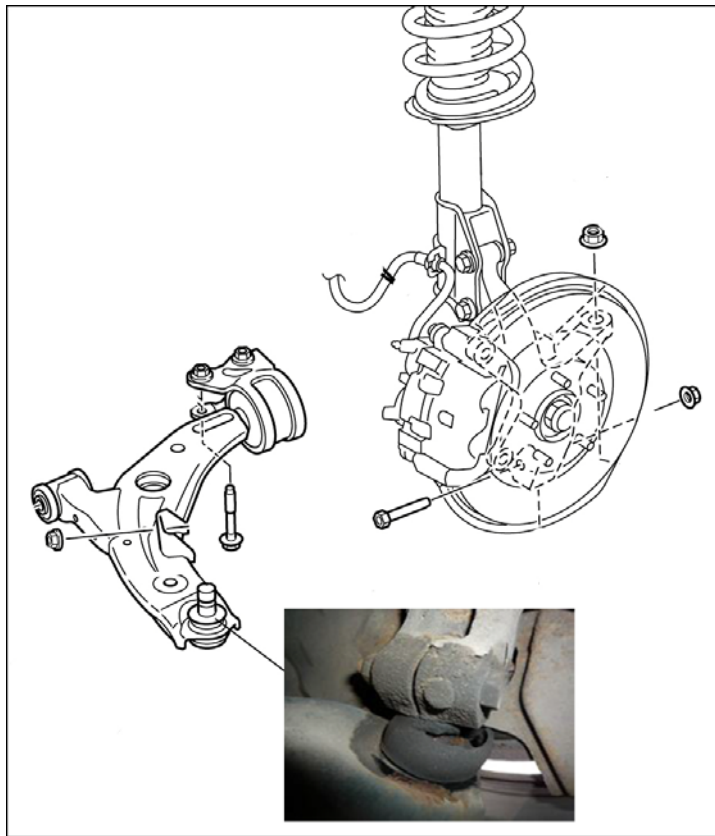
2. Inspect both front lower control arm ball joint dust covers (both sides).
 - If any damage is found (cracking and/or damage), replace both front lower control arms. Refer to **C. REPAIR PROCEDURE.**
 - If no damage is found on both dust covers, continue with Step 3 below.

Example of a damaged front lower control arm dust cover is shown below:

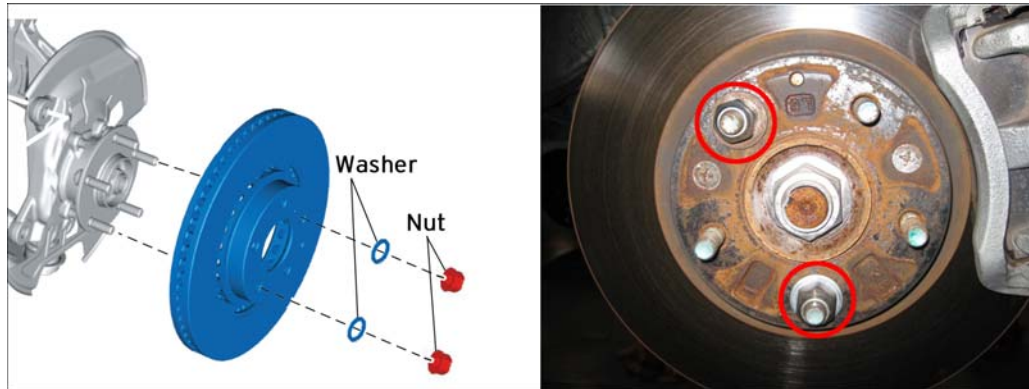
6. Secure the brake rotor to the hub using 2 lug nuts and washers as shown below:

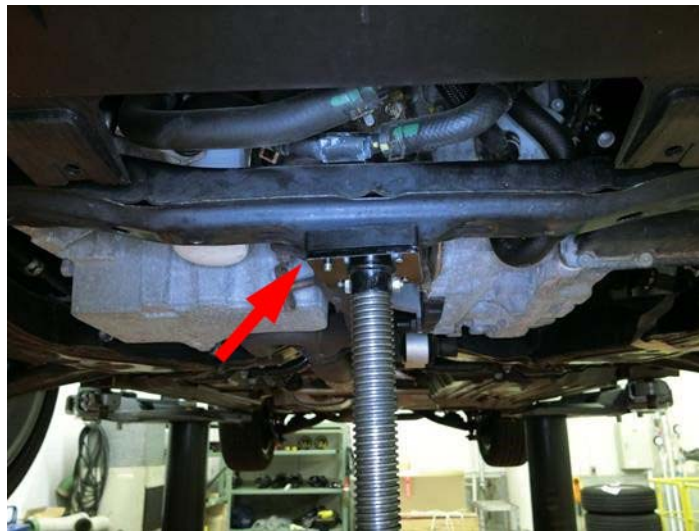
7. Support the front cross member from the bottom using a jack.

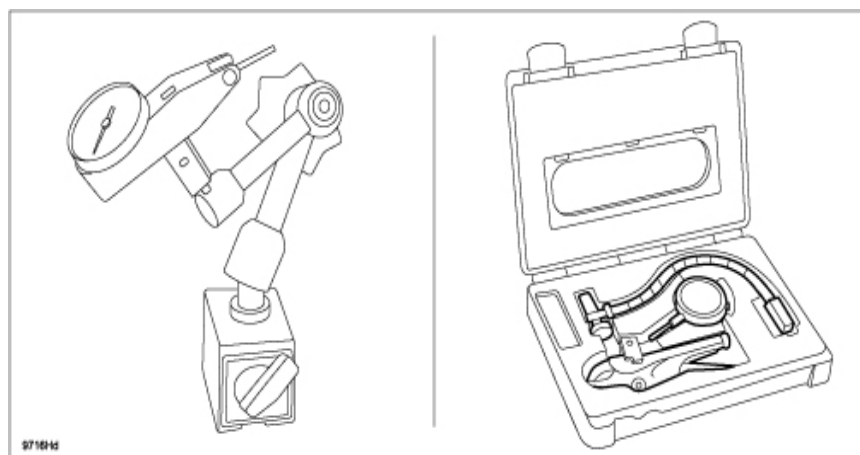
8. Obtain one of the following tools to measure the lower control arm play.

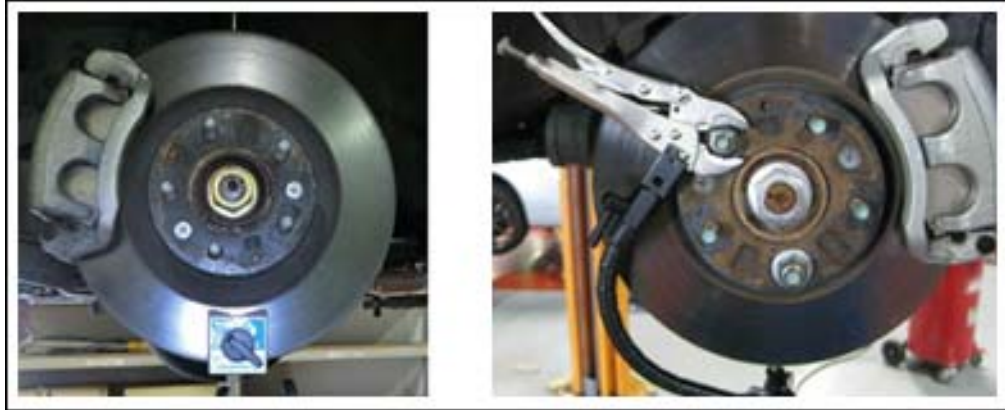
9. Fix a magnetic base or locking pliers to the brake rotor (to set the dial gauge).

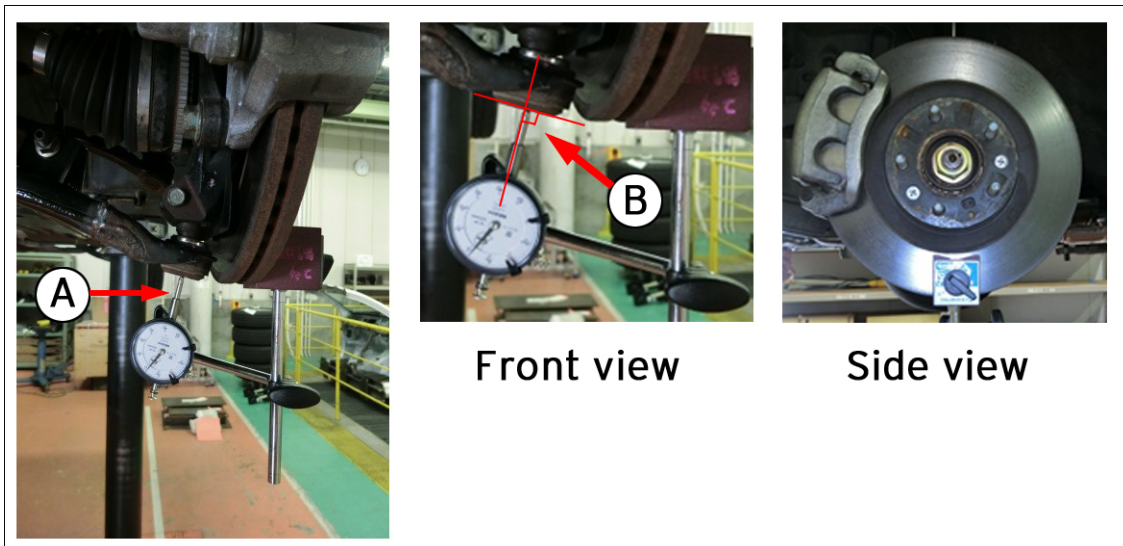
10. Place the sensing tip of the dial gauge on the bottom of front lower arm ball joint (A) as shown below:

NOTE: Place the sensing tip of the dial gauge at a right angle to the ball joint base (B) as shown below:

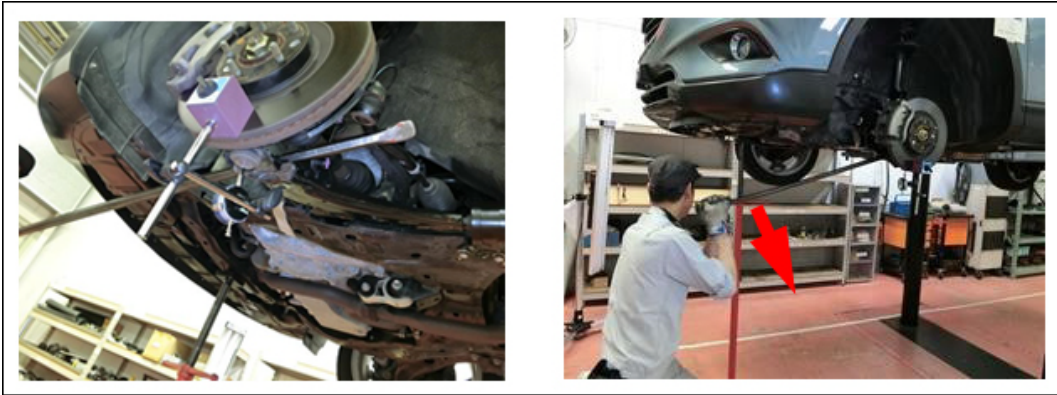
11. Press down/release on the front lower arm with a pry bar or metal bar at least three times to prepare for the lower ball joint measurement.

NOTE: To avoid damaging the vehicle body, be sure to apply adequate protection (such as a shop rag) along the contact surface.

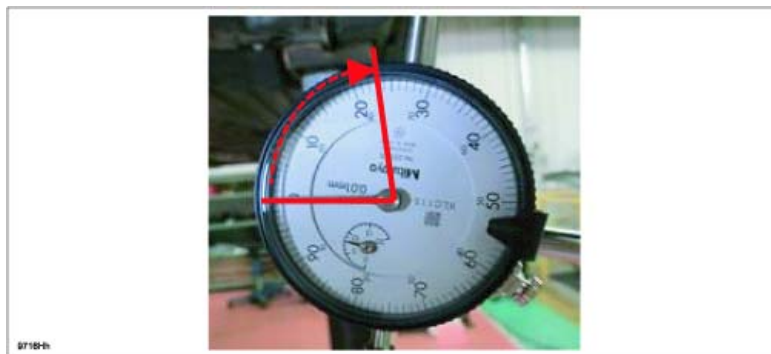
12. Adjust the needle of the dial gauge to 0 mm {0 in.}.
13. Press down on the front lower arm with a pry bar or metal bar
14. Measure the play of the ball joint with the dial gauge.

NOTE: Acceptable amount of play: 2.0 mm {0.079, 5/64 in.} or less.

NOTE: If dial gauge scale does NOT return to 0 mm {0 in.} when release the pry bar, it is NOT being measured correctly. Re-start the inspection procedure step 9.

- If both ball joints inspection **PASS the inspection**, inform the customer that they will still need to bring their vehicle back to replace the front lower arms once they receive another notification from Mazda informing them that the repair parts are available.
- If one or both ball joint(s) inspection **FAIL the inspection**, replace both front lower arms and spacers. Proceed to **C. REPAIR PROCEDURE**.

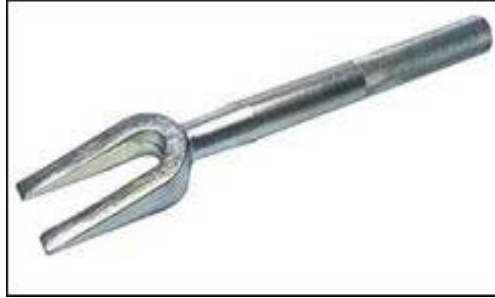
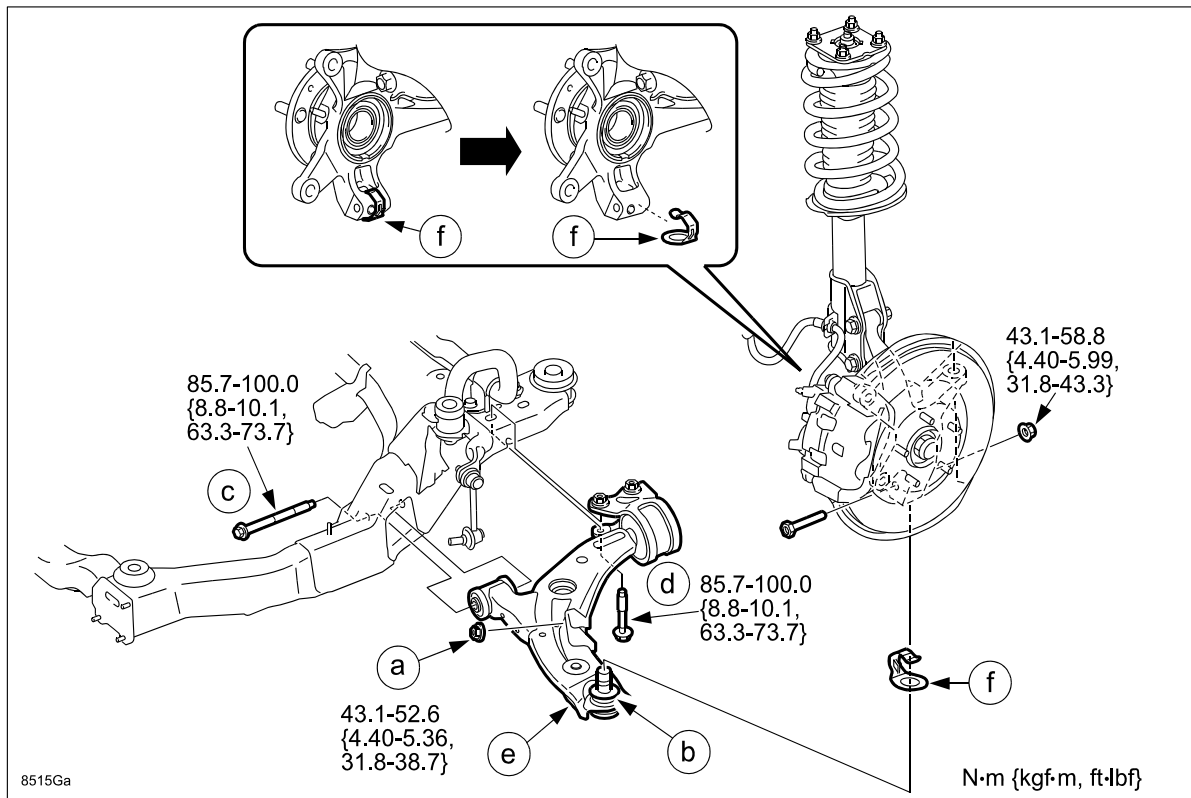
1. Safely raise the vehicle on a lift.
2. Remove both front wheels.
3. Remove the front lower arm in the order indicated below (a - e):

CAUTION: Use a suitable fork tool (as shown below) to separate the lower ball joint. NEVER USE A HAMMER OR MALLET.

- a. Disconnect the stabilizer control link (lower arm side).
- b. Remove the lower arm ball joint attaching nuts.
- c. Remove the attaching bolt between the lower arm and body (front side).
- d. Remove the attaching bolt between lower arm and body (back side).
- e. Remove the lower arm.

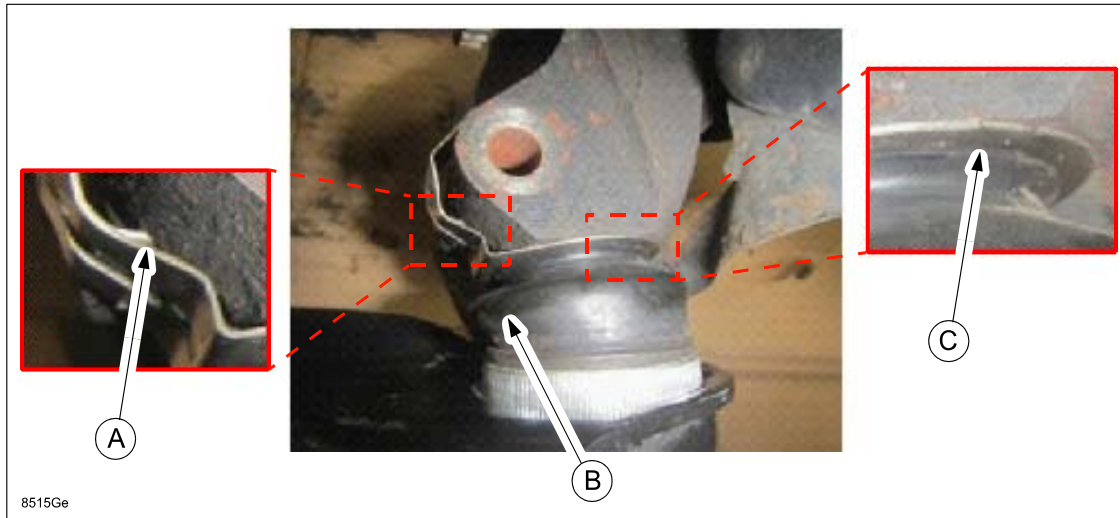
CORRECT:

CAUTION: Before installing the new lower arm, be sure to install the ball joint cover (f) and ball joint boot to the steering knuckle as shown below.

- The protrusion of the cover (A) is engaged in the notch of the knuckle.
- The boot (B) is NOT caved in.
- The cover (C) is in close contact with the boot all the way around.

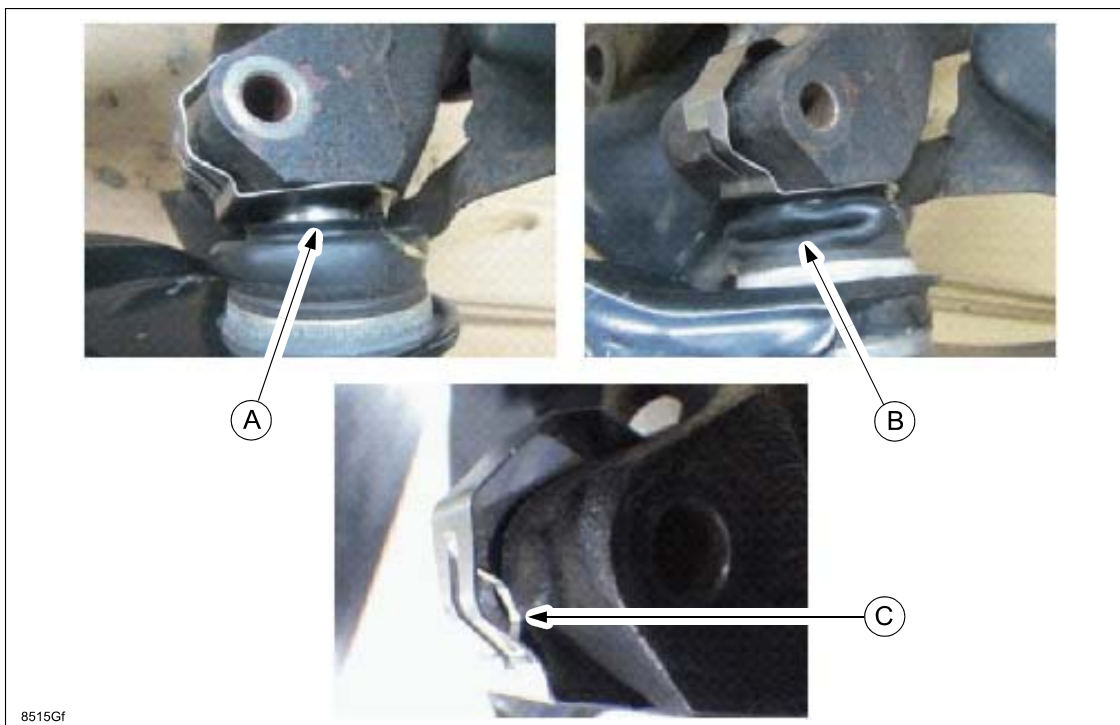
**INCORRECT:**

- The cover (A) is NOT in close contact with the boot.
- The boot (B) is caved in.
- The protrusion of the cover (C) and the notch of the knuckle are misaligned.

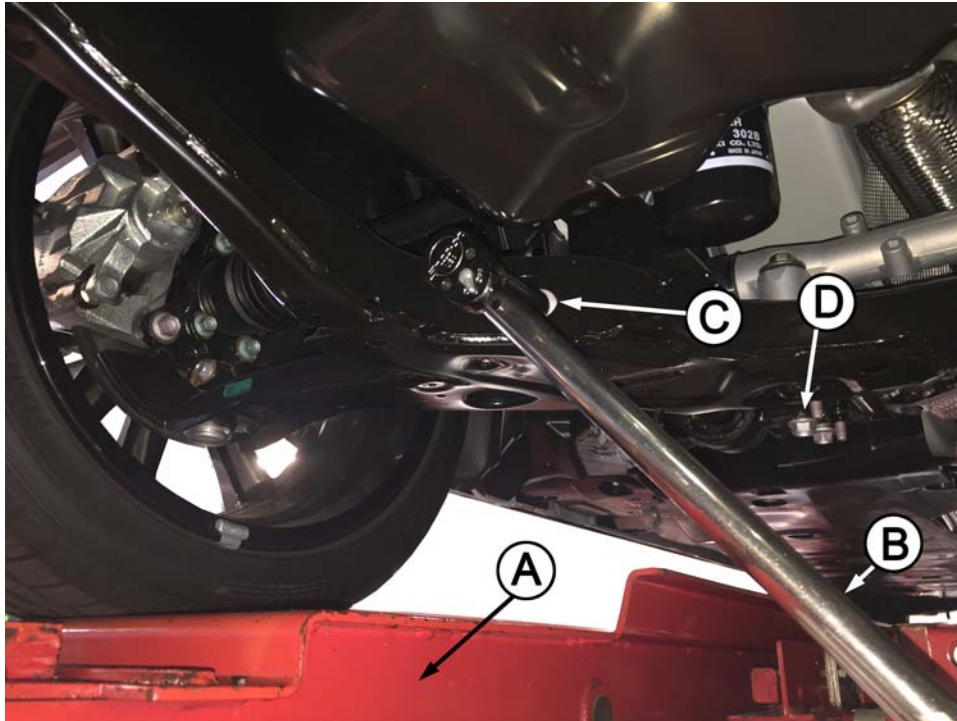
2. Check the tightening torque of the front brake hose banjo bolt:
Tightening Torque: 21.6-29.4 Nm {2.21-2.99 kgf-m, 16.0-21.6 ft-lbf}.
3. Temporarily tighten bolt (c) to **27 Nm {2.8 kgf-m, 20 ft-lbf}**.
CAUTION: The suspension needs to be under the full weight of the vehicle before bolt (c) is fully torqued.
4. Re-install the front tires.
5. Raise the vehicle using a wheel alignment lift rack (A) or lower the vehicle to the ground (to load the suspension). Use a torque wrench (B) to tighten the bolts (C) and (D) to:
Tightening Torque: 85.7-100 Nm {8.8-10.1 kgf-m, 63.3 - 73.7 ft-lbf}.

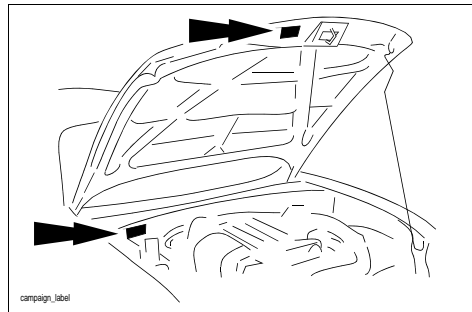
2. Affix it to the hood or bulkhead as shown:
