Safety Recall

Code: 80B9

Subject	Coolant Shut-off Valve (N488)
Release Date	October 6, 2016
Affected Vehicles	U.S.A.: 2011-2012 MY Audi A8 CANADA: 2010-2012 MY Audi A8 <i>Check Campaigns/Actions screen in Elsa on the day of repair to verify that a VIN qualifies for repair under this action. Elsa is the <u>only</u> valid campaign inquiry & verification source.</i> <ul style="list-style-type: none">✓ Campaign status must show "open."✓ If Elsa shows other open action(s), inform your customer so that the work can also be completed at the same time the vehicle is in the workshop for this campaign.
Problem Description	Over time, it is possible for coolant to leak through a coolant valve wire connection, causing coolant migration into the engine control module. If this happens, it can cause a short circuit, placing the vehicle into "limp-home mode", or possibly even cause a stall without warning. Stalling can lead to a vehicle crash.

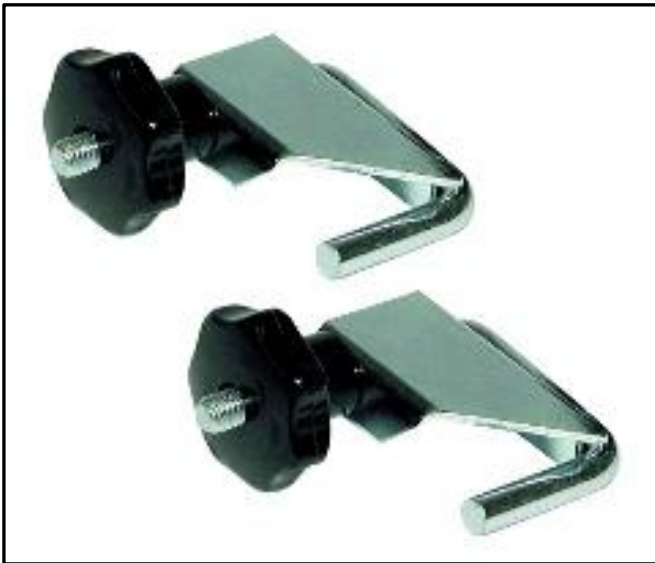
- Hose Clamps – Up To 25mm - 3094 (or equivalent)

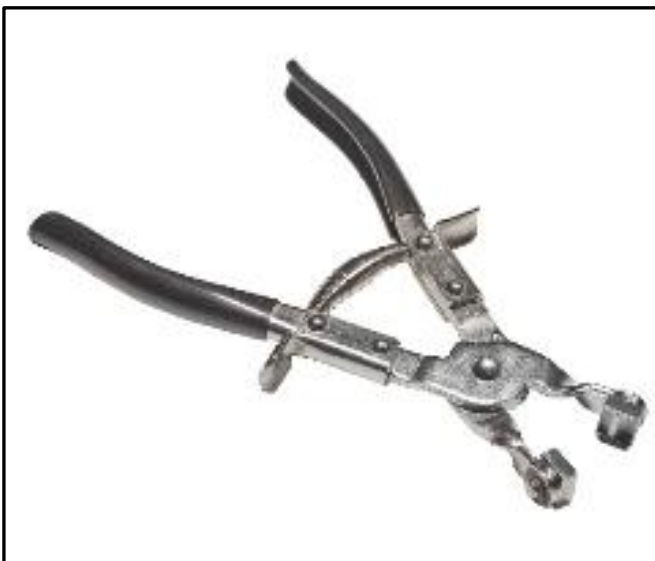
- Hose Clip Pliers –VAS6362- (or equivalent)

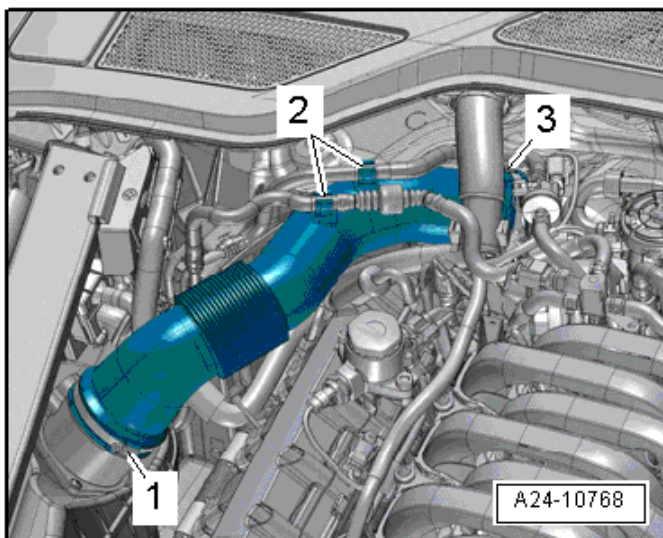
- Free up the hoses <2> on the air guide pipe.
- Loosen the clamps <1 and 3> and remove the air guide pipe.

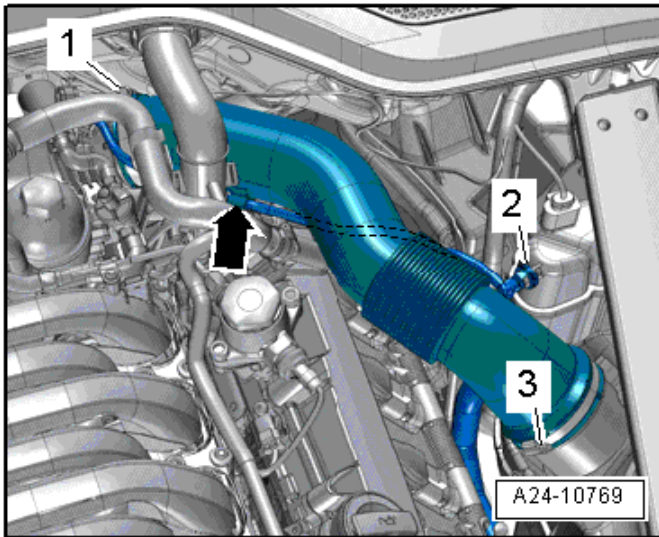
- Loosen the clamps <1 and 3>.
- Free up the coolant hose <2> <arrow> and remove the air guide pipe.

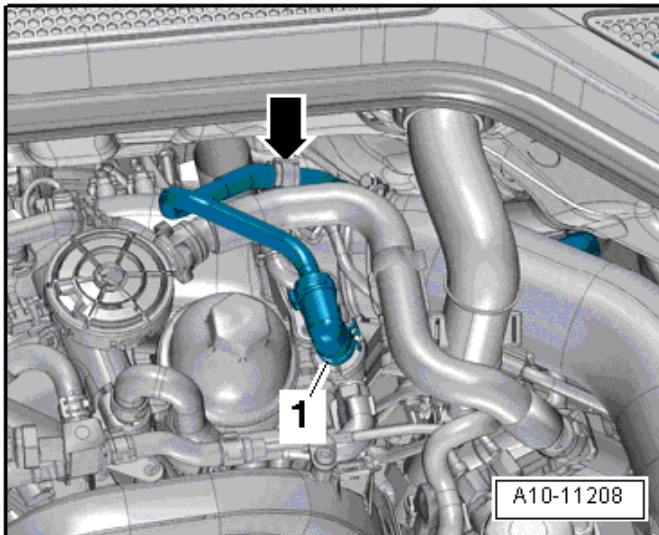
- Disconnect the vacuum hose <1> and free it up <arrow>.

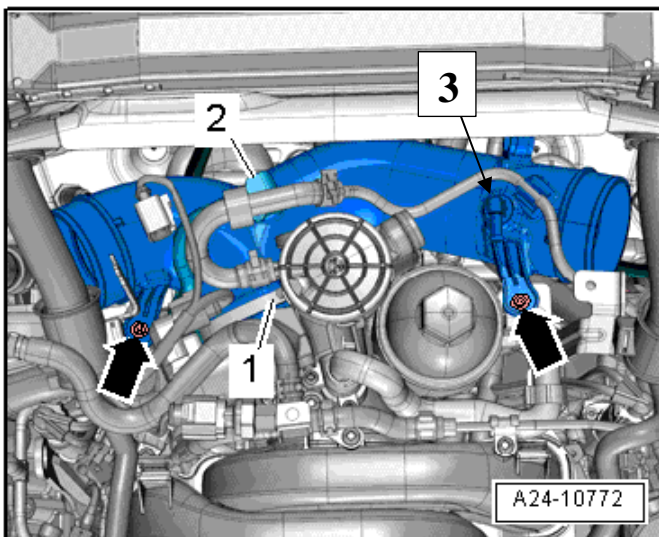
- Remove the bolts <arrows>.
- Loosen the clamp <1>.
- Remove the crankcase vent hose <2>.
- Remove vacuum line <3>.
- Remove the air guide pipe.

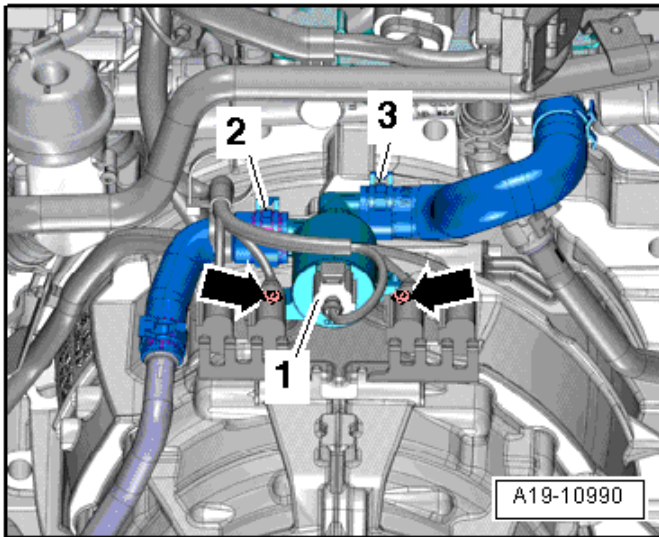
- Remove the bolts <arrows>.
- Disconnect the connector <1>.
- Inspect the interior of the wire harness connector <1> for presence of coolant.
 - If coolant is present **-STOP-** take a picture of connector and create a technical assistance case for further direction of repair.
 - If coolant is not present continue with the following steps.
- Loosen the hose clamps <2 and 3>.
- Clamp off the coolant hose with the Hose Clamps -3094-.
- Cover the area under the heater coolant shut-off valve –N488– with an absorbent rag.
- Remove the hoses from the coolant valve.
- Remove the Transmission Coolant Valve –N488-.
- Install new coolant valve –N488-, torque bolts <arrows> to 9 Nm.

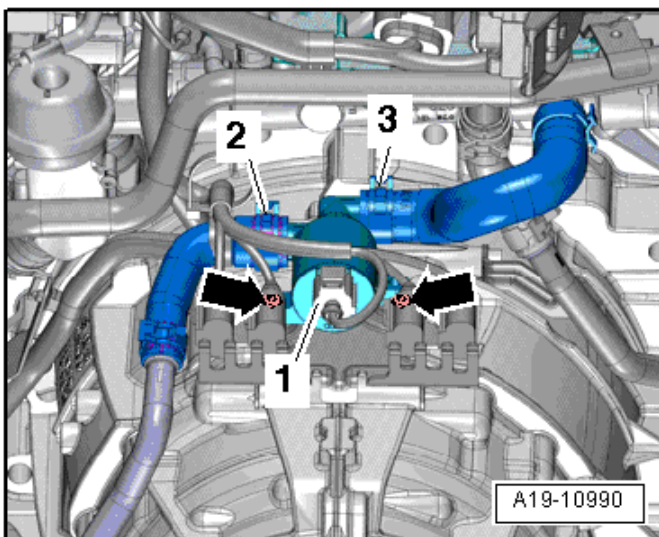
- Connect connector <1>.
- Connect hoses to coolant valve.
- Remove the Hose Clamps -3094-.
- Position clamps <2 and 3> in the original location and orientation.

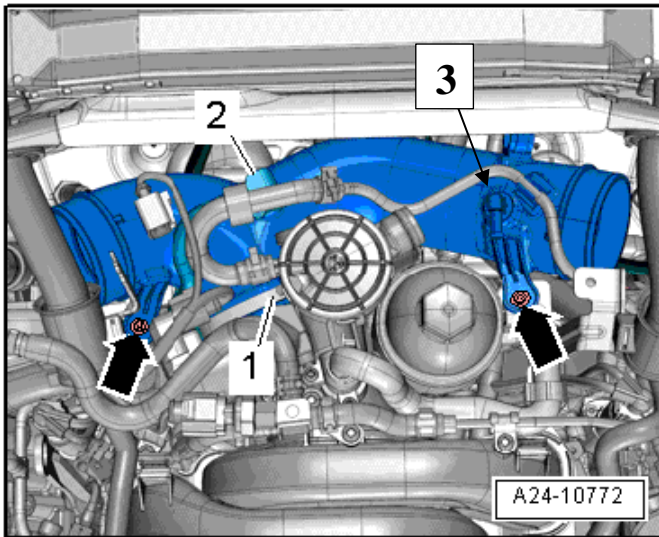
- Reinstall the air guide pipe.
- Reconnect vacuum line <3>.
- Reconnect crankcase vent hose <2>.
- Position clamp <1> in the original location and orientation and tighten.
- Reinstall bolts <arrows> and torque to 9 Nm.

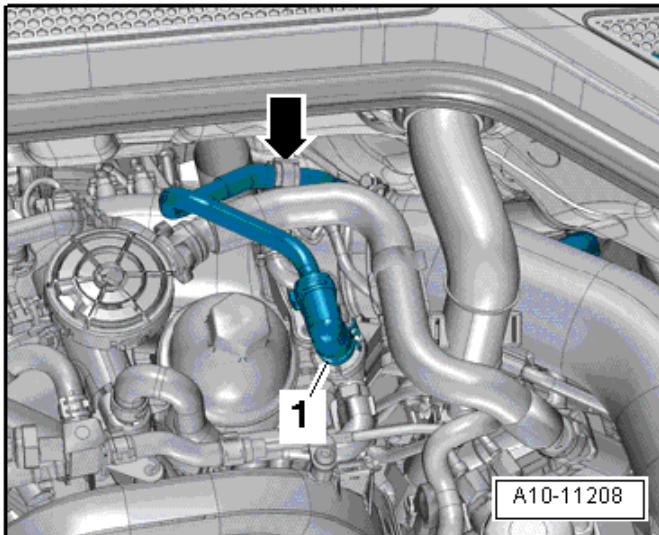
- Reconnect the vacuum hose <1> and place back in bracket <arrow>.

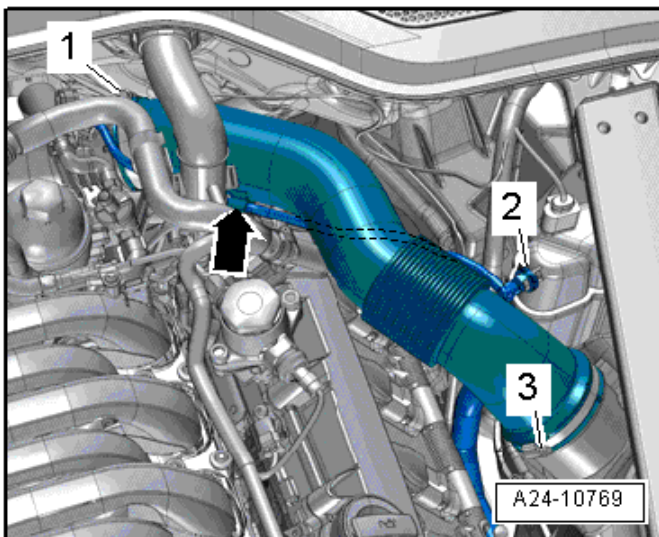
- Reinstall the air guide pipe.
- Position clamps <1 and 3> in the original location and orientation and tighten.
- Reinstall the coolant hose <2> and place in bracket <arrow>.

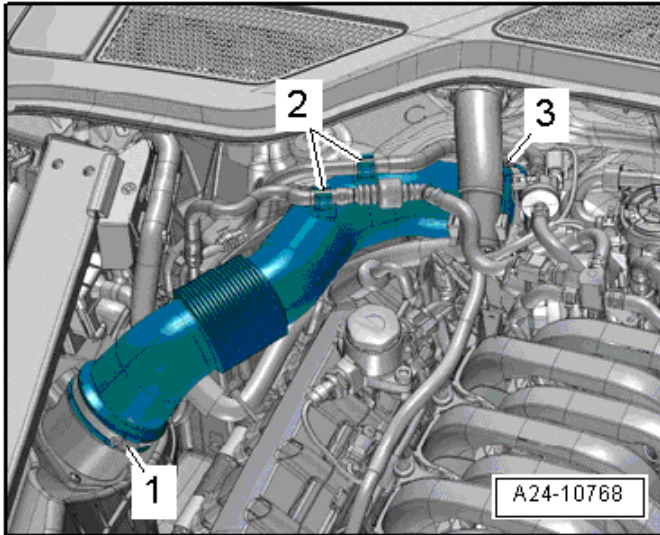
- Reinstall the air guide pipe.
- Position clamps <1 and 3> in the original location and orientation and tighten.
- Reinstall the hoses <2> and position in brackets.

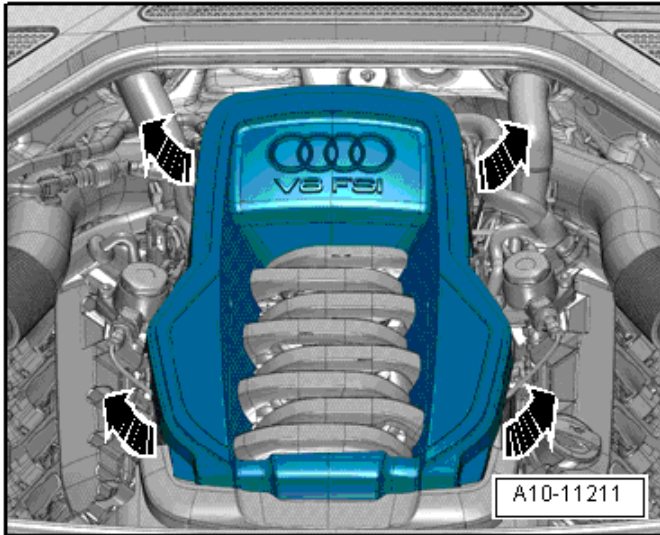
- Reinstall the engine cover by first pushing the engine cover with both hands into the rubber grommets in the rear and then into the rubber grommets in the front.
