Safety Recall

Code: 72F8

Subject	Third Row Seat
Release Date	September 27, 2016
Affected Vehicles	U.S.A. & CANADA: 2017 MY Audi Q7 <i>Check Campaigns/Actions screen in Elsa on the day of repair to verify that a VIN qualifies for repair under this action. Elsa is the <u>only</u> valid campaign inquiry & verification source.</i> <ul style="list-style-type: none">✓ Campaign status must show "open."✓ If Elsa shows other open action(s), inform your customer so that the work can also be completed at the same time the vehicle is in the workshop for this campaign.
Problem Description	The third row seat may move forward if subject to high loading, such as in a frontal collision. As a result, it may not adequately restrain an occupant and would increase the risk of injury.
Corrective Action	Install additional support bracket to the third row seat.
Precautions	Until this recall repair has been performed, do not allow any passengers to use the third row seat in the vehicle.

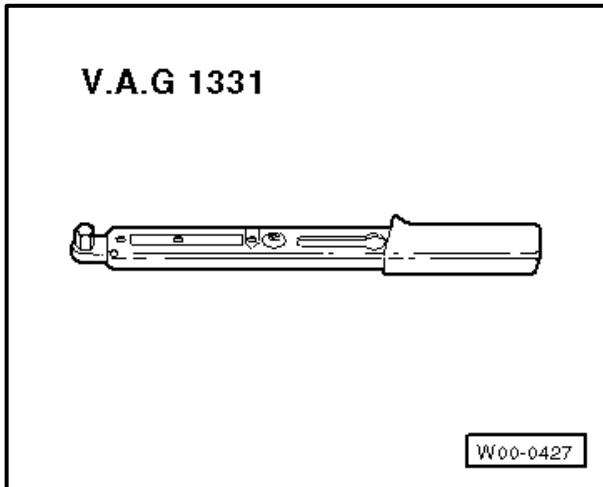
- Torque Wrench 1331 5-50Nm -VAG1331- (or equivalent).
