Safety Recall

Code: 48M5

Subject	Steering Rack
Release Date	September 27, 2016
Affected Vehicles	U.S.A.: MY 2017 Audi Q7 <i>Check Campaigns/Actions screen in Elsa on the day of repair to verify that a VIN qualifies for repair under this action. Elsa is the <u>only</u> valid campaign inquiry & verification source.</i> <ul style="list-style-type: none">✓ Campaign status must show "open."✓ If Elsa shows other open action(s), inform your customer so that the work can also be completed at the same time the vehicle is in the workshop for this campaign.
Problem Description	Silicone gel used to protect a circuit board within the steering rack control unit does not harden according to factory specifications. Because of this, the circuit board is not protected against particles that may enter the area, and can lead to a short circuit and loss of power steering assist. If a vehicle experiences a loss of power steering assist, extra steering effort will be required at lower speeds, increasing the risk of a vehicle crash.

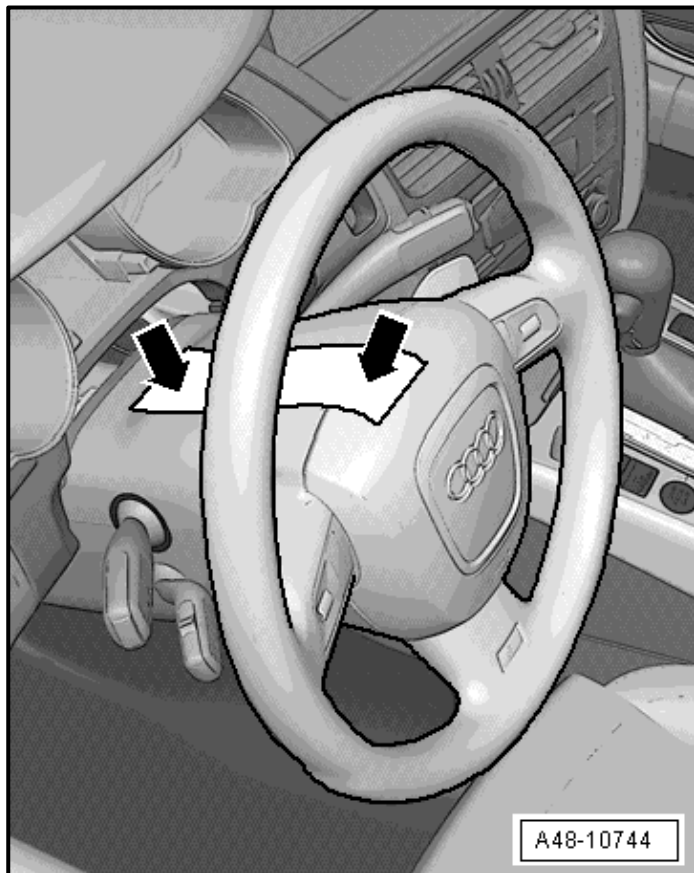
- Use adhesive tape, which can be removed without leaving any adhesive residue.
- Be careful not to turn the steering wheel during the repair because the clock spring - F138- can become damaged.
- Secure the steering wheel in the straight-ahead position using tape so that it does not turn unintentionally <arrow>.
- Remove the front wheels.

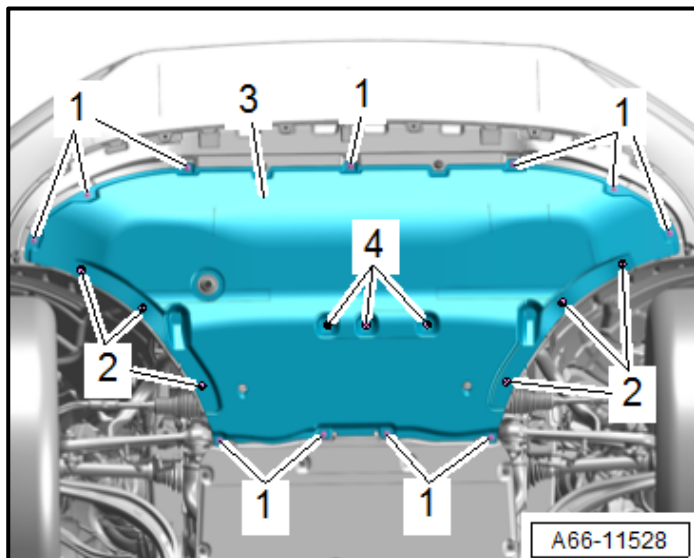
- Remove the front noise insulation bolts <1, 2 and 4>.
- Remove the front noise insulation <3>.

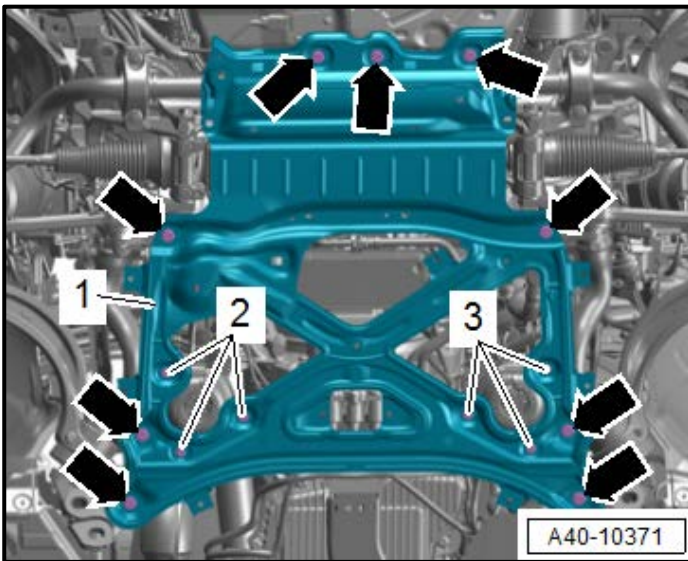
Equipment Versions with Side Transmission Mount:

- Remove the bolts <2 and 3>.

Equipment Versions without Sway Stabilization:

- Remove the bolts <arrows> and the subframe crossbrace <1>.

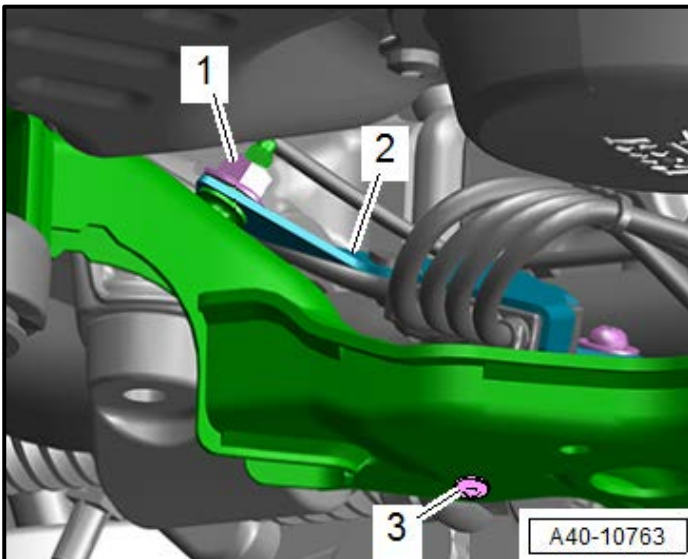
Equipment versions with Sway Stabilization:

- Remove the nut <1> and bolt <3>, and free up the bracket <2> with the wires.

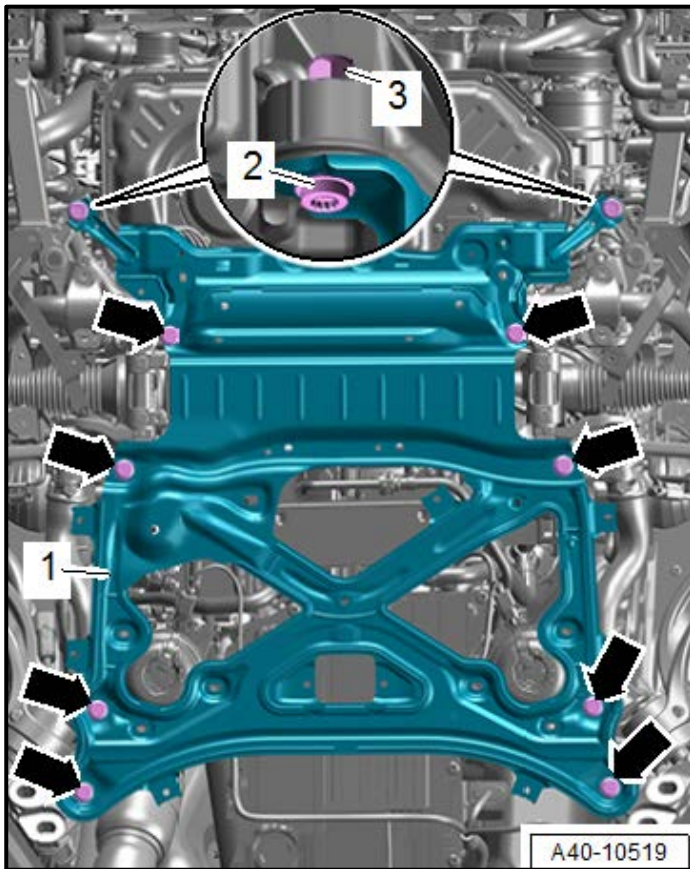
- Counter-hold the nut <3> and remove the left and right bolt <2>.
- Remove the bolts <arrows> and the subframe crossbrace <1>.

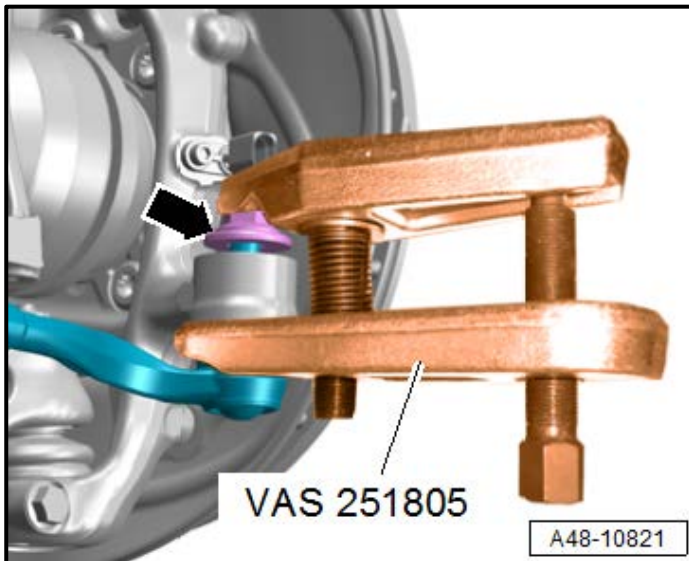
- To protect the threads, remove the nut <arrow> from the tie rod end joint pin until it is flush with the joint pin threads.

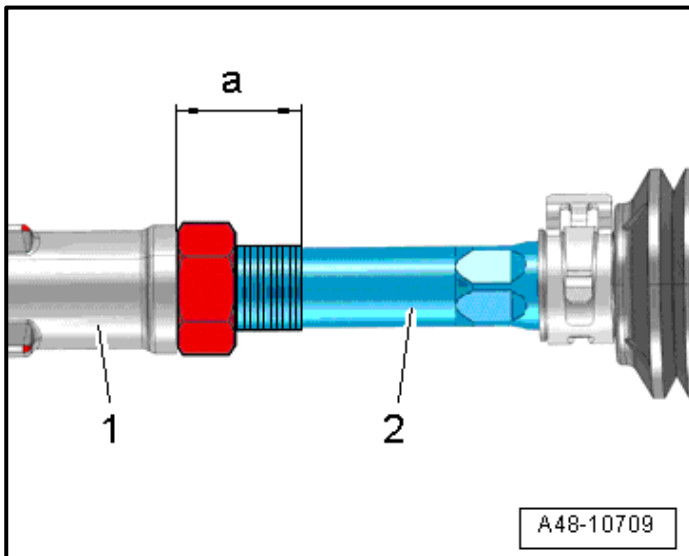
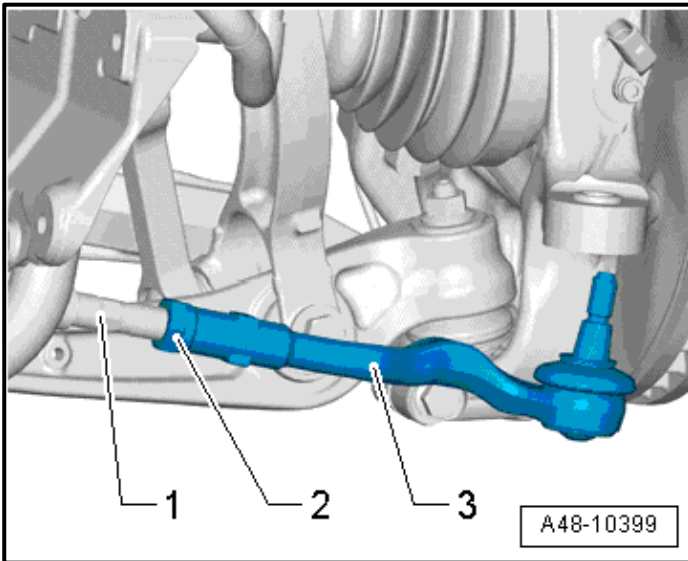
- Remove the tie rod end with the -VAS251805- from the wheel bearing housing.
- Then remove the nut. Use a 6 mm inner hex socket to counter-hold at the joint pin if necessary.
- Remove the adhesive residue from the pin threads after removing.
- Repeat the procedure on the other side of the vehicle.
- Measure the dimension <a> between the tie rod head <1> and the left and right tie rod <2> and make a note of the value.

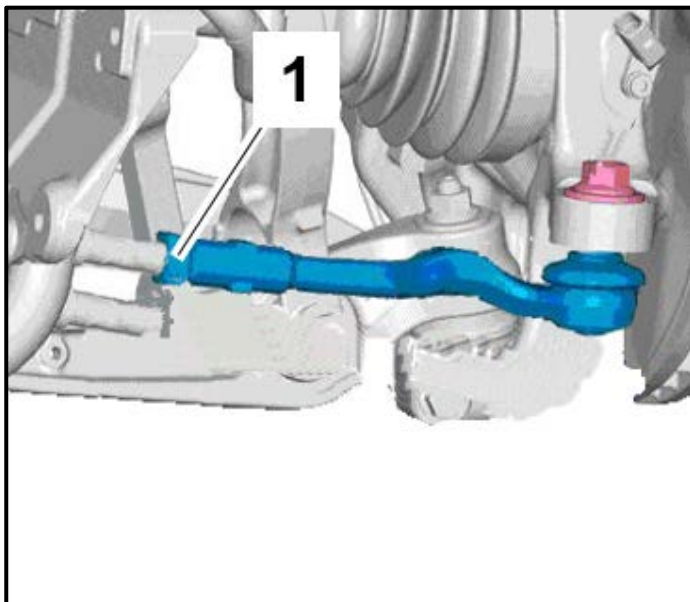
- Insert the tie rod end all the way into the wheel bearing housing.
- Counter-hold at the joint pin with a 6 mm hex socket wrench if necessary to tighten the new nut <1> to 140 Nm.

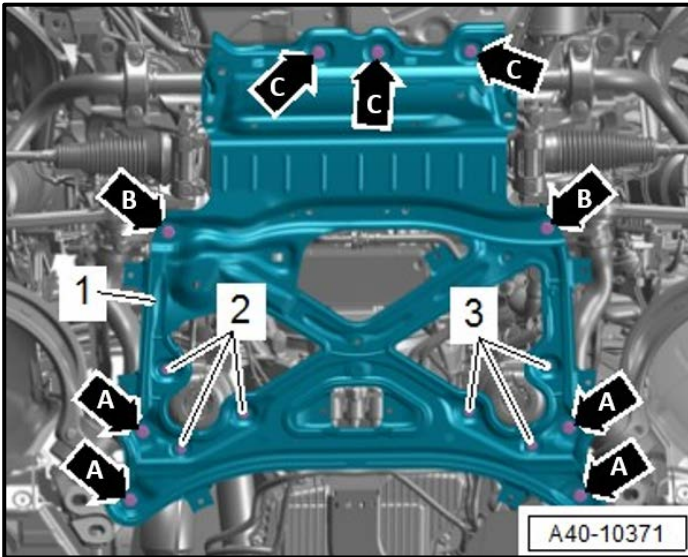
- Tighten the nut <1> to 80 Nm.

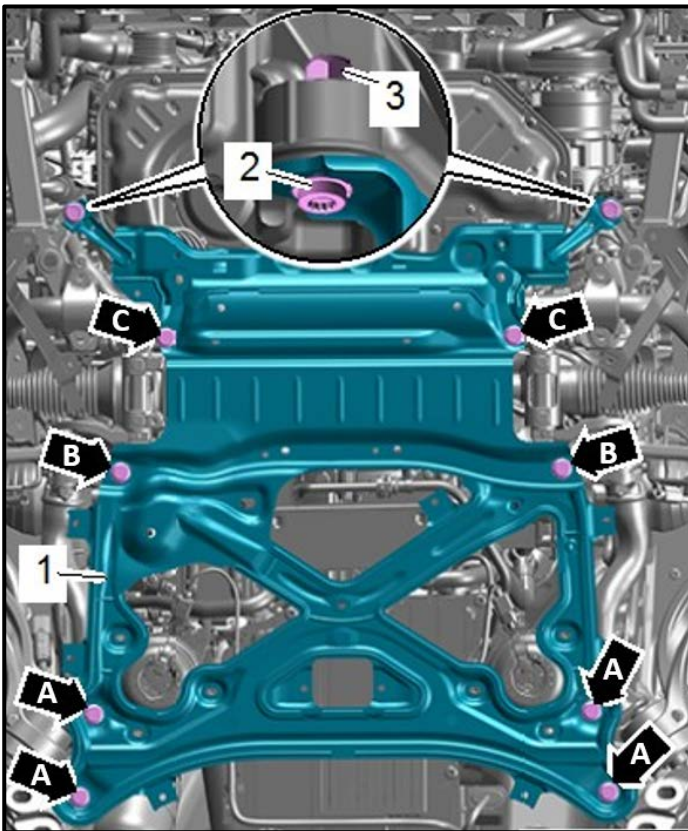
Equipment Versions with Side Transmission Mount:

- Reinstall bolts <2 and 3> and tighten to 20 Nm.

Equipment Versions without Sway Stabilization:

- Install new rear bolts <A> and tighten to 90 Nm +135°.
- Install new middle bolts and tighten to 90 Nm +90°.

- Reinstall the front bolts <C> and tighten to 20 Nm.

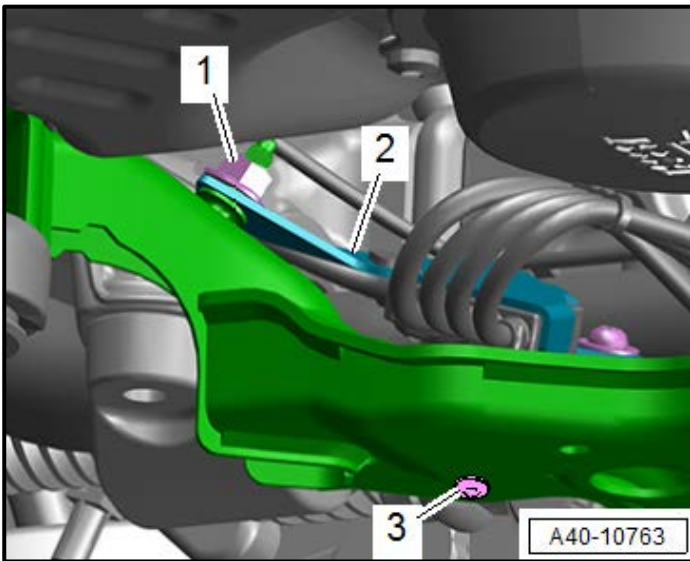
Equipment versions with Sway Stabilization:

- Install new rear bolts <A> and tighten to 90 Nm +135°.
- Install new middle bolts and tighten to 90 Nm +90°.

- Reinstall the front bolts <C> and tighten to 20 Nm.
- Reinstall the corner bolts and nuts <2 and 3> and tighten to 20 Nm.
