Converter Dolly Inspection

6/17/2016

Issue Overview: Cracked dolly counterbalances (Fig 1-3). The failure of this connection is progressive in nature and inspection is required until units can be repaired.

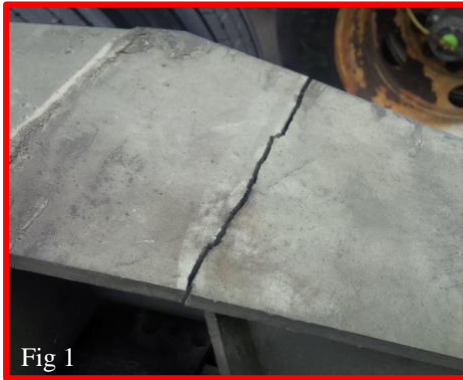
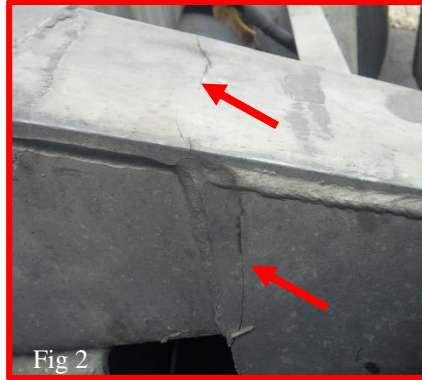
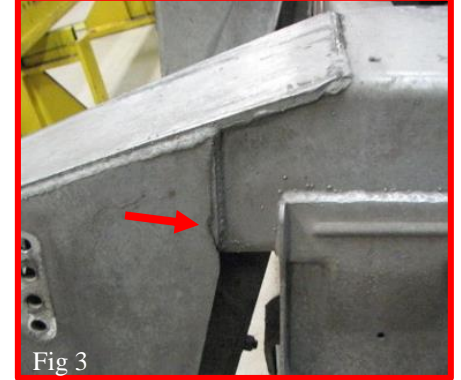
Cracked counterbalance

- Inspect counterbalance connections for cracks (Fig 4). Dollies with cracks across top plate are to be taken out of service immediately until repairs can be made (Fig 1). These units need to be transported on flatbed to repair location.
- Outboard vertical side welds can be temporarily repaired to get units to a repair location, coordinated with WNC Warranty.
- Temporary repairs still require a final repair as soon as possible.

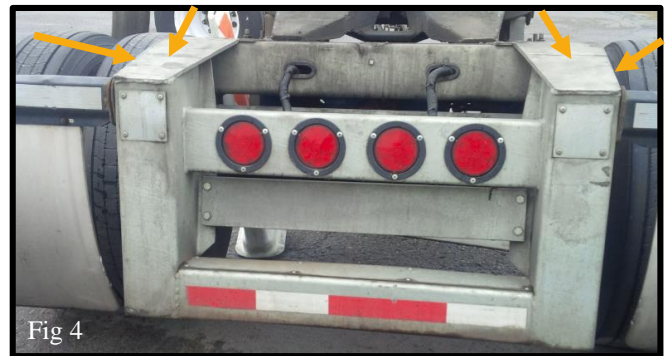
Arrows indicate areas of inspection

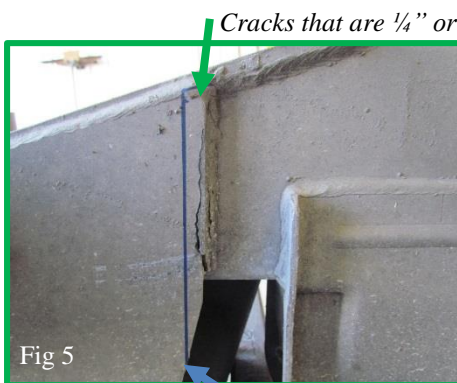
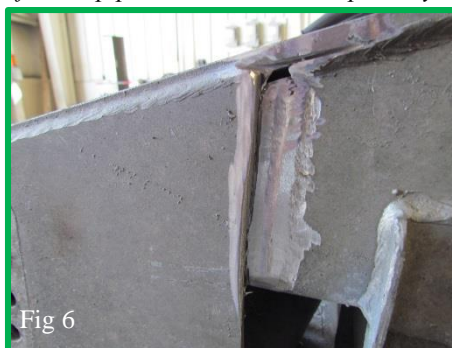
Cracks that are 1/4" or more from top plate weld can be temporarily repaired

Regardless of crack length, grind to new material behind crack and through entire vertical leg. See cut line

- If crack is present only on outboard vertical weld, unit can be temporarily repaired by grinding out the entire crack. Care must be taken not to grind into top cap. Any notch to top plate must be welded and ground smooth. Grind vertical line down through entire leg (Fig 5 & 6). Re-weld with a *vertical up joint* (Fig7).
- Then coat the repair with cold galvanization.
