# Safety Recall

## Code: 20W9

<b>Subject</b>	<b>Fuel Pump Flange</b>
<b>Revision Summary</b>	<b>Work procedure and claiming instructions updated.</b>
<b>Release Date</b>	December 8, 2016
<b>Affected Vehicles</b>	<b>U.S.A. &amp; CANADA: Certain 2009-2012 MY Audi Q5 &amp; 2007-2012 MY Audi Q7</b> <i>Check Campaigns/Actions screen in Elsa on the day of repair to verify that a VIN qualifies for repair under this action. Elsa is the <u>only</u> valid campaign inquiry &amp; verification source.</i> <ul style="list-style-type: none"><li>✓ Campaign status must show "open."</li><li>✓ If Elsa shows other open action(s), inform your customer so that the work can also be completed at the same time the vehicle is in the workshop for this campaign.</li></ul>
<b>Problem Description</b>	On certain vehicles, the fuel pump flange may develop fine cracks or fissures, which could result in a fuel leak. Leaking fuel, in the presence of an ignition source, could lead to a fire causing injury and/or damage to property.

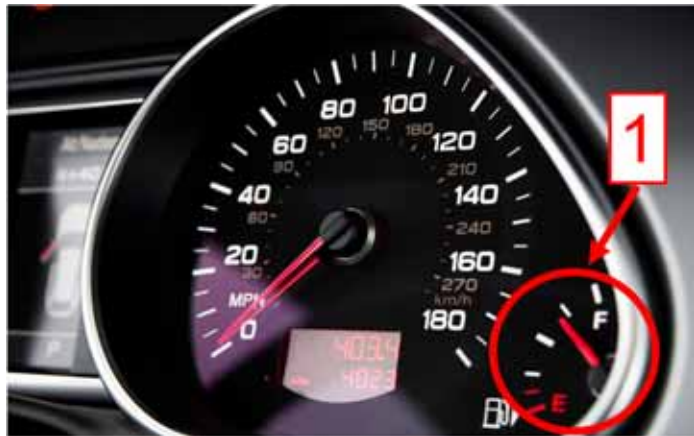
- Check the vehicle fuel level displayed on the instrument cluster <1>.
- Record the vehicle fuel level on the repair order.

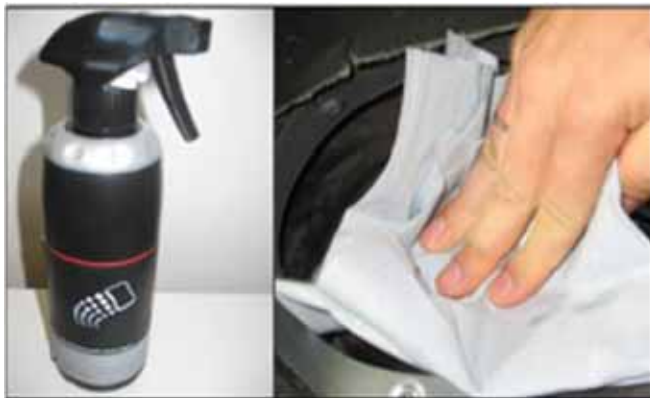
- Clean top of fuel filter with suitable plastic cleaner.

- Check the entire top area of the fuel pump flange for leaks.
- Document if there are leaks, cracks <arrows> and/or yellow discoloration on the repair order for inclusion in the SAGA claim.
  - Take picture showing the presence of leaks, cracks <arrows> and/or yellow discoloration and provide to warranty administrator.

- If there is a visible presence of leaking fuel, proceed to **Section D and Replace the Fuel Filter Flange**, all others continue to the next step.

- If there are no signs of leaking present, but there **ARE cracks and/or discoloration present** <circles>;
- Apply protective film as shown. Start application from the center and work the protective film towards the outside edges of the fuel pump flange taking care to eliminate air gaps or bubbles under the film.

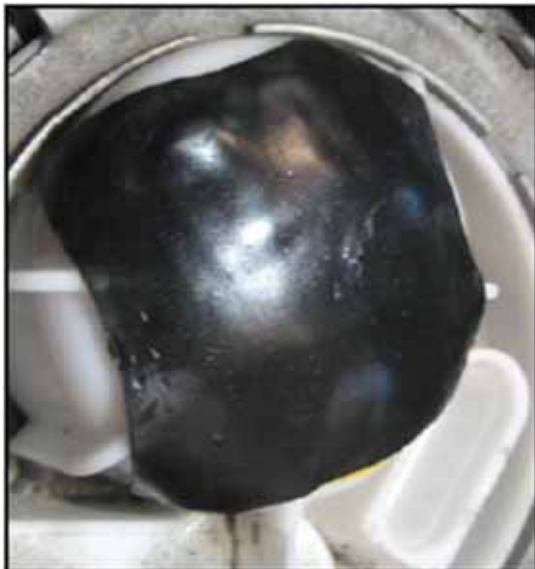
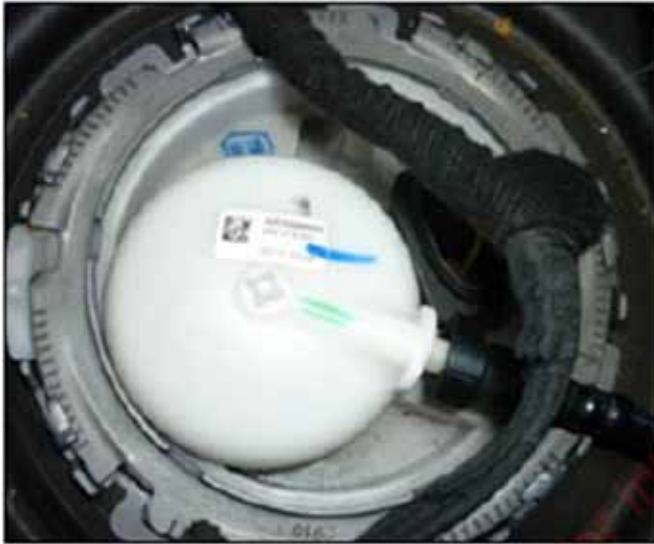
- If there are **NO** cracks and/or yellow discoloration present, apply the protective film as shown in the next step.

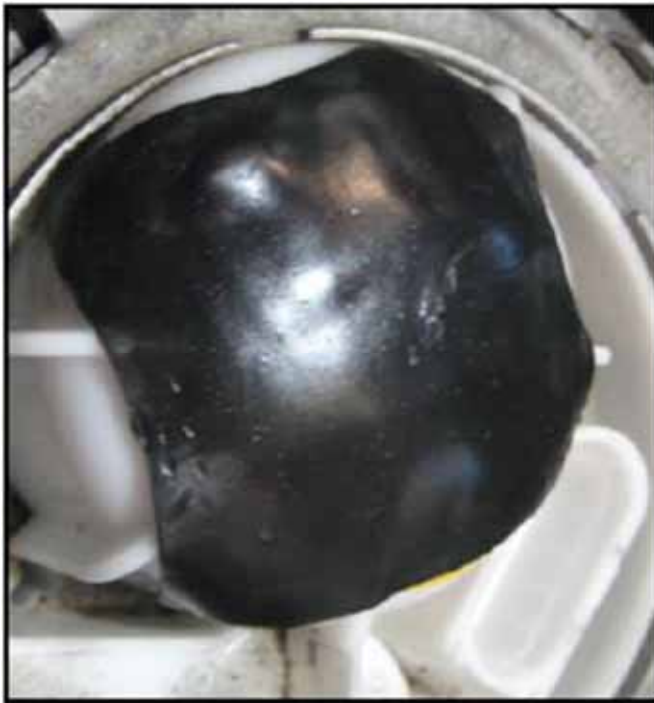
- Apply protective film as shown. Start application from the center and work the protective film towards the outside edges of the fuel pump flange taking care to eliminate air gaps or bubbles under the film.

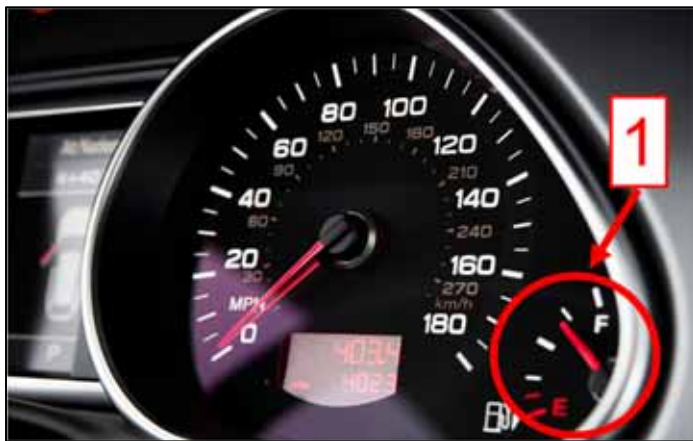
- Turn on the ignition.
- Cycle the ignition four to five times to prime the fuel system and verify there are no DTC's present and no warning lamps illuminated.
- Start the vehicle to verify fuel system functionality. Make sure to check for any fuel leaks before delivering the vehicle to the customer.
- Check the vehicle fuel level displayed on the instrument cluster <1>.
- Refer to the vehicle fuel level on the repair order and verify the proper operation of the fuel level sensor.
- Reset customer convenience basic settings (i.e. one touch windows, instrument cluster clock, etc.).

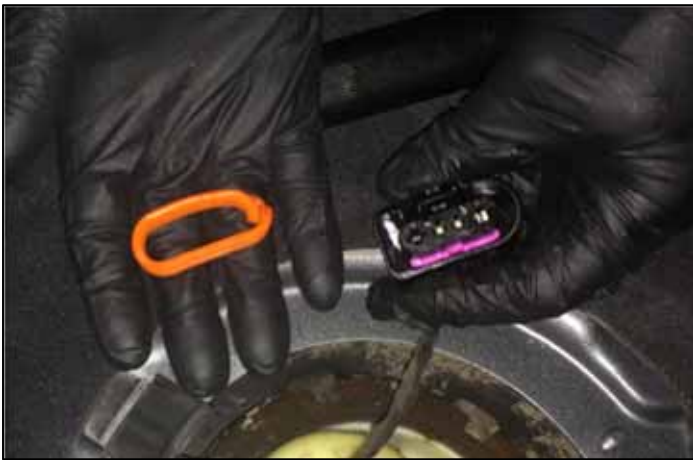
- If the fuel filter flange was leaking fuel, inspect the wiring harness connector carefully for damage due to fuel wicking into the weather pack seals.
- If damage to the weather pack seal and/or wiring harness is discovered, include pictures in the same Technical Assistance WEB ticket and follow the direction of the Technical Assistance Consultant for performing the repair.

- Attach photo(s) to the ATA case clearly indicating the filter flange is leaking and if present damage to the wiring harness. An ATA Consultant will review the photos and then update the ATA case with a case code.
- Provide this case code to your parts department so the filter flange can be ordered by your parts department.
  - If required order the necessary wiring harness repair parts at this time.

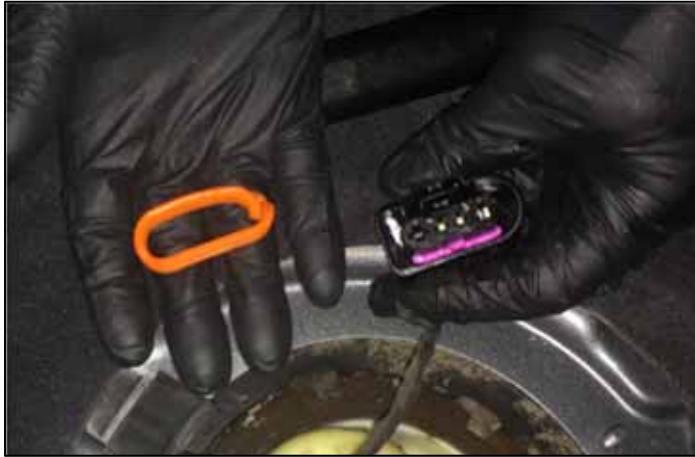
- If required, repair the wiring harness connector, wiring, and weather pack seals as instructed by Technical Assistance.

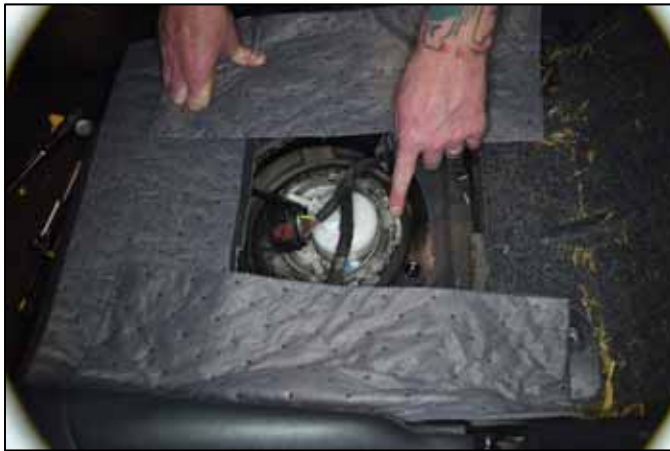
There is a risk of fuel leaking out from the filled fuel filter flange. Lay cloths, rags, or other absorbent material below to catch the leaking fuel.

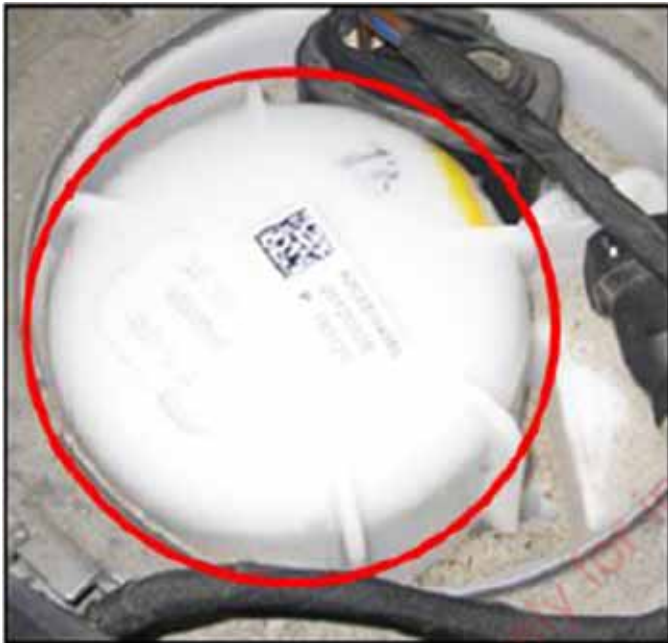
- Install new fuel filter flange assembly into fuel tank.
- Discard the old fuel filter flange seal ring, and use new fuel filter flange ring seal. Install the seal dry. Do not lubricate the seal.

The new replacement fuel pump flange <part number 7L8 919 679> does **NOT** require the installation of the protective film.

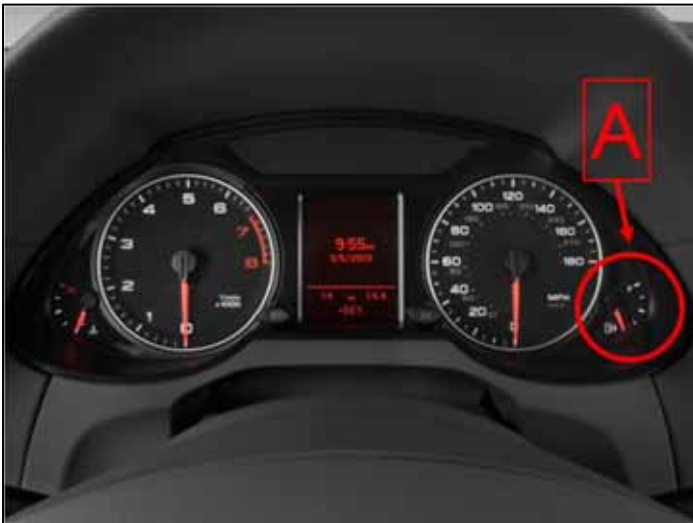
- Check the vehicle fuel level displayed on the instrument cluster <A>.
- Record the vehicle fuel level on the repair order.

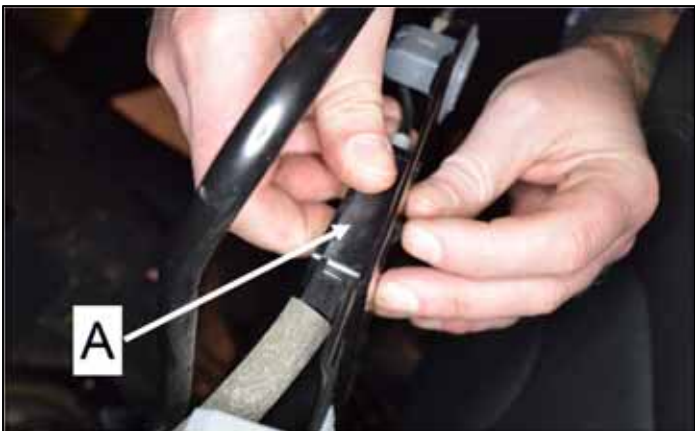
- Flip the seat frame up to gain access to the seat frame adjustment cable connector.
- Unclip the seat frame adjustment cable connector <A> from the seat frame (if equipped).

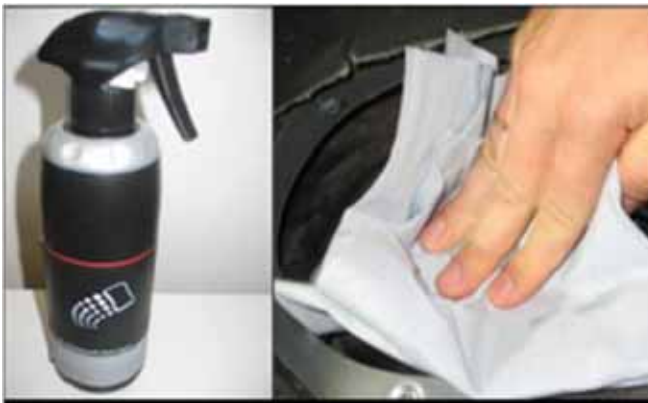
- Clean top of fuel pump with suitable plastic cleaner.

- Check the entire top area of the fuel pump flange for leaks.
- Document if there are leaks or cracks <arrows> and/or yellow discoloration on the repair order for inclusion in the SAGA claim.
  - Take picture showing the presence of leaks or cracks and provide to the warranty administrator.

- If there is a visible presence of leaking fuel, proceed to **Section G and Replace the Fuel Pump Flange.**

- If there are no signs of leaking present, but there **ARE cracks and/or yellow discoloration present** <circles>;
- Apply protective film as shown. Start application from the center and work the protective film towards the outside edges of the fuel pump flange taking care to eliminate air gaps or bubbles under the film.

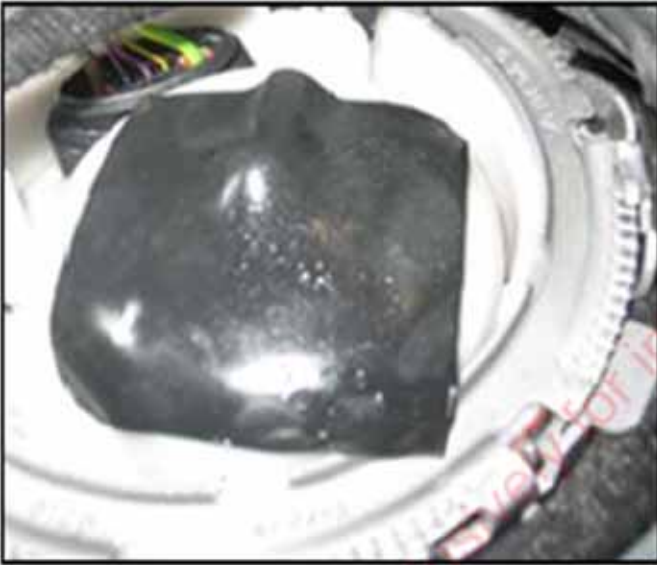
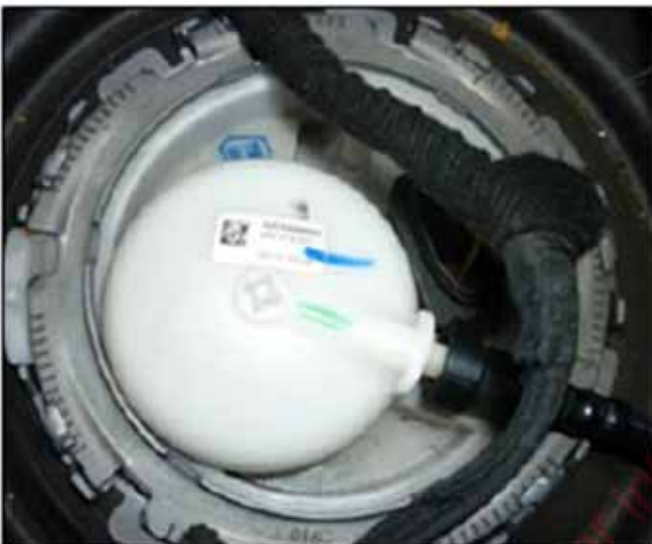
- If there are **NO** cracks and/or yellow discoloration present, apply the protective film as shown in the next step.

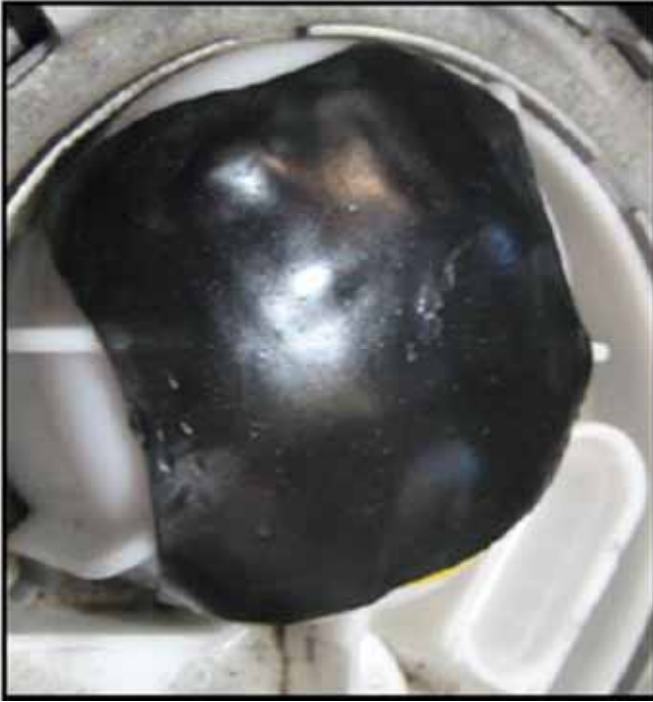
- Apply protective film as shown. Start application from the center and work the protective film towards the outside edges of the fuel pump flange taking care to eliminate air gaps or bubbles under the film.

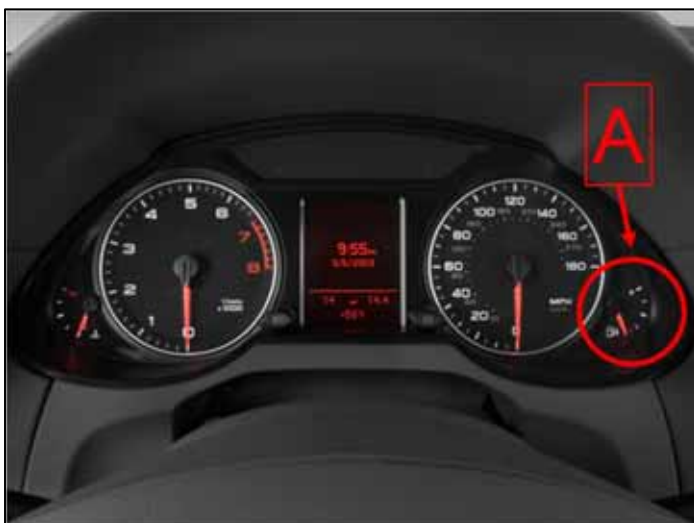
- Turn on the ignition.
- Cycle the ignition four to five times to prime the fuel system and verify there are no DTCs present and no warning lamps illuminated.
- Start the vehicle to verify fuel system functionality. Make sure to check for any fuel leaks before delivering the vehicle to the customer.
- Check the vehicle fuel level displayed on the instrument cluster <A>.
- Refer to the vehicle fuel level on the repair order and verify the proper operation of the fuel level sensor, and that the correct amount of fuel has been returned to the vehicle from

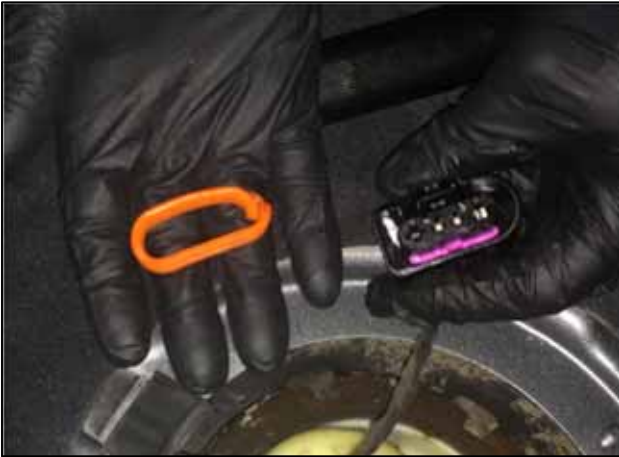
- If the fuel filter flange was leaking fuel, inspect the wiring harness connector carefully for damage due to fuel wicking into the weather pack seals.
  - If damage to the weather pack seal and/or wiring harness is discovered, include pictures in the same Technical Assistance WEB ticket and follow the direction of the Technical Assistance Consultant for performing the repair.
- Attach photo(s) to the ATA case clearly indicating the filter flange is leaking and if present damage to the wiring harness. An ATA Consultant will review the photos and then update the ATA case with a case code.
  - Provide this case code to your parts department so the filter flange can be ordered by your parts department.
    - If required order the necessary wiring harness repair parts at this time.

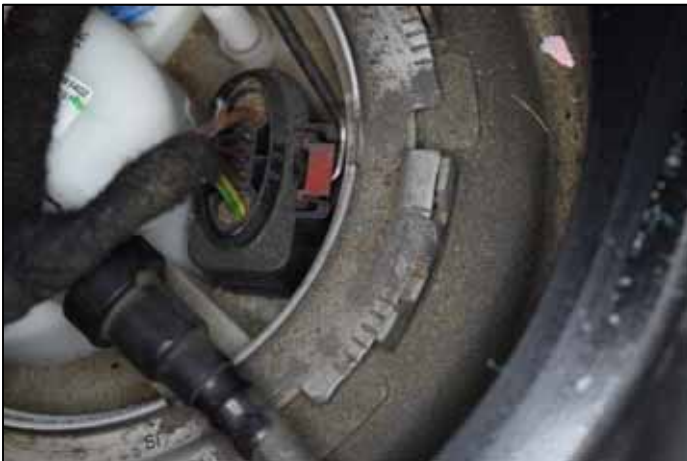
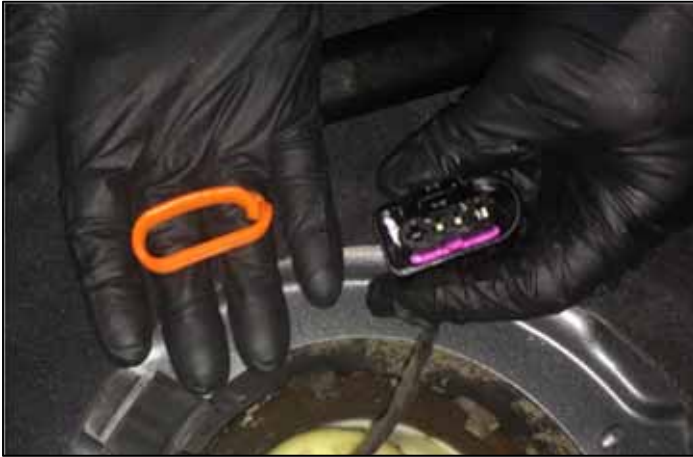
- To disconnect the connector, pull up <arrow A> on the red locking tab <1>, then depress the tab <B> inward following the direction of the <arrow B>.
- If the fuel filter flange was cracked and leaking, inspect the electrical connector for any potential damage to the sealing rings, wires, or contacts.

- If required, repair the wiring harness connector, wiring, and weather pack seals as instructed by Technical Assistance

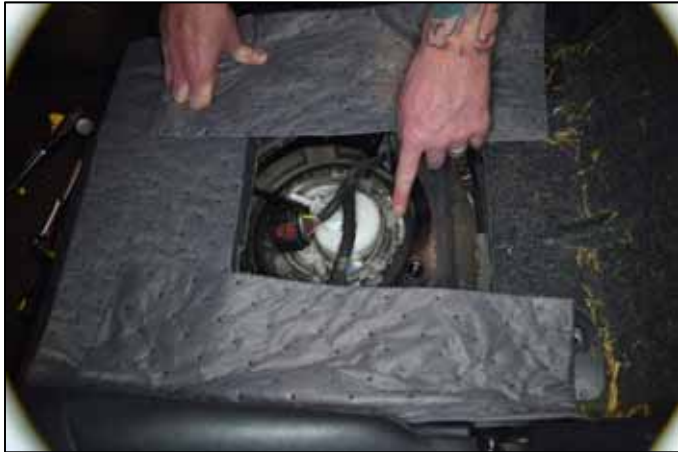
! NOTE	
<p>Accurately record the amount of fuel in liters removed from the vehicle using the sightglass measurement viewport on the side of the -VAS 5190- Fuel Extraction Unit. It is required to</p>

return to the fuel tank precisely the amount of fuel removed from the fuel tank. Failure to do so may result in fuel sending unit faults.

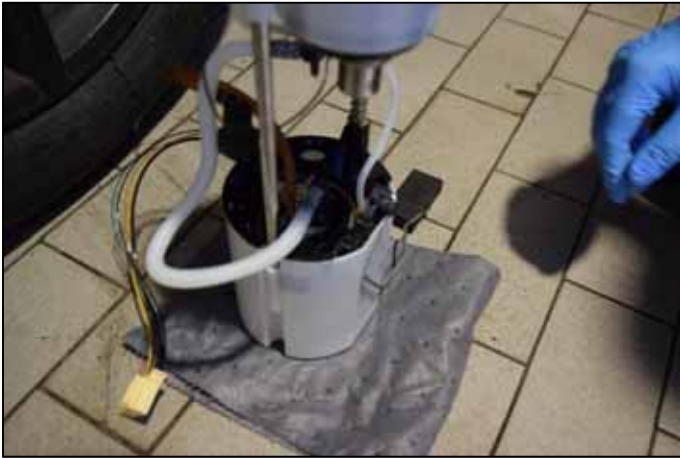
- Make sure the fuel hoses and wires are routed correctly as shown in the illustration.
- The fuel supply line must be routed in front of the guide pipe.
- The suction jet pipe must be routed behind the guide pipe.
- Insert the guide tube and the sealing flange into the guide holes of the fuel delivery unit.

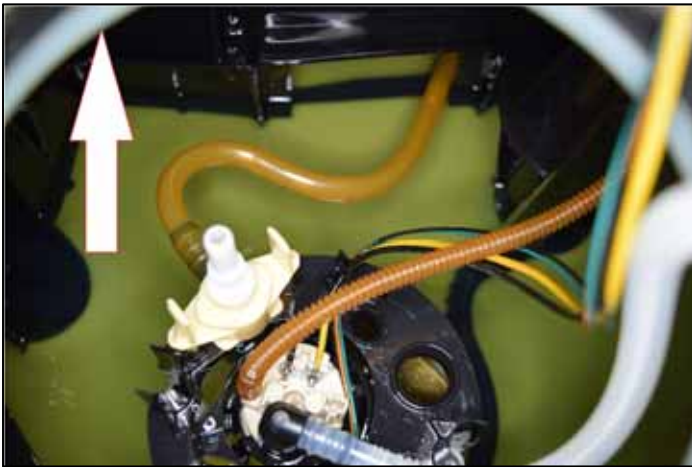
- Arrow denotes the front of the vehicle.
- Attach the suction jet pump to the fuel delivery unit. To do this, reach into the fuel tank through the opening and press down until you hear an audible click.
- Suction jet pump must engage audibly.
- Make sure the suction jet pipe and the suction jet pump are securely locked in place.

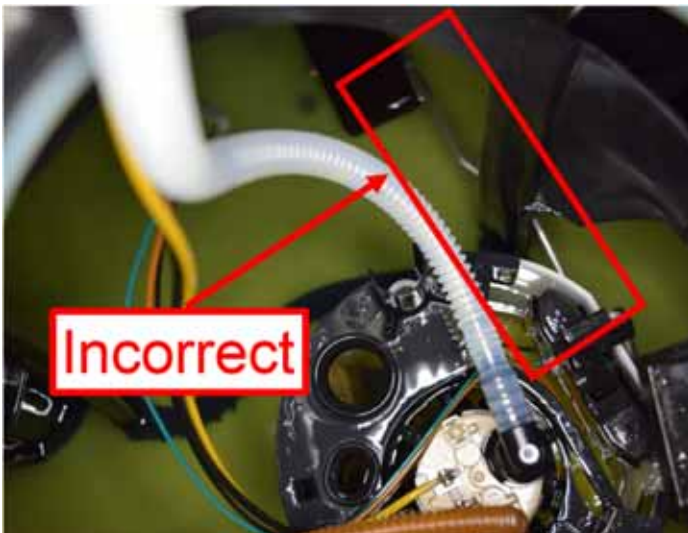
- Pay attention to the installation position of the Fuel Level Sensor Float.

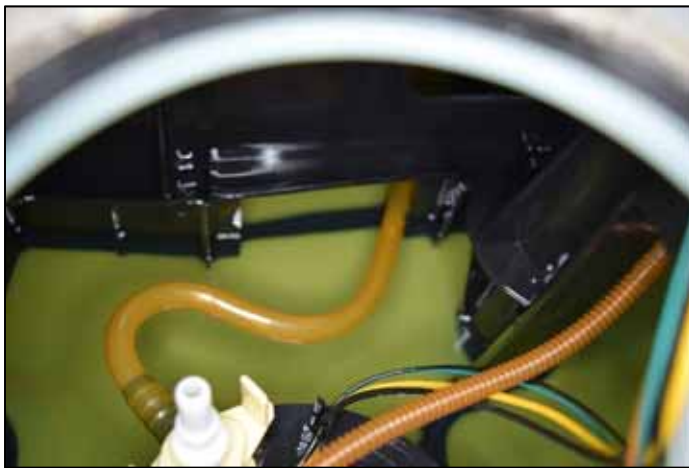
- Note the proper routing of the suction jet pipe. The suction jet pipe should be directed forward through the opening in the fuel tank baffle.

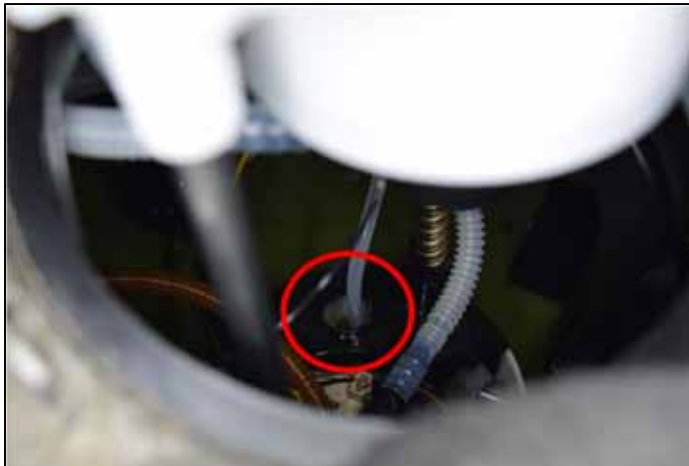
- Note the proper routing of the vent pipe <circle>.

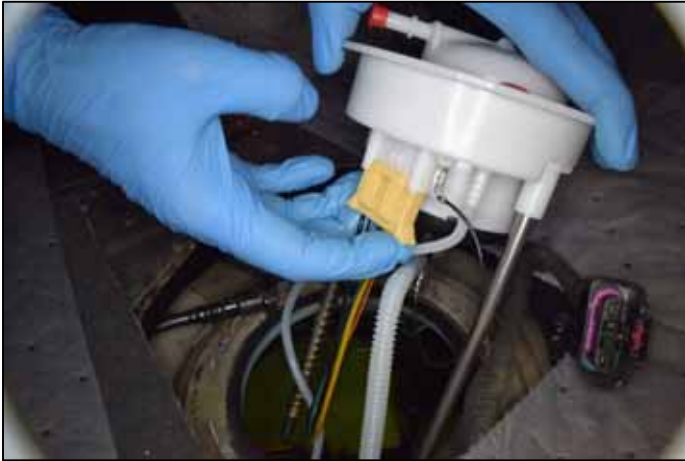
- Reconnect the fuel pump connector to the fuel filter flange.
