Service Bulletin

SAFETY and EMISSIONS RECALL

2014-2015 NSS300/A (Forza) FUEL PUMP REPLACEMENT

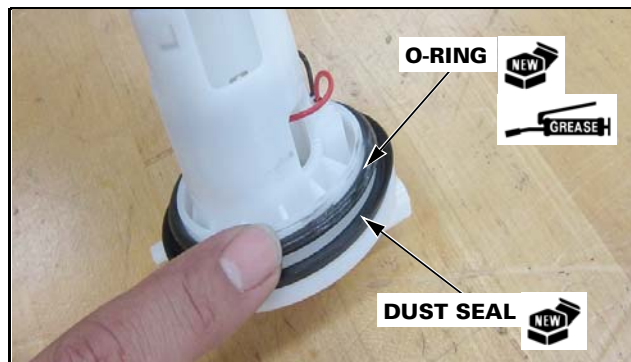
- Apply a very thin layer of multi-purpose grease to ONLY the outer surface areas of the new O-ring to allow it to slip evenly into the channel on the fuel tank during installation.

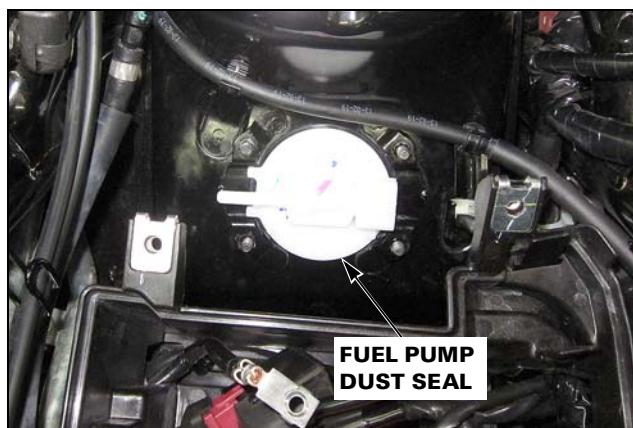
- Center the pump assembly over the fuel tank opening and gently align it with the opening until the dust seal is perfectly square with the tank face and centered with the opening.

Firmly push the fuel pump into the opening until it seats evenly all around. Let go of the fuel pump.

- If the fuel pump remains seated into the fuel tank by itself, continue with the repair as shown in the Service Manual.

- If the fuel pump pops out or does not remain seated by itself it is not properly installed. Back out the pump and ensure the O-ring is on the shoulder of the fuel pump. Continue inserting the pump until it seats into the fuel tank squarely and remains seated by itself then continue with the repair as shown in the Service Manual.

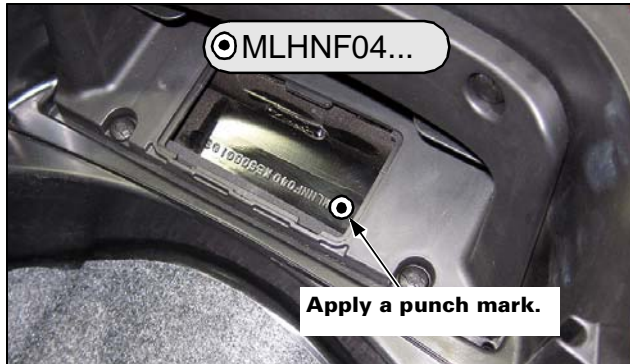
After you have completed the REPAIR PROCEDURE, apply a punch mark BEFORE the first character of the VIN located on the frame, under the tool box, inside the luggage box as shown.

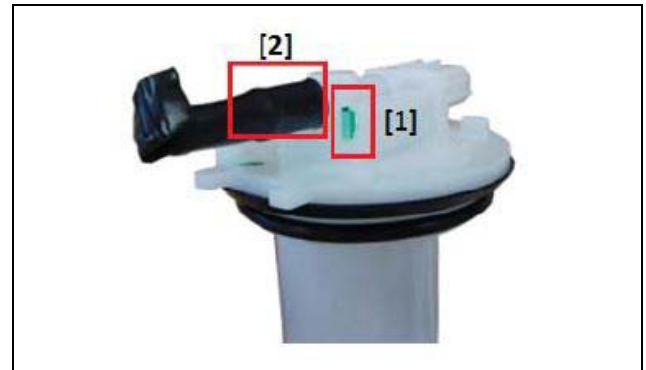
Be careful not to mix up the defective or original recall parts with countermeasure parts. The countermeasure part is identified by a green paint mark [1] on top of the fuel pump unit and a black cap cover [2] as shown. Use care during unpacking and installation as the paint mark is easily wiped off.
