TECHNICAL INSTRUCTIONS

SAFETY RECALL GOW

FRONT PASSENGER AIR BAG

CERTAIN 2016 MODEL YEAR PRIUS

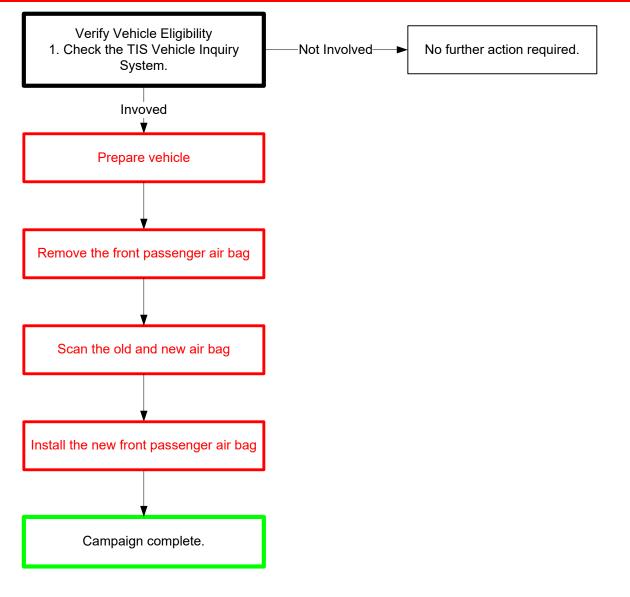
I. OPERATION FLOW CHART

The flow chart is for reference only. *DO NOT* use it in place of the full technical instructions. Follow *ALL* steps as outlined in the full technical instructions to confirm the campaign is completed correctly.

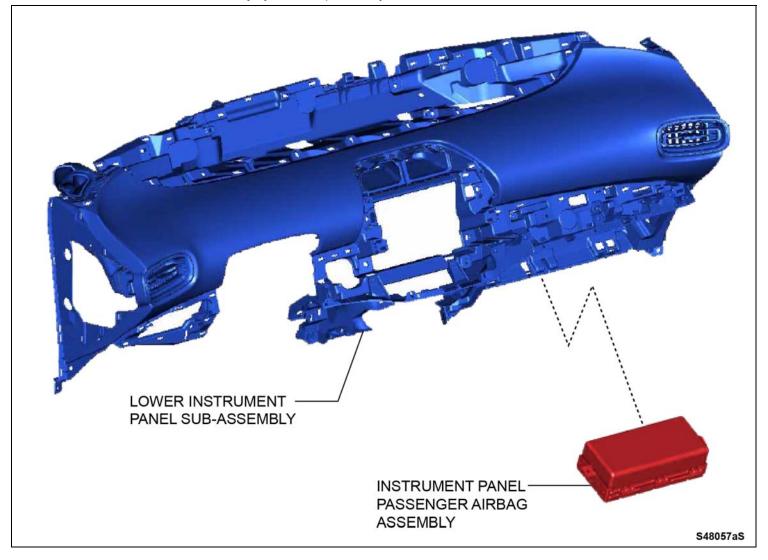
The involved vehicles are equipped with a front passenger air bag which contains stored, compressed gas in the inflator. A component in the air bag assembly may have been improperly welded and/or misassembled. If this occurs, the stored gas may escape without a deployment signal and result in the partial inflation of the air bag. This has been observed when the vehicle is parked and unoccupied for a period of time. An air bag that inflates in this manner can, under some circumstances, increase the risk of injury and the possibility of a crash.

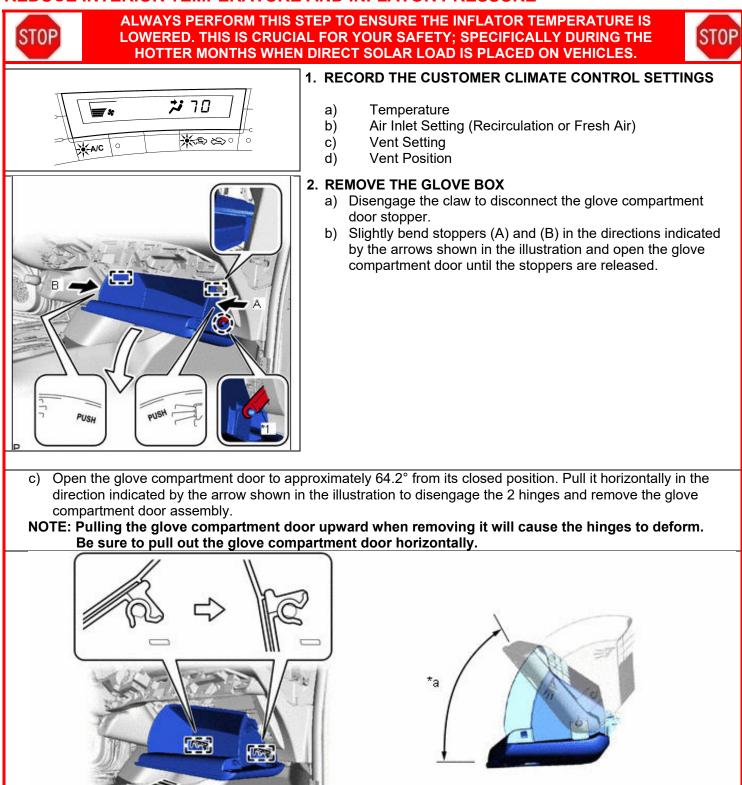
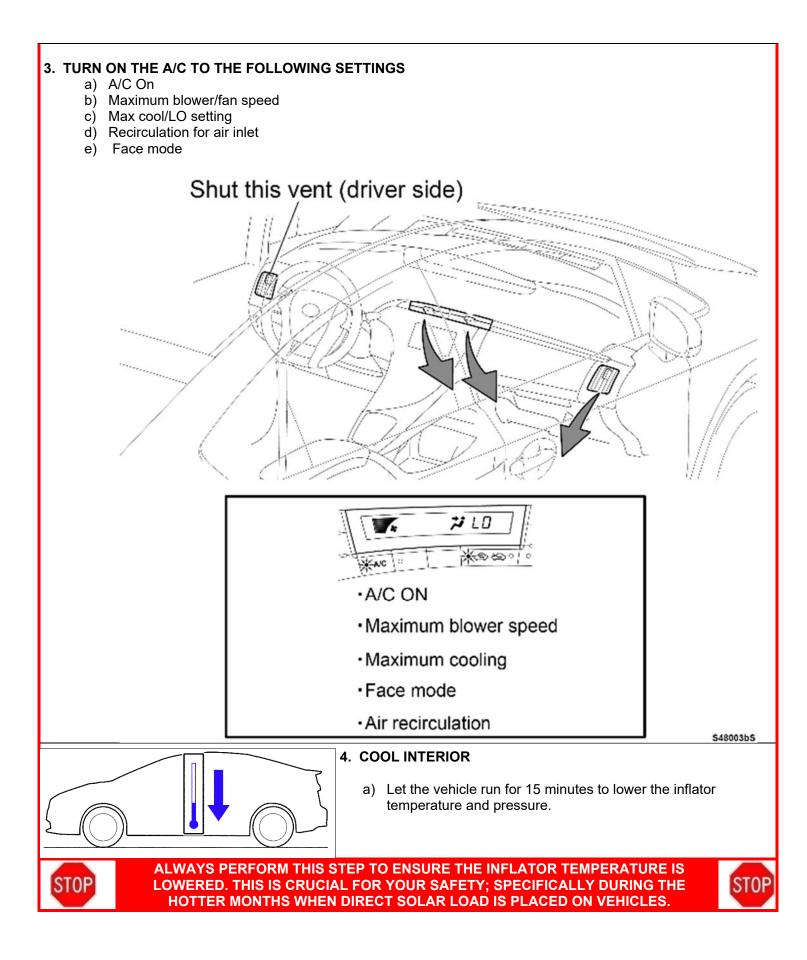
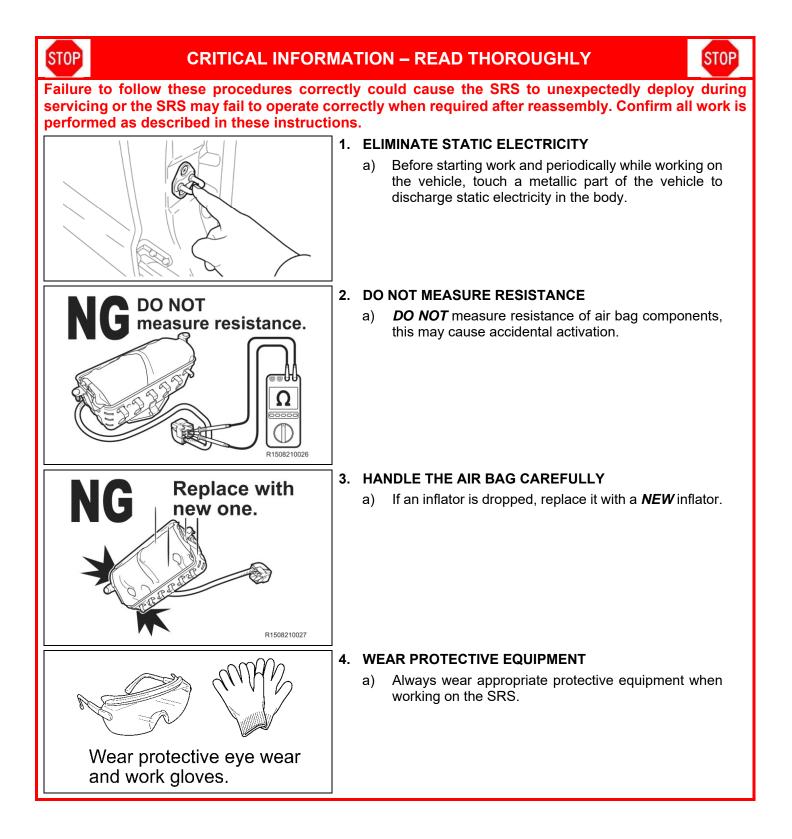
REDUCE INTERIOR TEMPERATURE AND INFLATOR PRESSURE

Ensure that the interior temperature inside the vehicle has been lowered as described in Section V .VEHICLE PREPARATION AND PRECAUTIONS. High interior temperature leads to higher gas pressures in the air bag inflator.

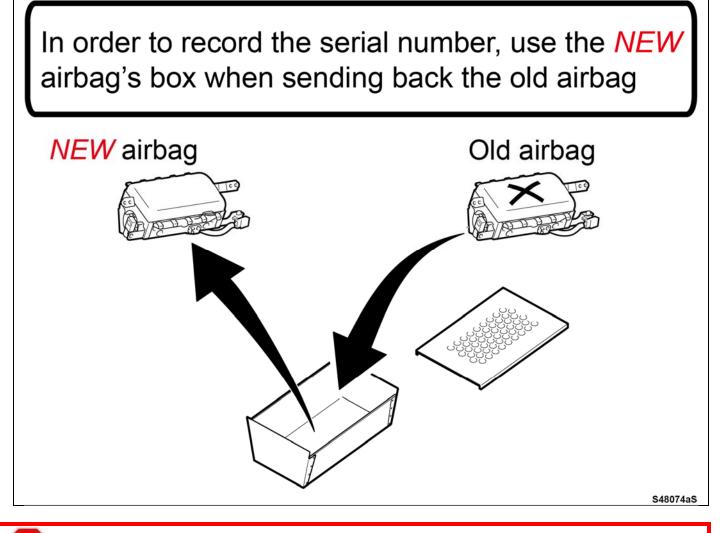
- g) Mark the old airbag so it is not reused.
- NOTE: The air bag sub-harness will be reused, remove as described in the repair manual. After scanning the old air bag serial number immediately place the old air bag into the shipping container the new air bag arrived in and return the old air bag to the parts department for recovery. Refer to Section IX Step B PACKAGING THE OLD AIR BAG FOR RETURN

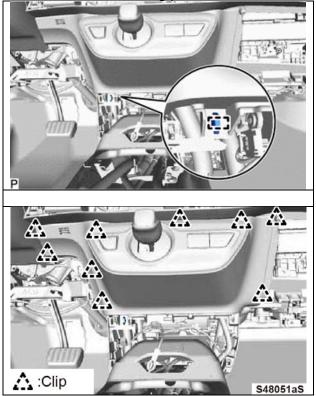
NOTE: Use the following procedure to reinstall the No.2 lower finish panel.

a) Engage the clamp.

- b) Reinstall the No.2 lower finish panel and shift lever cover.
- c) Reconnect the connectors.
- d) Reengage the 9 clips.

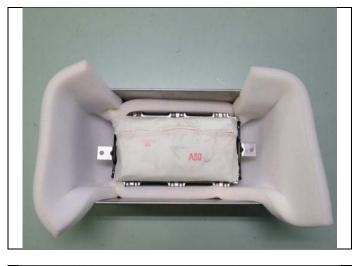
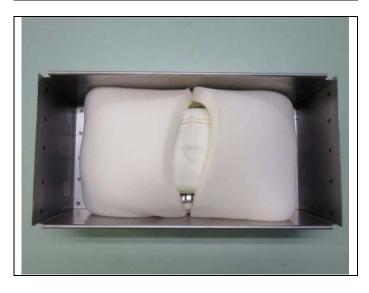
a) Place the polyurethane in the center of the steel case.

b) Place the old air bag in the center of the case.

c) Fold over the urethane as shown and tuck the urethane between the air bag and the case.

d) Repeat on the other side.

NOTE: To allow the lid to close properly ensure that the urethane is tucked between the air bag and the case. Ensure to tuck the urethane all the way around the air bag to avoid contact with the case.

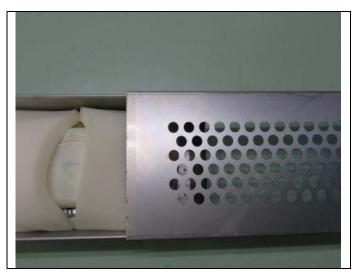
e) Slide the lid onto the case and ensure the lid engages the flange.

NOTE: Ensure that the lid fully engages the case flange on both sides.
