IMPORTANT SAFETY RECALL NOTICE

Aero Industries has decided that a defect which relates to motor vehicles safety exists in certain Conestoga XP systems with a RAD style rear closure.

Rivet Replacement

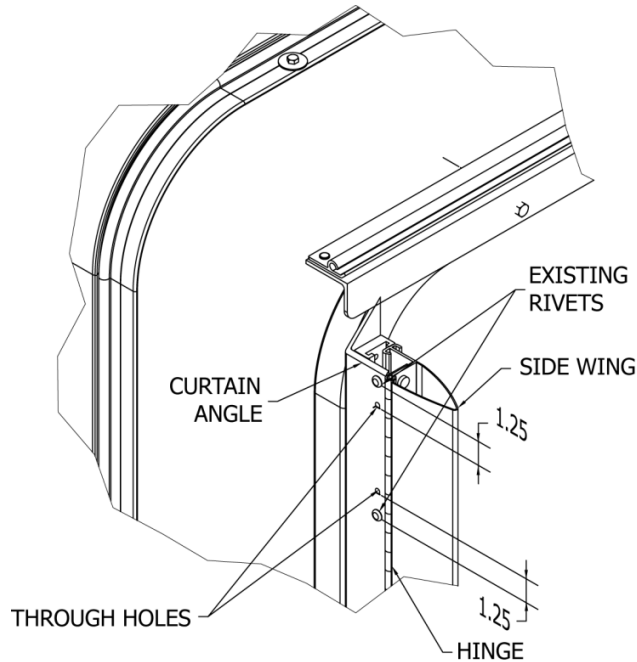
Detail 3

Locate the top two rivets on the angle side of the hinge. Using the included "G" drill bit, drill holes 1.25" below the top rivet and 1.25" above the bottom rivet. Holes are to go through the hinge and the angle. (Do not drill through the side wing.) All rear lock details show the driver side. The passenger side is to be done the same.

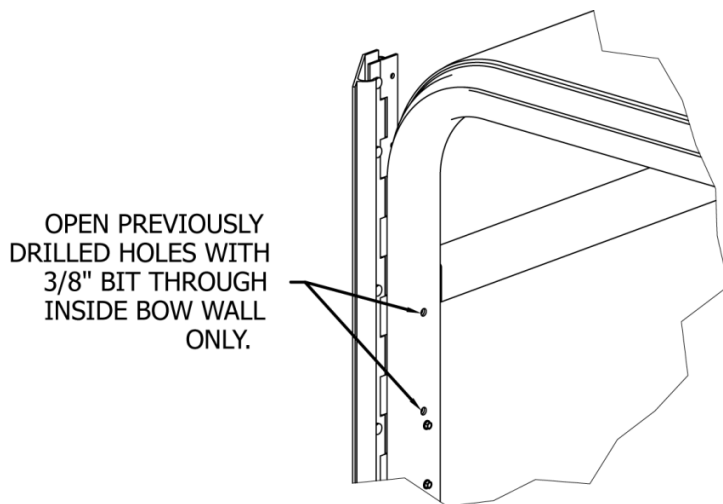
Detail 1A

Using the included 3/8" drill bit, enlarge the two holes from the previous step. Drill through the inside wall only.

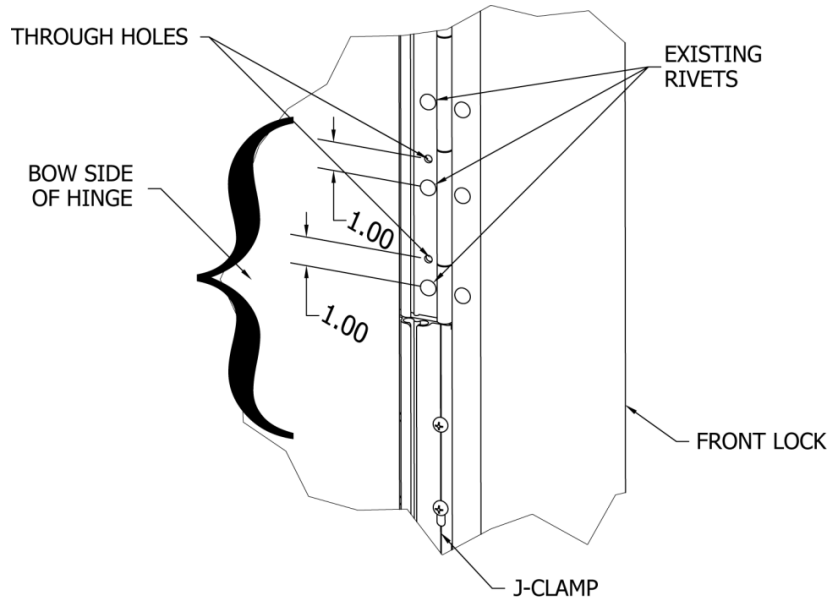
Detail 2

Locate the bottom two rivets on the bow side of the hinge, just above the J-Clamp.

Using the included "G" drill bit, drill holes 1" above each of the two rivets. Holes are to go all the way through the

hinge and both walls of the bow.

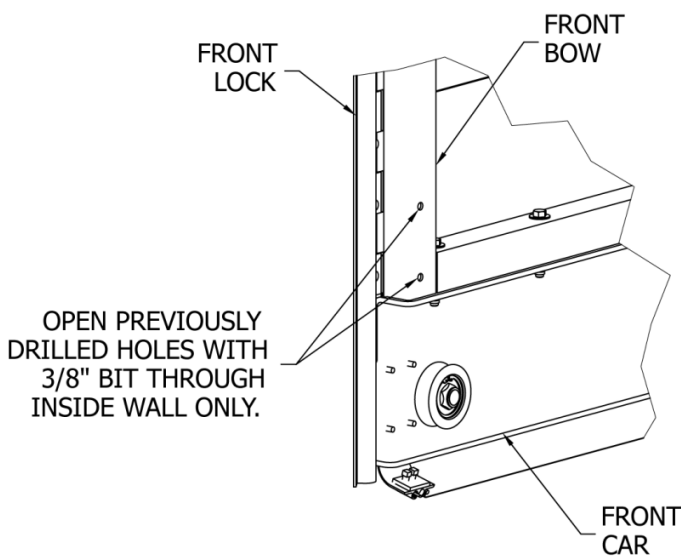
Detail 2A

Using the included 3/8" drill bit, enlarge the two holes from the previous step. Drill through the inside wall only.
