SI B65 22 16
Audio, Navigation, Monitors, Alarms, SRS

RECALL CAMPAIGN 16V-683: DRIVER'S AIR BAG MODULE F15 F25 F26

SI B65 22 16 - Recall Campaign 16V-683: Driver's Air Bag Module

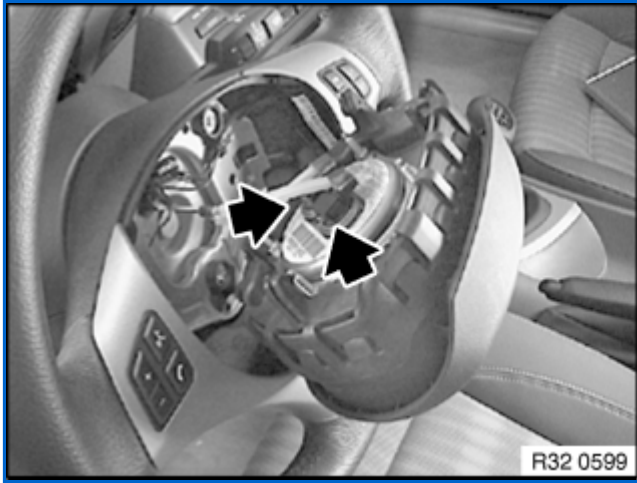
Tilt airbag unit forwards.

Disconnect plug connections and remove airbag unit.

Installation note:

Connect plugs to connections of same colour on airbag unit.
