SIB 65 22 16

## RECALL CAMPAIGN 16V-683: DRIVER'S AIR BAG MODULE F15 F25 F26

This Service Information Bulletin (Revision 4) replaces SI B65 22 16 **dated December 2018**.

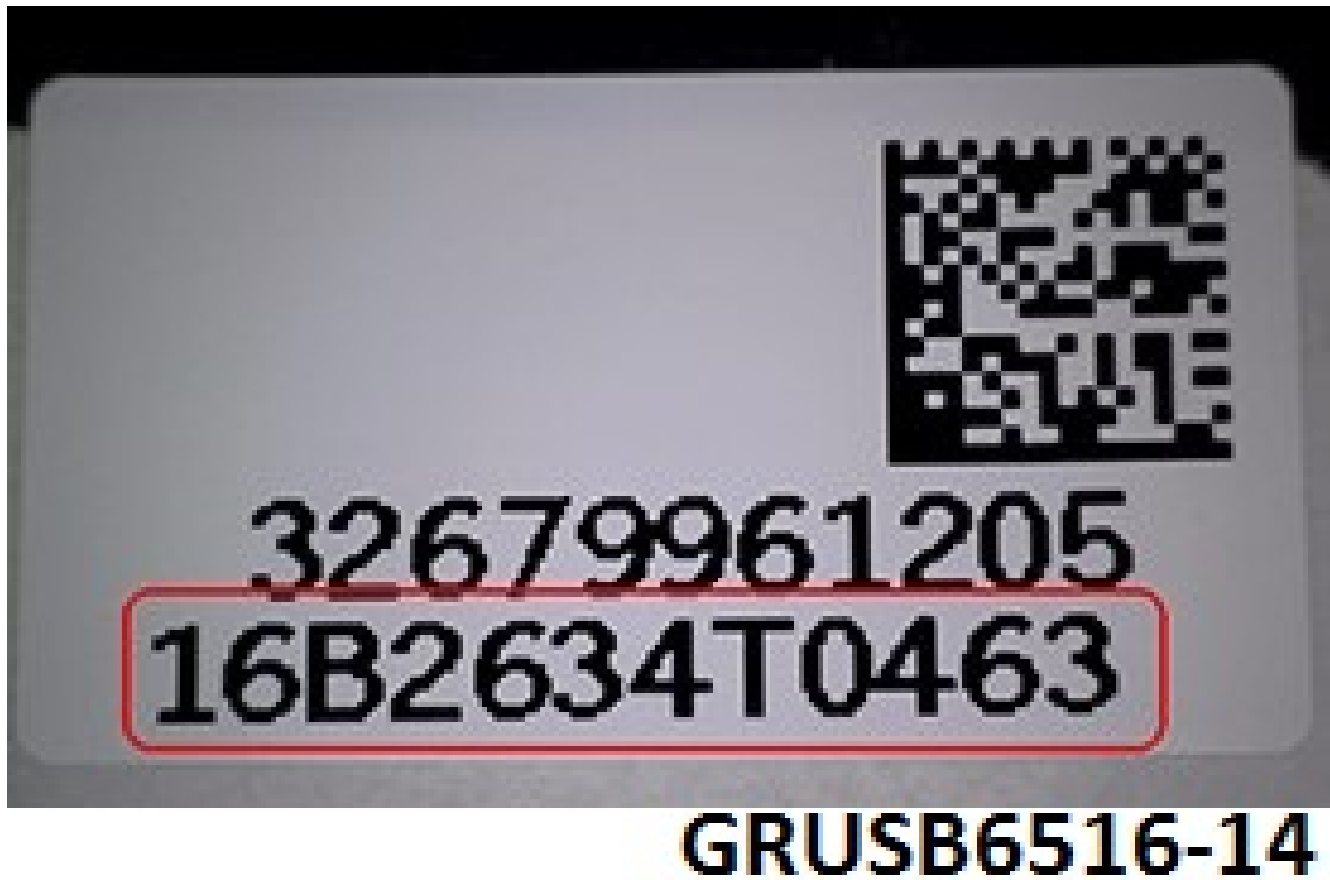
Before installing the replacement part, the new air bag module's serial number (circled above) must be documented by the technician on the repair order so it can also be entered into the warranty claim's comment section.

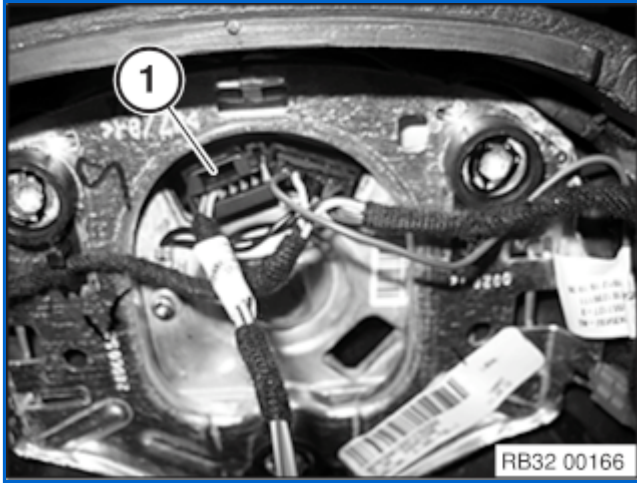
Tilt airbag unit towards rear.

Disconnect electrical connectors (1) and remove airbag unit.
