Keystone RV Company

SAFETY ADVISORY # 16-266

Coleman Power Center Wiring

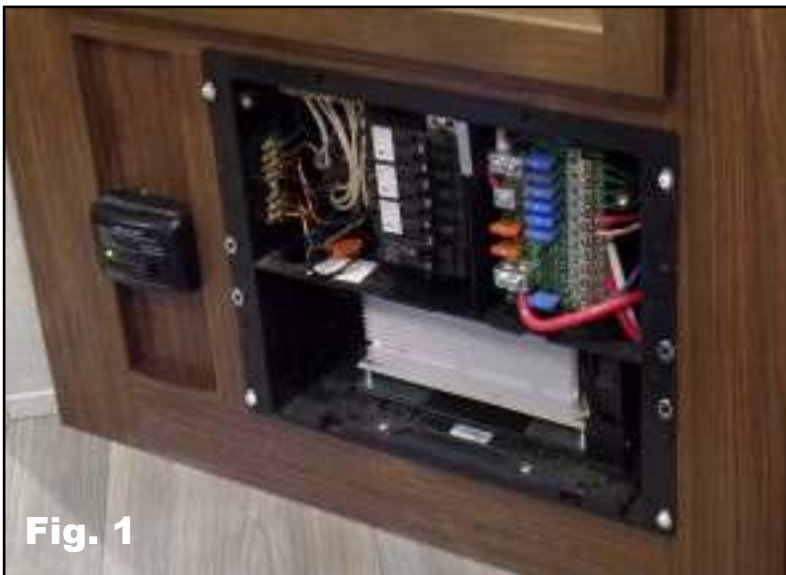
Fig. 1

Remove the screws securing the cover on the power center, Figure. 1.
