# TECHNICAL SERVICE BULLETIN

## Slingshot

Bulletin Number: T-16-06  
Model Years: 2015-2017

**2015-17 SLINGSHOT – Swingarm Replacement**

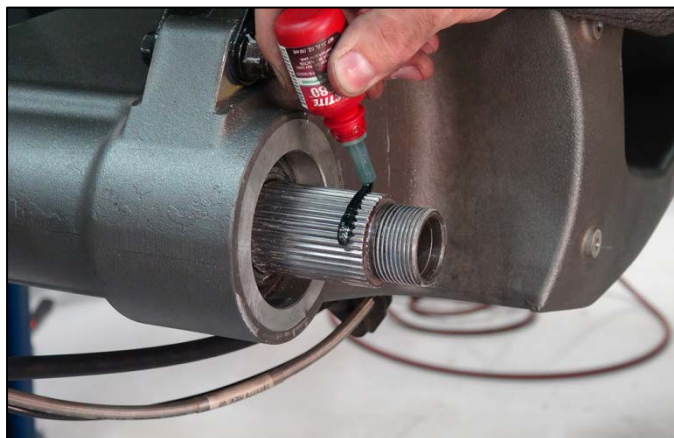
12. Inspect axle splines and threads, sprocket splines, and axle nut threads to ensure they are clean and free of old Loctite.
13. Apply a bead of Loctite (provided in kit) around the leading edge of the rear axle and driven sprocket splines.

A secondary dealer representative must verify that Loctite has been applied to leading edge of the rear axle and driven sprocket splines. Record time and date of Loctite application on the T-16-06 bulletin completion form.
