# TECHNICAL SERVICE BULLETIN

Bulletin Number: T-16-06  
Model Years: 2015-2017

**2015-17 SLINGSHOT – Swingarm Replacement**

Certain Slingshot vehicles may have been assembled with an improperly manufactured swing arm, resulting in decreased swing arm strength. If the swing arm is compromised it can result in a loss of forward momentum or control, increasing the risk of a crash.

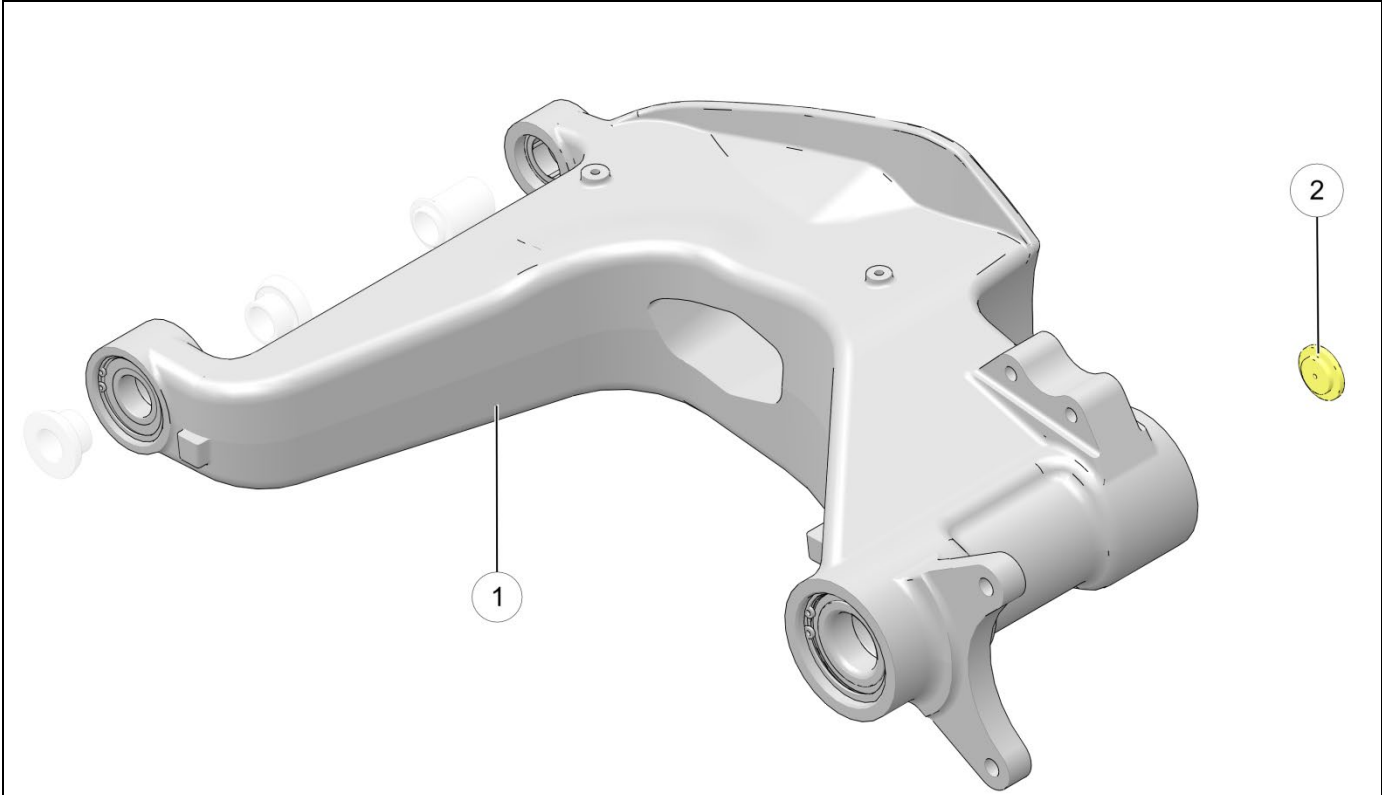
**KIT CONTENTS (P/N 2207085)**

| REF | PART DESCRIPTION | PART NUMBER | QTY |
|---|---|---|---|
| ① | Swingarm Assembly w/bearings | 5141107-XXX | 1 |

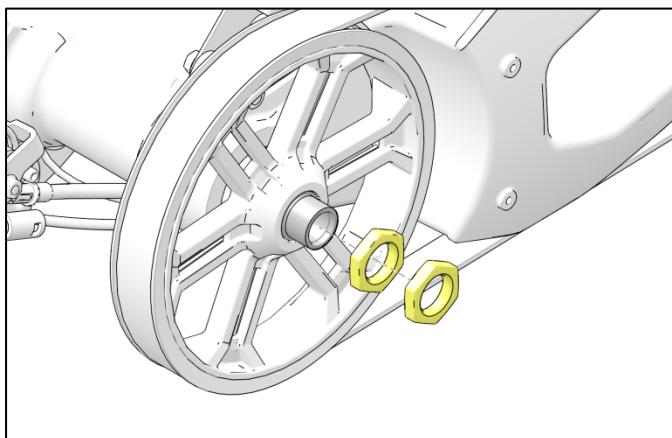
DO NOT reuse single axle nut.  
**SINGLE AXLE NUT = DISCARD**  
**DOUBLE AXLE NUTS = KEEP & CLEAN**

5. Remove the Axle Nut(s).

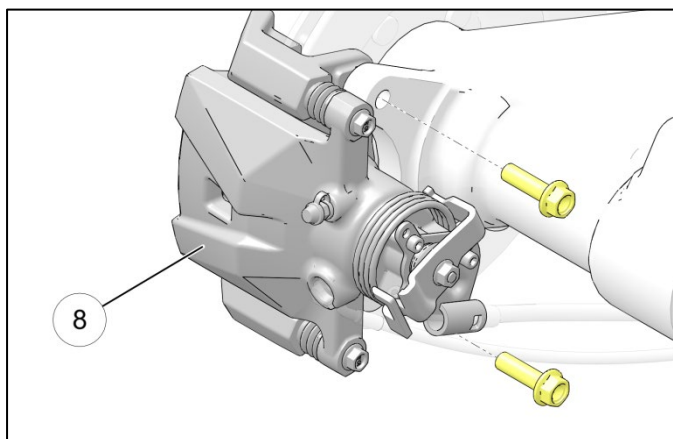
When removing caliper, use care not to damage brake line. Support caliper to avoid kinking or bending brake line.

10. Remove two fasteners and brake caliper ⑧. Retain fasteners for installation.

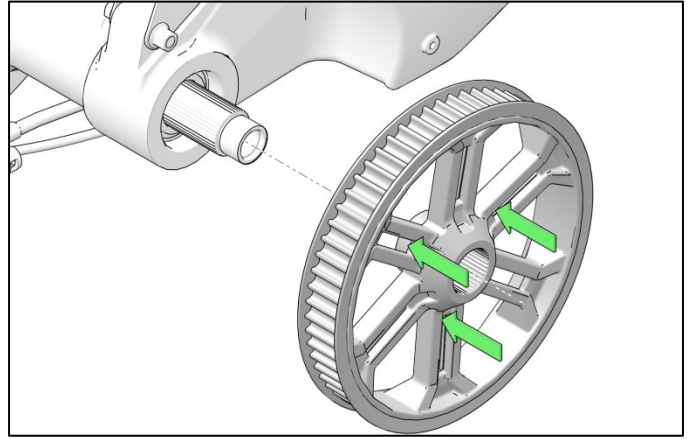
Do not use puller on outer flange of the sprocket. Pulling on the outer flange will damage the sprocket.

15. Use a commercially available 3 jaw puller to remove the rear sprocket, pressing against the provided puller seat. Install the puller between the sprocket spokes as shown.

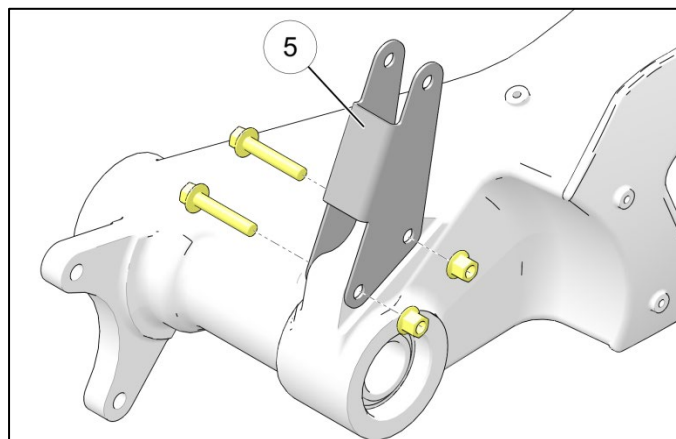
A secondary dealer representative must verify that the shock bracket fasteners have been torqued using a torque wrench set to the correct specification. Mark the fasteners with a paint pen to indicate the audit has been completed.

2. Install two fasteners securing rear shock bracket ⑤ to the swingarm. Torque fasteners to specification.

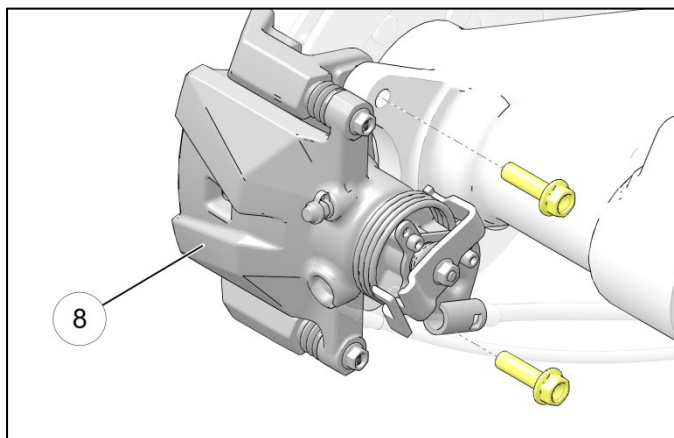
A secondary dealer representative must verify that the brake caliper fasteners were torqued using a torque wrench set to the correct specification. Mark the fasteners with a paint pen to indicate the audit has been completed.

8. Position Brake Caliper (8) onto rotor and re-install two original fasteners. Torque fasteners to specification.

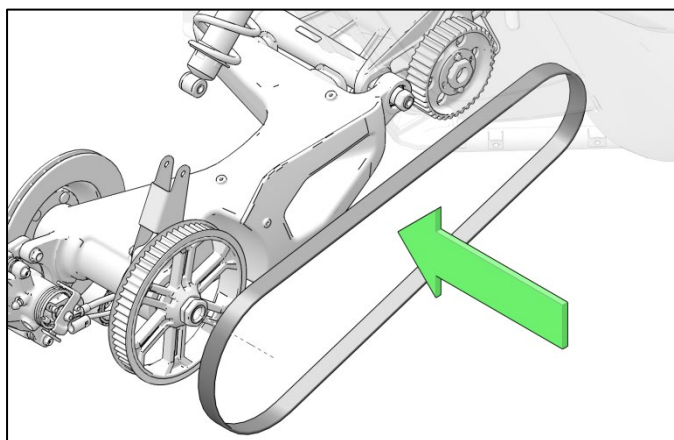
The belt is directional and marked with a part number that can be read when facing the vehicle. Make sure the belt is installed properly.

20. Install drive belt around the drive sprocket splines. Remove lower shock mount fastener and allow swingarm to pivot downward. Install drive belt around the driven sprocket splines.

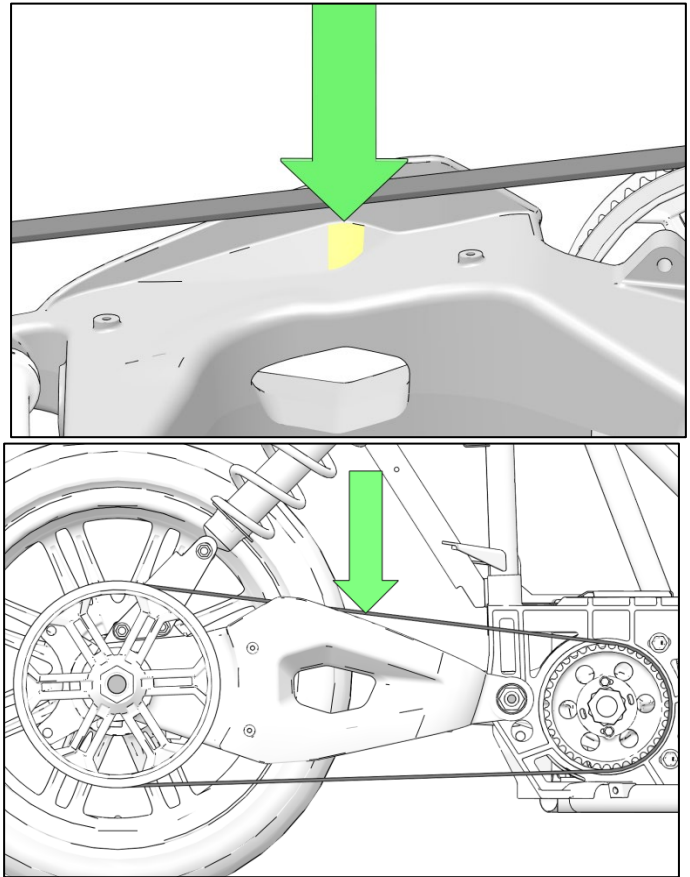
Drive Belt Deflection with 10 lbs of pressure:  
**0.63 in (16 mm)**

19. \* If belt tension is within specification, proceed to next step.  
\* If belt tension is outside specification, repeat steps 1-15 until proper belt tension is achieved.
20. Elevate and secure the rear of the vehicle so that the rear suspension is fully extended.
21. Rotate the rear wheel forward and observe where the belt tracks on the rear sprocket.

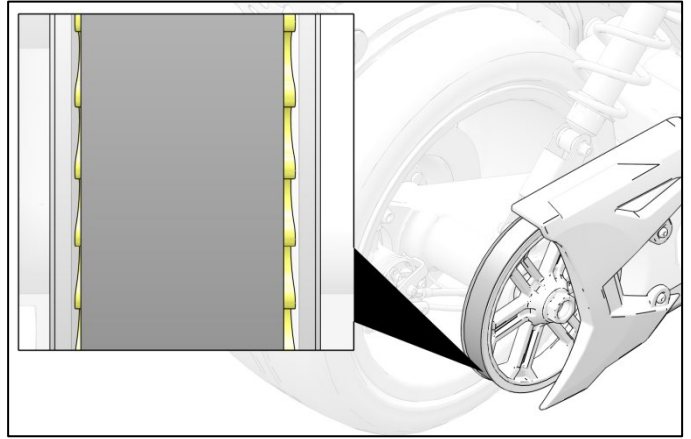
22. Rear wheel alignment is satisfactory when the drive belt tracks closer to the inboard driven sprocket flange. Sprocket teeth should still be visible on both sides of the drive belt.
23. If drive belt does not track properly, loosen Pivot Shaft Nut and tighten or loosen Pivot Shaft  $\frac{1}{4}$  turn at a time to adjust where the drive belt tracks. Rotate the rear wheel forward and observe where the belt tracks on the rear sprocket.

If the drive belt is too far inboard, the belt will make noise during deceleration. If the belt is too far outboard, the belt will make noise during acceleration or while under load.
