Subject **Body Tip Bracket Inspection**

Series **V-Range - 651, 801.**

Technical Bulletin

TB1706

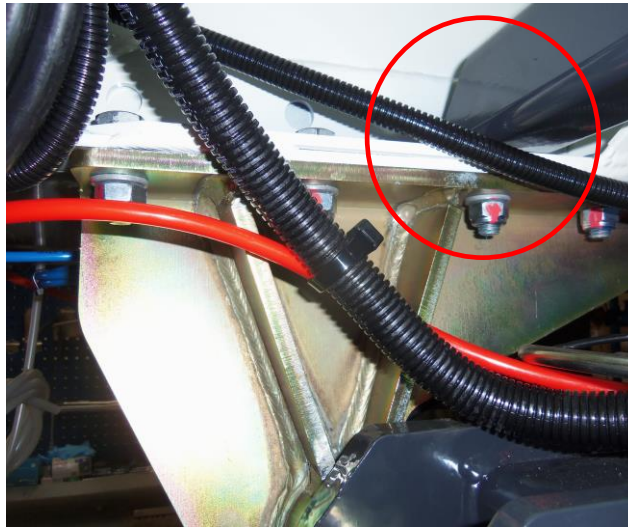
Figure 1 – Reaction beam fitted to left hand side of vehicle.

1. Working with the body in the lowered position and accessing the brackets from the rear of the machine, remove the third bolt from the back on each tip bracket – See Figure 1.
Note: Machines are fitted with either four bolt brackets or five bolt brackets, the reaction beam must always be fitted to the third bolt from the rear of the vehicle.
