GROUP Safety Recall Campaign	MODEL 2016MY Sorento (UMa)
	NUMBER SC140	DATE November 2016
SAFETY RECALL CAMPAIGN		
SUBJECT: DRIVER SEATBACK FRAME INSPECTION AND REPLACEMENT (SC140)

DRIVER SEATBACK FRAME INSPECTION AND REPLACEMENT (SC140)

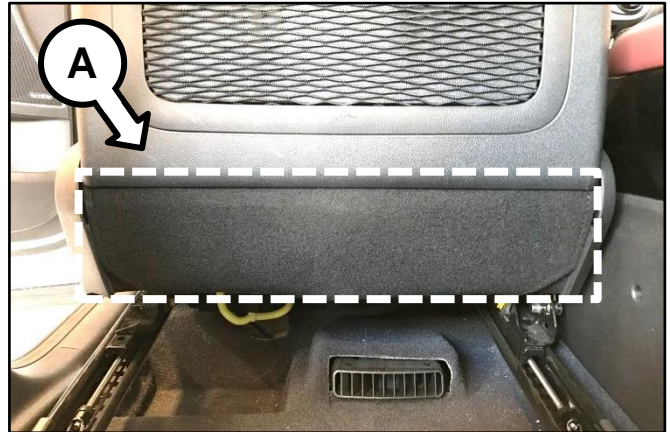
1. Unhook the driver's lower seat protector (A).

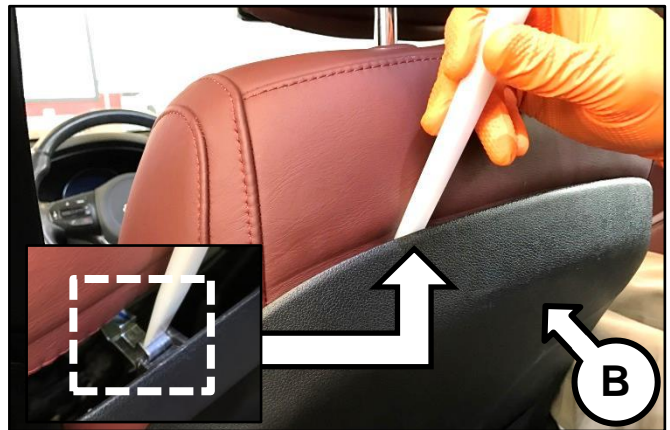
2. Using a non-marring trim removal tool, remove the driver seat backboard (B) by inserting the tool behind the upper section of the backboard and pushing down on the two (2) lock pins. Pull the backboard outwards and lift up to remove.

Use a non-marring trim removal tool (Such as Snap-on® Part Number PBN5 or equivalent) to avoid damaging the backboard.

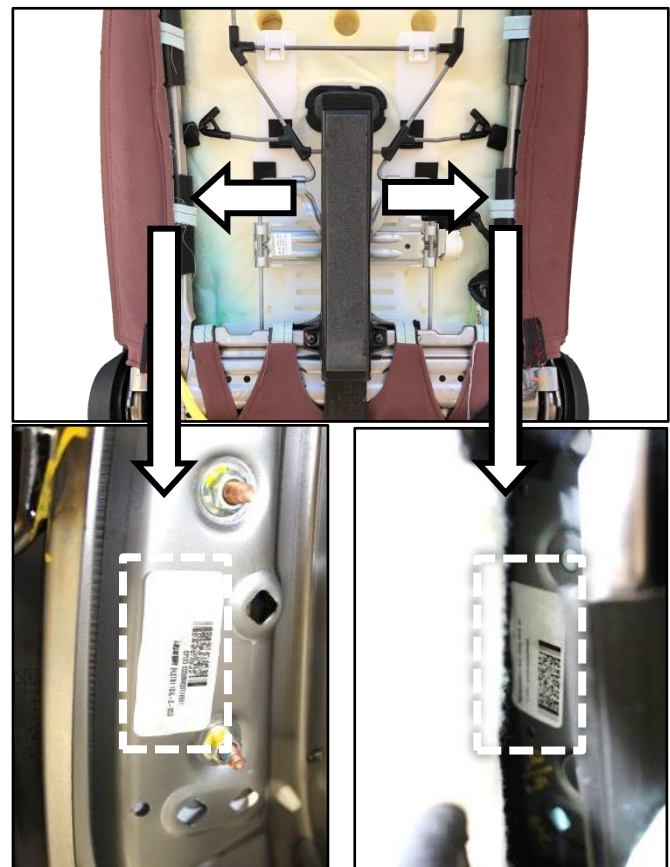
3. Inspect both inner side rails of the seatback frame for barcode labels at the locations shown.

If the two (2) labels are present, no further action is required. Reinstall the removed components in the reverse order of removal.

If only one (1) or no labels are present, proceed to the Weld Inspection procedure on page 3.

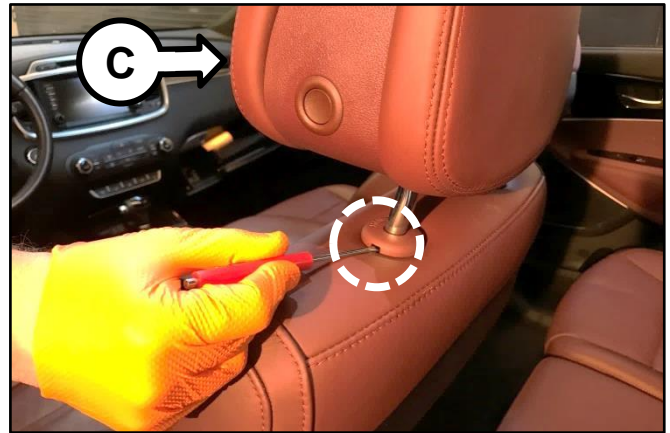
1. Record the customer's radio presets.
2. Tilt the seat backwards and remove the headrest (C) by carefully pushing the lock pin.

Use caution when inserting a tool into the lock pin opening to avoid damage to the seat and trim cover.

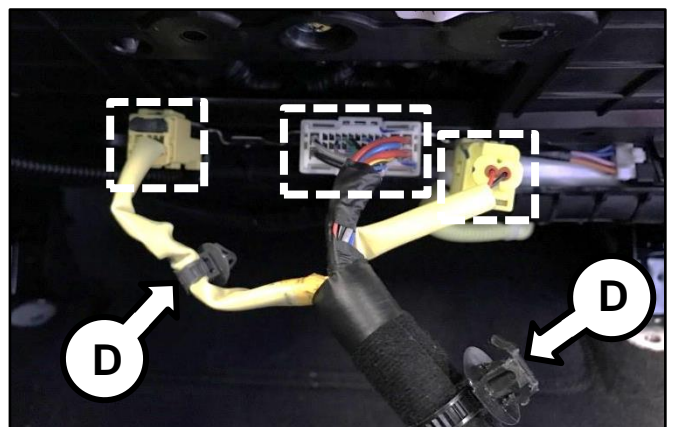
5. Disconnect the three (3) connectors underneath the seat and detach the harness clips (D) from the seat.

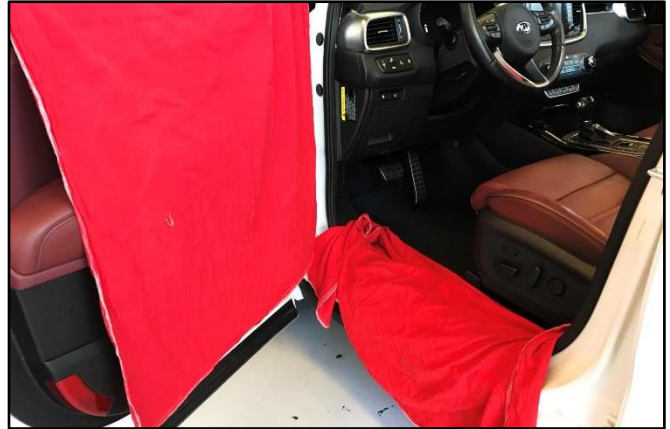
- 6. Carefully remove the seat from the vehicle.

CAUTION
Protect the door sill and door trim panel with protective covers to prevent damage.

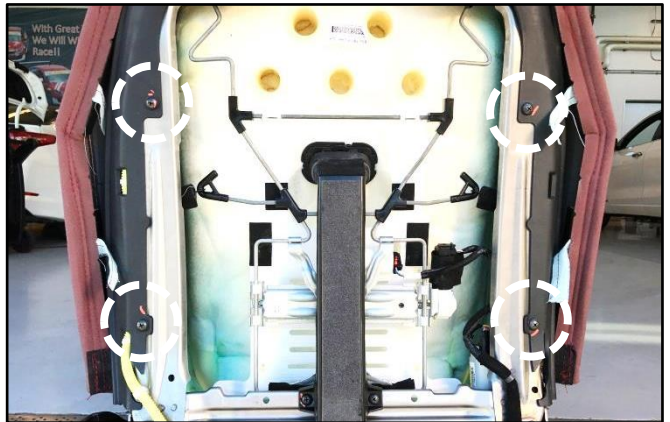
- 7. Unhook the seat cover and pull it away from the frame to expose the plastic trim and remove the four (4) plastic trim retaining screws.

WARNING
Use the straps attached to the hooks to unhook the seat cover to prevent personal injury from the sharp edges on the seat frame.

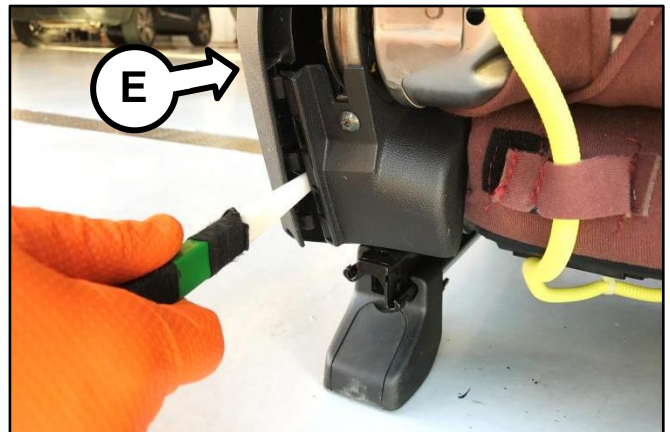
- 8. Using a non-marring trim removal tool, carefully remove the outboard shield cover (E).

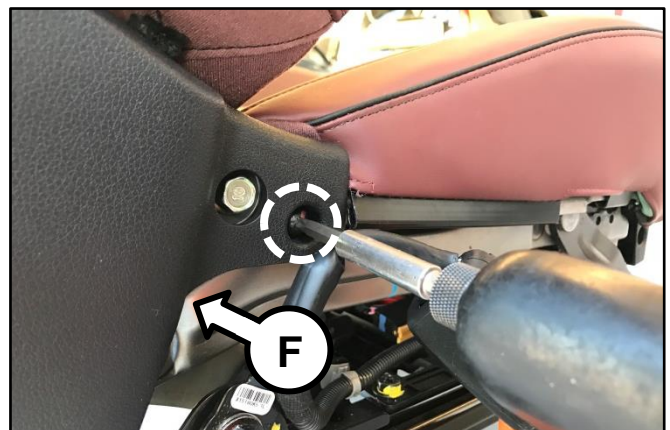
- 9. Using a Phillips screwdriver, remove the inboard shield cover retaining screw as shown and remove the inner shield cover (F) with a non-marring trim removal tool.

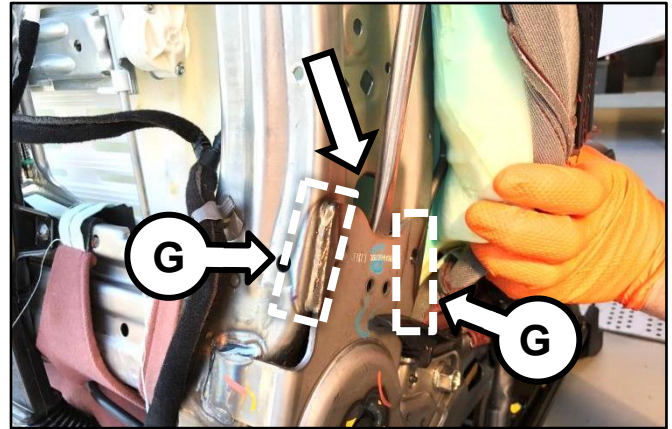
10. Starting at the right side weld joint, insert a large flat-head screwdriver in the top of the opening and with moderate force, pry away from the seat frame to verify proper welding at the joints (G).

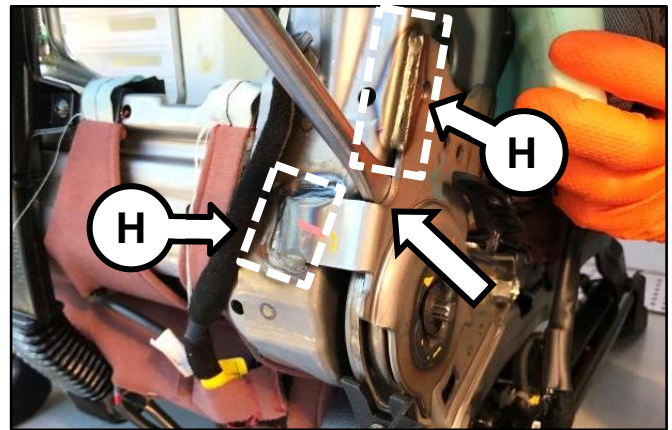
11. Insert the large flat-head screwdriver in the lower opening and with moderate force, pry away from the seat frame to verify proper welding at the joints (H).

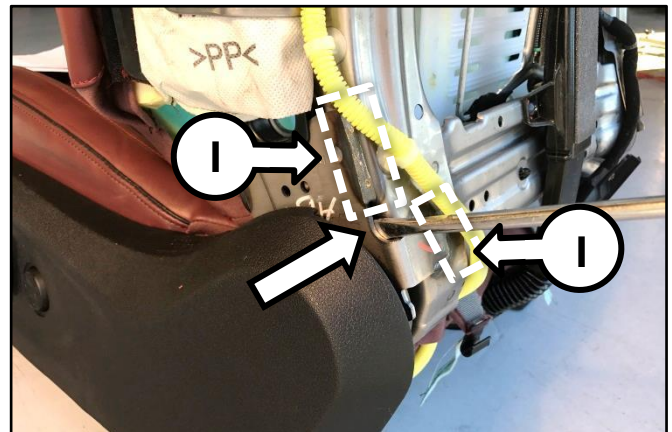
12. At the left side weld joint, insert the large flat-head screwdriver in the bottom of the frame and with moderate force, pry away from the seat frame to verify proper welding at the joints (I).

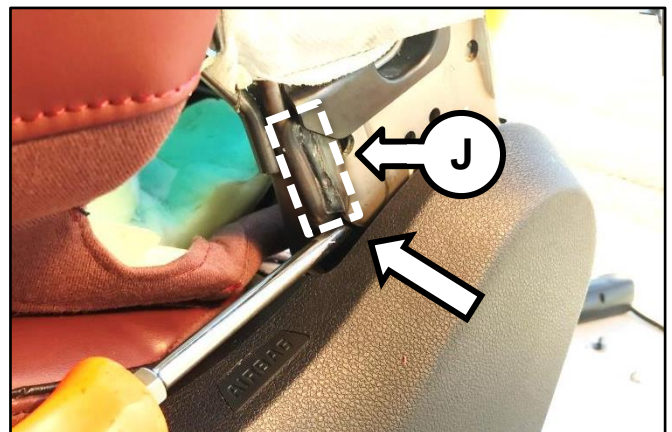
13. Insert the large flat-head screwdriver in the front of the frame and with moderate force, pry away from the seat frame to verify proper welding at the joint (J).

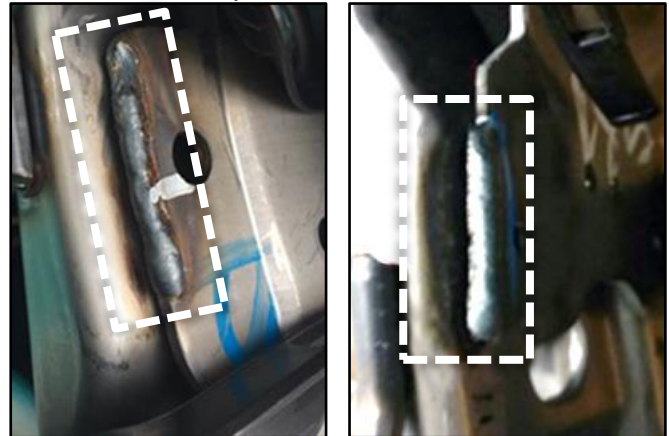
Examples of broken welds

- 14. If the welds are intact and not broken, no further action is required. Reinstall all removed components in the reverse order of removal.

If a weld is found to be broken, proceed to the service procedure below to replace the seatback frame assembly.

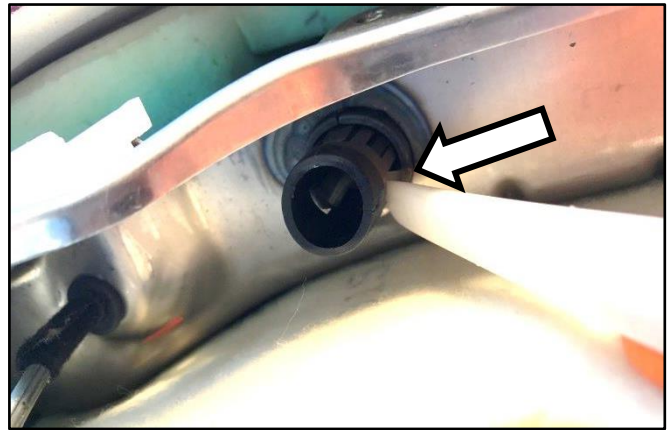
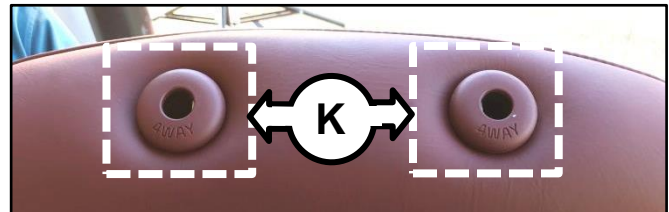
- 1. Using a non-marring trim removal tool, push in the tabs securing the headrest guides and remove the headrest guides (K) from the seat.

Label the headrest guides (LH and RH) after removal to ensure proper installation as they are directional.

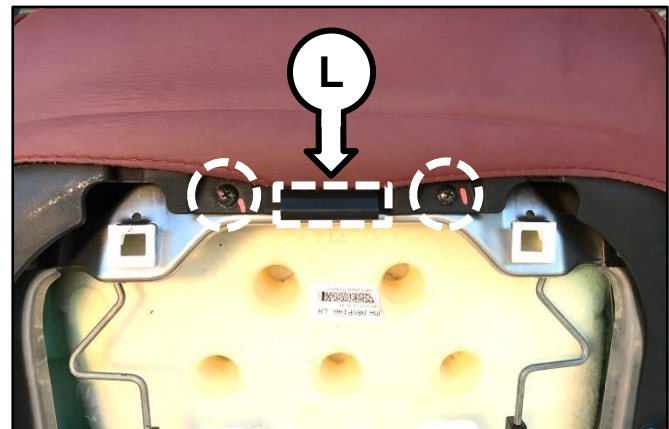
- 2. Completely unhook the seatback cushion cover (L) and remove the remaining two (2) plastic trim retaining screws.

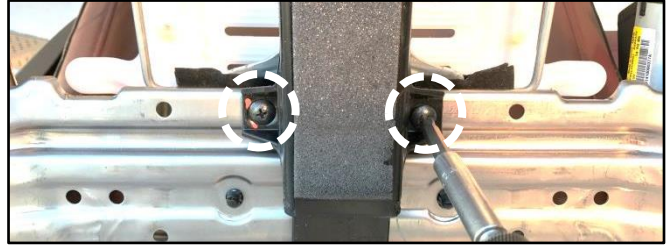
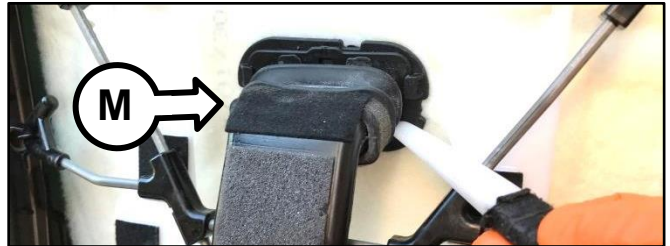
3. If equipped, remove the two (2) seatback ventilation inlet hose retaining screws and carefully slide the hose (M) upwards.

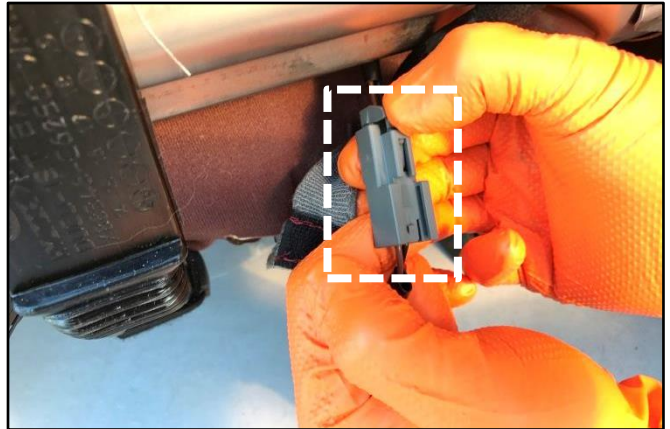
4. Disconnect the seatback heater connector.

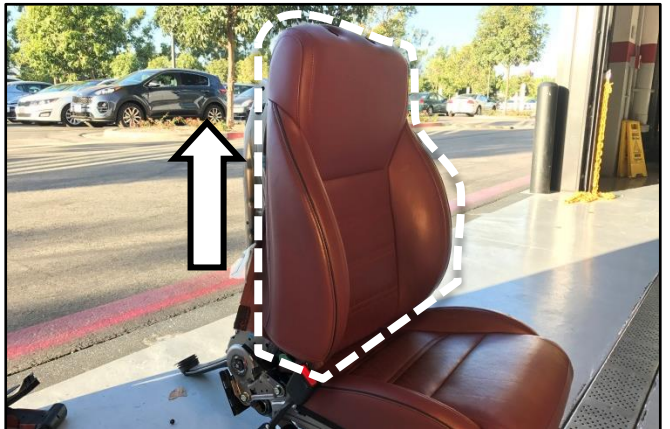
5. Remove the seatback cover and cushion from the seatback frame assembly.

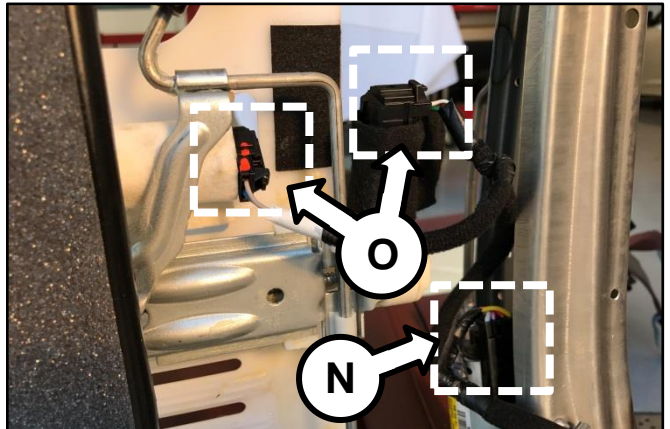
6. Disconnect the seatback recliner motor connector (N) and the two (2) lumbar support connectors (O) if equipped.

Mark the two (2) lumbar connectors to prevent incorrect reconnection of the connectors as they are interchangeable.

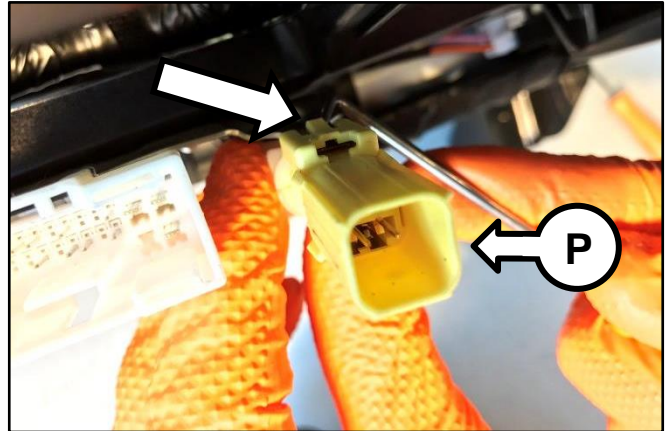
7. Carefully unclip the side airbag connector (P) located underneath the seat with a 90° pick tool and detach the harness from the seat frame.

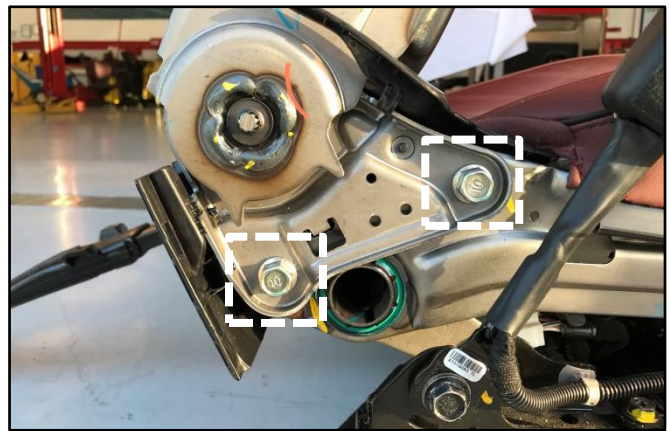
8. Remove the two (2) seatback frame retaining bolts on both sides of the seat and pull the frame upwards to separate it from the seat cushion frame.

**Tightening torque:
32.5 – 39.8 lb·ft (44.1 – 53.9 Nm)**

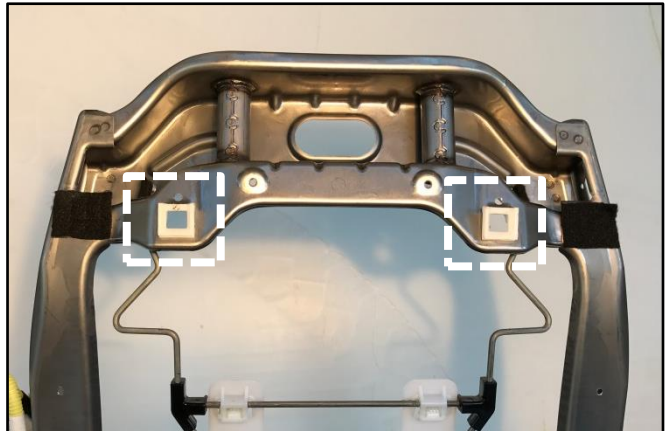
9. Remove the seatback cover guides from the old seatback frame and install onto the new seatback frame. If needed, replace the seatback cover guides.
