RECALL BULLETIN:
161018REV

PRODUCT(S) AFFECTED:
Holiday Rambler
Vacationer

SUBJECT:
Adding support for the front truss and re-routing wire harnesses and/or hydraulic lines to avoid contact by the front truss

ISSUE DATE:
November 2016

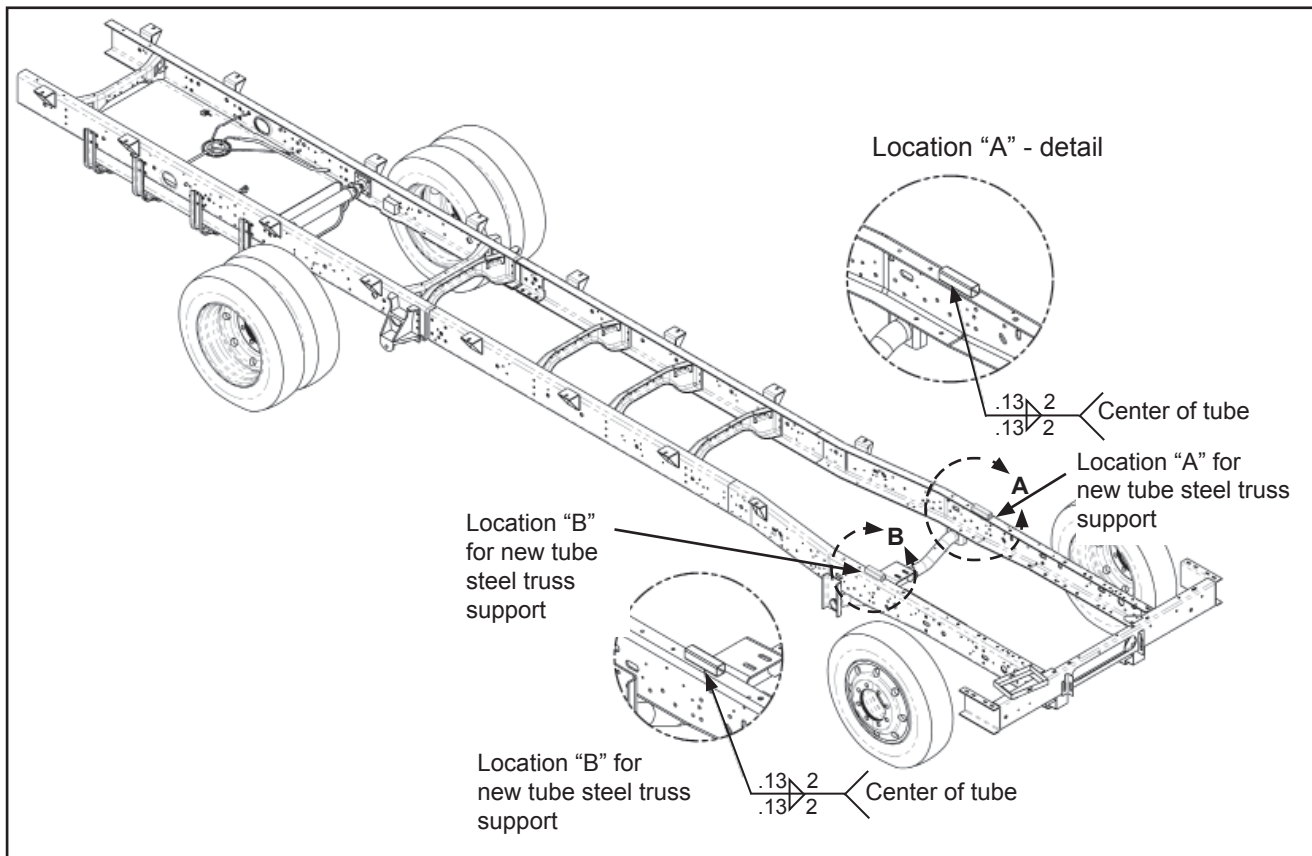
1. Park the motor home on level pavement. Place the transmission in NEUTRAL and set the park brake.
2. Referring to Locations A and B in Figure 1 (page 2), turn the steering wheel all the way to one side, as needed, to gain access to the repair areas.

6. From the front wheel well, inspect for the presence of wire harnesses and/or hydraulic lines that may be routed under the front truss, near the frame rail. Refer to Locations A and B in Figure 1.
 - a) If any wire harnesses or hydraulic lines are found damaged, contact REV Dealer Technical Support for instructions and Prior Authorization (PAR) for extended repairs.
 - b) Remove loop clamps and wire ties for wire harnesses or hydraulic lines as necessary to move them away from the repair area while work is performed.

9. Turn the steering wheel all the way to the opposite side to allow access to the opposite side of the front truss. Repeat Steps 7 and 8 for the opposite side (Location B shown in Figure 1). Ensure the truss is supported by both new tube steel supports; correct as necessary.
10. Re-route wire harnesses or hydraulic lines as necessary to avoid future damage by structural components. Secure with loop clamps & nylon wire ties as needed.
11. Clean and prep both newly installed sections of tube steel and coat with black spray paint. See Figure 6.

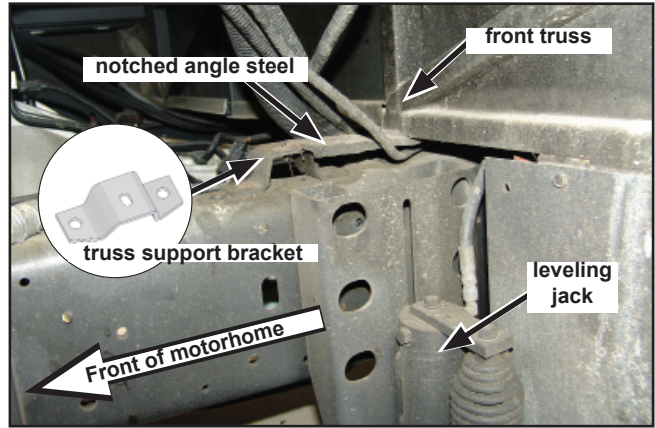
Figure 2 (as viewed from wheel well prior to repairs)

7. Locate the two “hat-shaped” truss supports and notched sections of angle steel, mounted to the frame rail on each side under the front truss near locations A and B (see Figure 1). Refer also to Figure 2 at right.

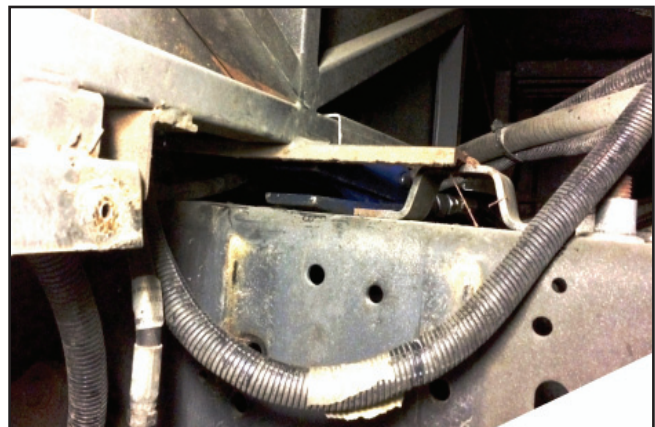
To allow room for the installation of two new tube steel support pieces, use a floor jack and a scrap piece of 2” x 4” lumber on the inside frame rail under the front truss and carefully raise the truss upward slightly. On the opposite side of the front truss place a Porta Power spreader jaw attachment between the frame rail and the front truss. Spread the front truss and frame rail to allow room for the installation of a new section of 16 gauge tube steel. See Figures 3 and 4.

- It may be necessary to reposition the spreader attachment to give sufficient room when installing tube under the truss.

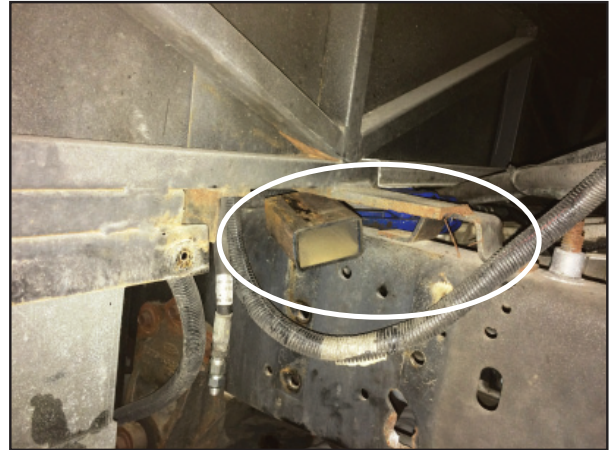
Figure 5

8. Using isopropyl alcohol and a clean shop cloth, clean and prep the new tube steel support pieces (fabricated in Step 5). Place one of the support pieces under the front truss, just below the junction of its cross-members. Use a MIG welder to put a 2" fillet weld in the approximate center of the tube. Do not weld the front or back edges of the tube. See Figure 5.

Note: If the hat-shaped" truss support and/or notched angle steel is cracked, re-weld the area after adding the tube steel support to this area.
