zoom-zoom

**SUBJECT: 2004-2008 RX-8 - Fuel Leak at Fuel Pump Rings
Safety and Emission Recall 0516J**

2004-2008 RX-8 - REPAIR PROCEDURE RECALL 0516J

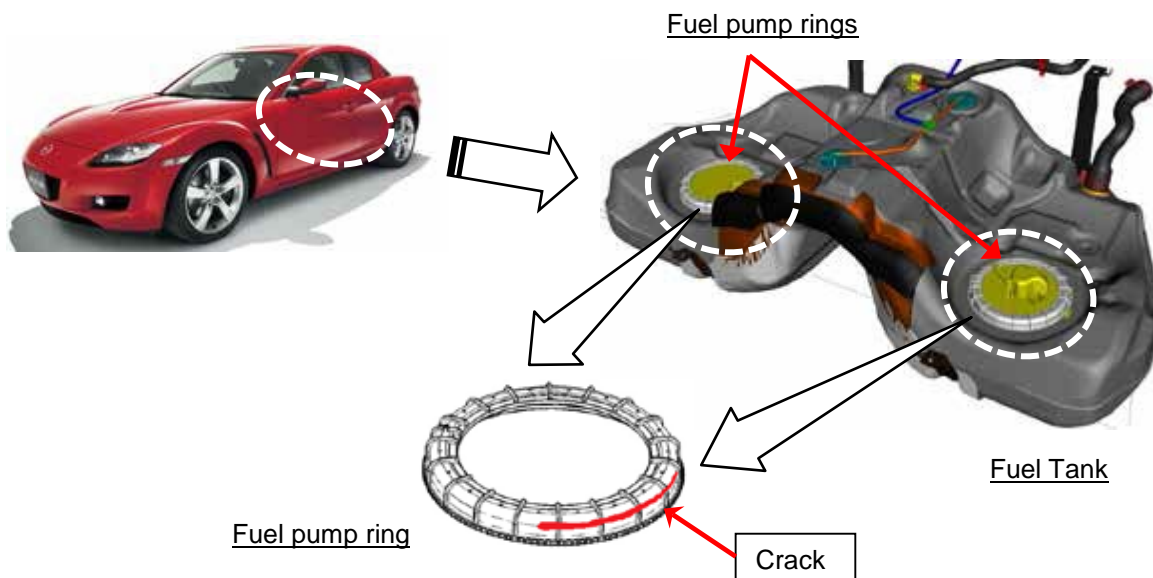
CONDITION OF CONCERN

On the fuel tank of certain RX-8 vehicles, the resin fuel pump rings, which are located on the top surface of the fuel tank, may deteriorate by heat from the engine and exhaust pipes due to insufficient heat insulating performance. Continuous use of the vehicle may allow the deterioration to progress, leading to a crack in the fuel pump rings and subsequent fuel leak, which may increase a risk of fire.

The purpose of this recall is to replace the fuel pump rings with new ones and install heat insulation pads onto the fuel tank. However, due to limited availability of repair parts, inspection of the fuel pump rings will be performed first and Not OK vehicles will be immediately repaired. The owners of OK vehicles will be asked to wait until repair parts are available and they will receive a second notification as soon as the parts are ready.

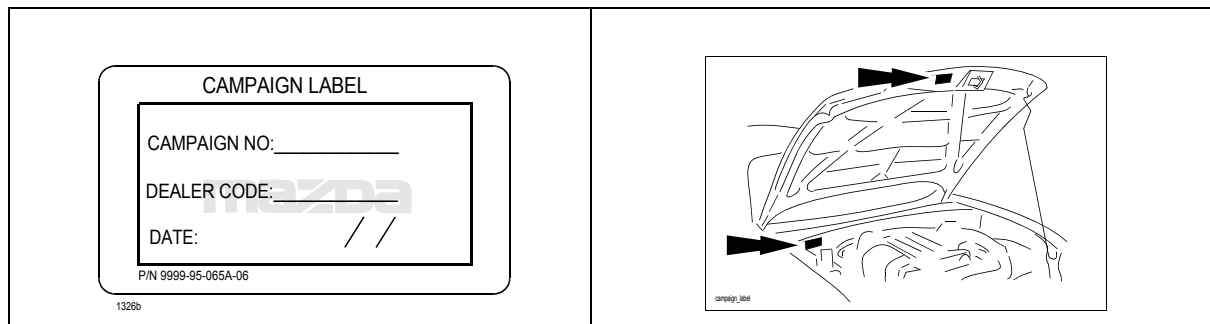
- If the vehicle is within the above range, proceed to Step 2.
 - If the vehicle is not within the above range, return vehicle to the customer or inventory.
2. Perform a Warranty Vehicle Inquiry using your eMDCS System and inspect vehicle for Campaign Labels **Recall 0516J** attached to the vehicle's hood or bulkhead. Refer to eMDCS System - Warranty Vehicle Inquiry Results table below.

NOTE: Be sure to verify Recall number as the vehicle may have multiple Recall labels.

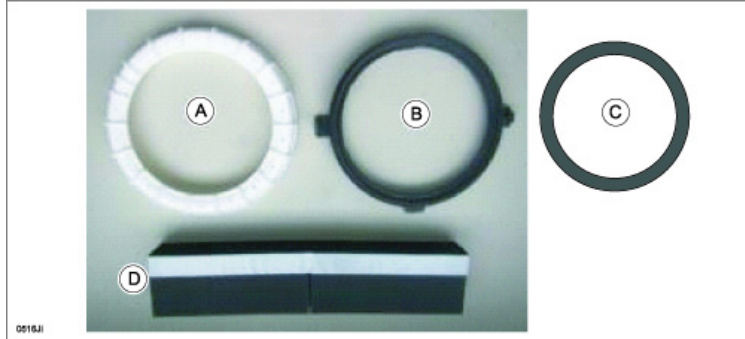
Use Kit (F1Y1-42-A1X) containing the following parts:

Part Name	Number of Pieces
A	Fuel Pump Ring	2
B	Retainer	2
C	Fuel Pump Gasket	2
D	Heat Insulation Pad	2

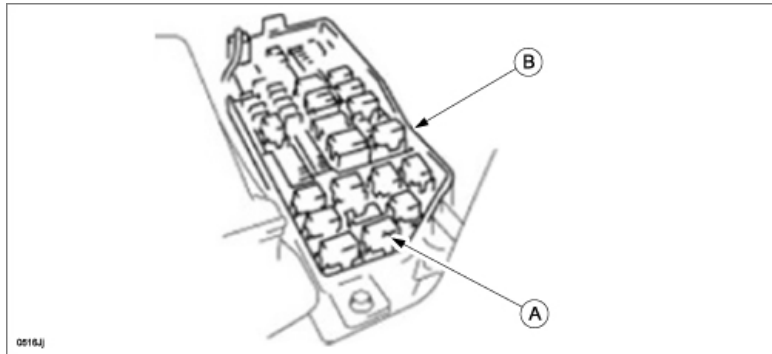
1. Perform the fuel line safety procedure.
 - a. Remove the fuel-filler cap to release the pressure inside the fuel tank.
 - b. Remove the fuel pump relay (A) from the main fuse block (B).

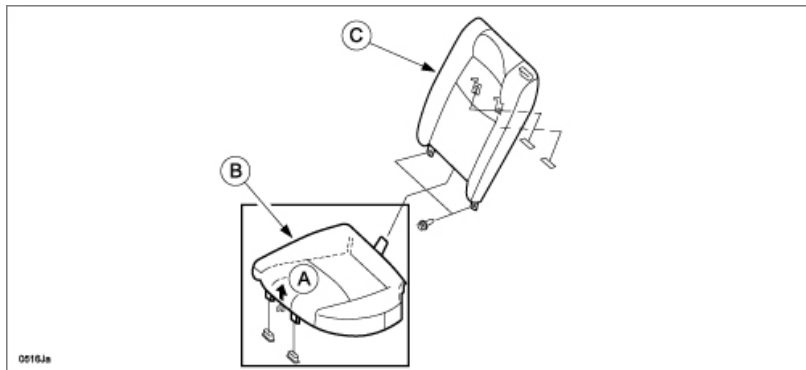
- c. Start the engine.
 - d. After the engine stalls, crank the engine several times.
 - e. Turn the ignition switch to the LOCK position.
 - f. Install the fuel pump relay.
2. Remove the rear seat cushion (both right and left sides). Lift the front edge (A) of the rear seat cushion (B) in the direction of the arrow, leaving the rear seat back (C) in place.

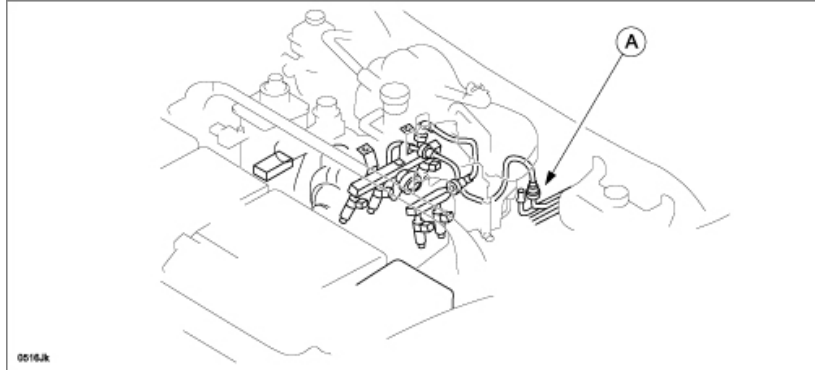
- a. Disconnect the quick release connector (A) in the engine compartment.

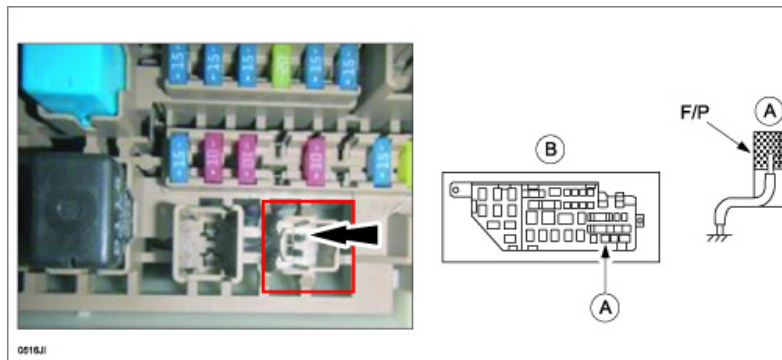
- b. Attach a long hose to the disconnected fuel pipe and drain the fuel into a proper fuel receptacle.
c. Ground the check connector (A) terminal F/P in the main fuse block (B) to the body using a jumper wire.

CAUTION: Shorting the wrong terminal of the check connector may cause electrical malfunctions. Make sure to short only the specified terminal.

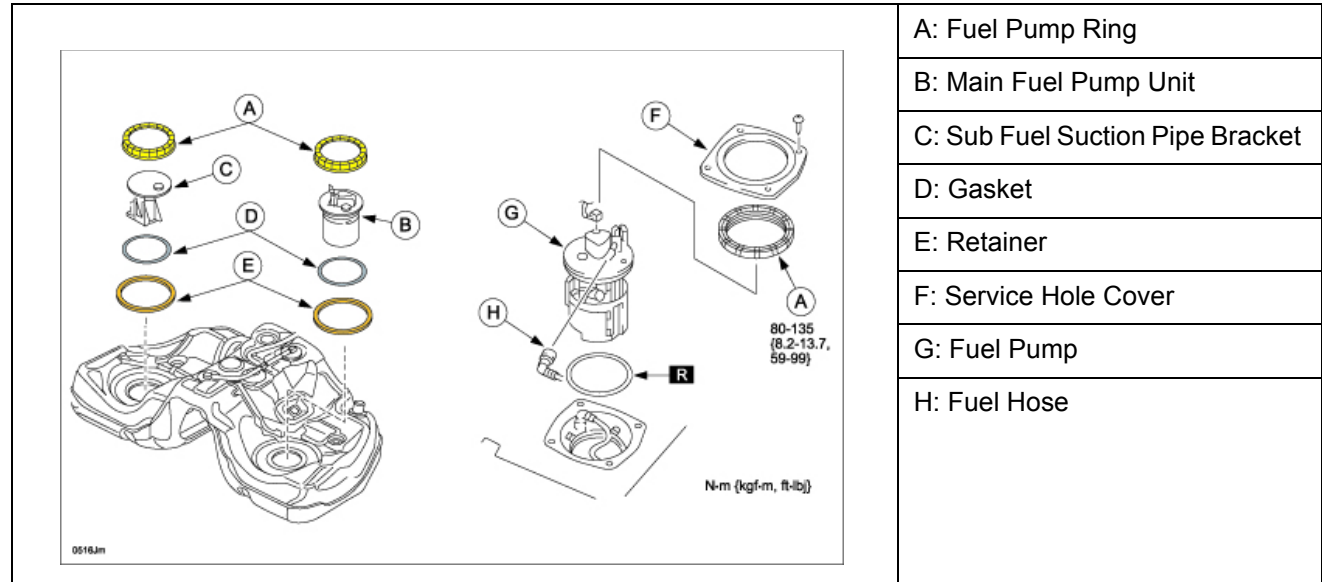
7. Replace the fuel pump ring with a modified one and the gasket and retainer with new ones.

CAUTION: DO NOT LEAVE THE FUEL TANK FOR A LONG TIME IN CONDITION THAT THE FUEL PUMP RING IS NOT INSTALLED. If the fuel tank is left for a long time without the fuel pump ring installed, the shape of the fuel tank where the fuel pump ring is installed could be deformed from swelling, making it difficult to install the fuel pump ring. Therefore, install a new one immediately after removing the old fuel pump ring. To complete the replacement in a short time:

- Place the replacement parts near the vehicle
- Complete the replacement at one side before proceeding to other side

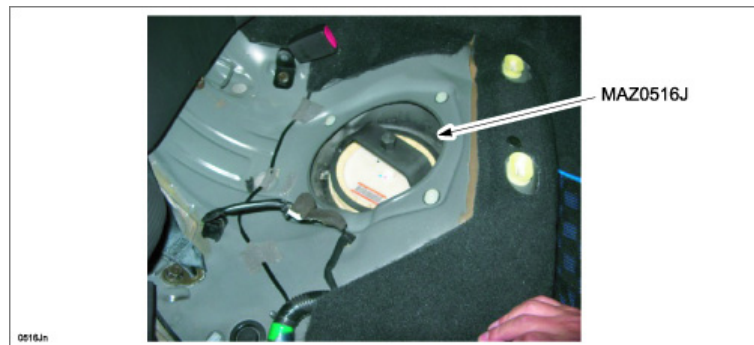
Main side (Fuel pump unit side)

- a. Disconnect the connector.
- b. Disconnect the quick connector (fuel hose).
- c. Remove the fuel pump ring using SST (Fuel Pump Ring Wrench).

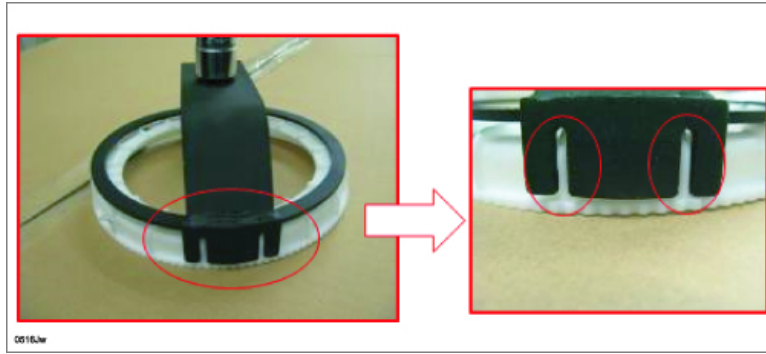
NOTE: Fit the groove of the SST into the rib of the fuel pump ring.

- The fuel pump ring could be damaged if the SST is used with any play between the fuel pump ring and the SST. Securely attach the SST so that there is no gap between the SST tabs and the side of the fuel pump ring.
- The fuel suction pipe might be damaged, if the fuel pump unit is lifted too much. Make sure to lift the pump only a small amount.

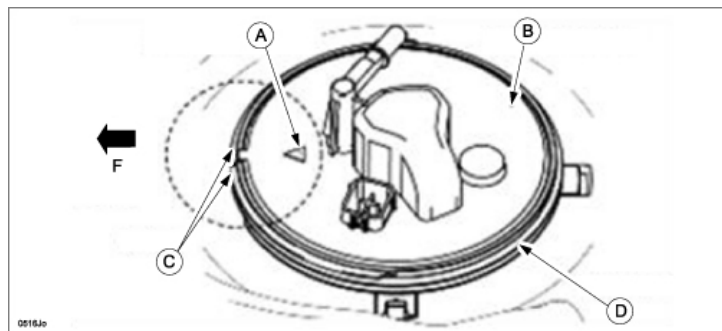
1. Align the alignment mark (B) on the fuel pump unit (A) with the notch (C) on the retainer (D) as shown.

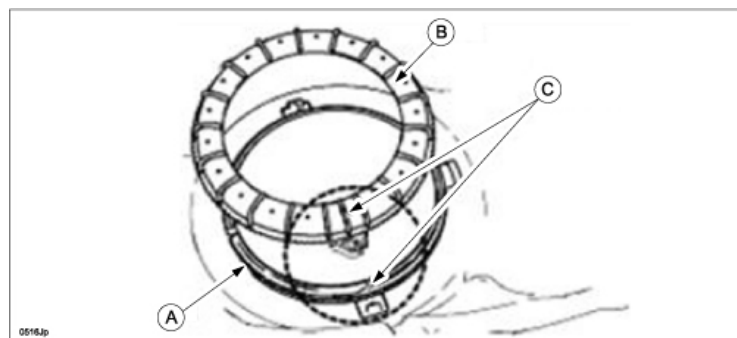
2. Align the positions of the retainer (A) and fuel pump ring (B) as shown (C), and tighten them one full rotation by hand.

NOTE: If the retainer and fuel pump ring cannot be tightened by hand, remove the fuel pump ring, verify that there is no damage or misalignment on the retainer and fuel pump ring, and then tighten again.

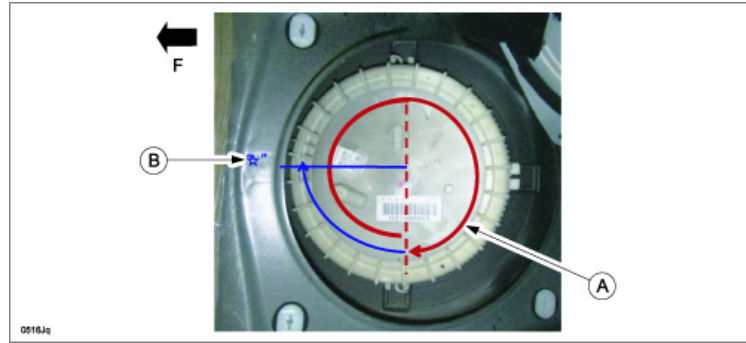
3. While keeping the alignment mark and the retainer notch aligned, tighten the fuel pump ring to the rotation angle (50-140 degrees) and specified torque (80-135 Nm, 8.2-13.7 kgfm, 59-99 ft lbf) using the SST. Total angle for step 2 and step 3 is 410-500 degrees: One full rotation (A) and tighten so the start position (3 ribs) comes to the star mark (B) using the SST (F=front of vehicle).

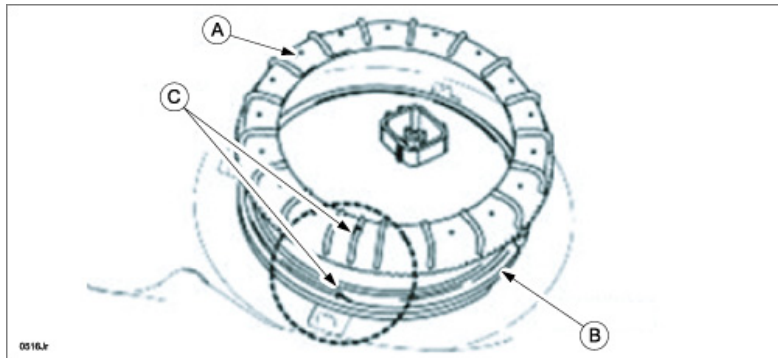
Sub side

- a. Disconnect the connector.
- b. Remove the fuel pump ring (A) using SST (49F 042 001).
- c. Replace the retainer (B) and gasket with new ones.

- d. Install the modified fuel pump ring with the same procedure as the main side (aligning the positions of the fuel pump (A) and retainer (B) as shown (C)).
8. Perform "Fuel Leak Inspection" after the fuel pump unit installation.
 - a. Start driving the vehicle from a standstill or brake suddenly 5 to 6 times at a low speed.
 - b. Stop the vehicle and verify from inside the vehicle that there is no fuel leakage around the fuel pump unit.

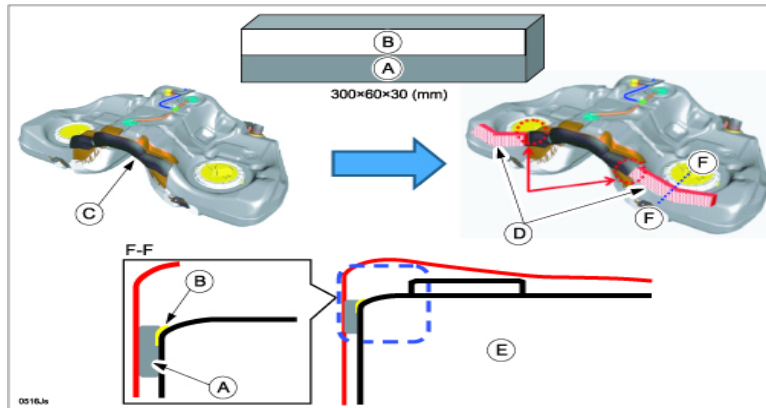
9. Attach two heat insulation pads (A) with tape (B) to the fuel tank (E) on either side (D) of the existing pad (C).

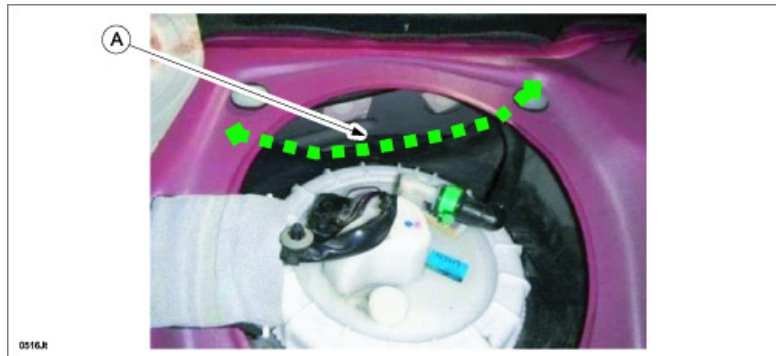
- a. Clean the fuel tank where the pad will be attached (A).

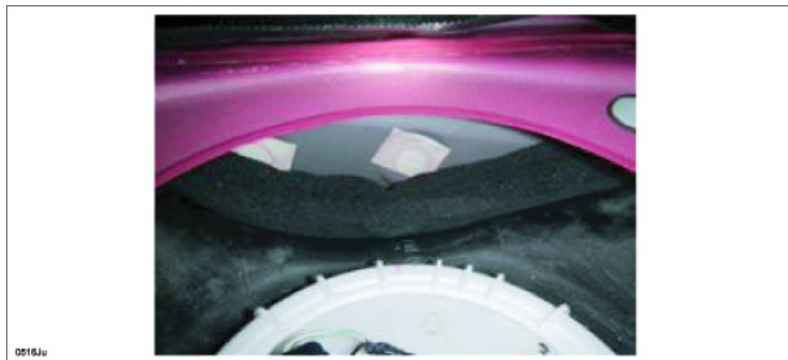
- b. Remove the backing tape and attach the pad to the fuel tank as shown.

- Attach the pad so it connects without clearance to the existing pad in the central portion of the fuel tank.
- Attach the pad onto the tank without clearance between the body and the tank.
- After attaching the pads, confirm that the tape is stuck securely.

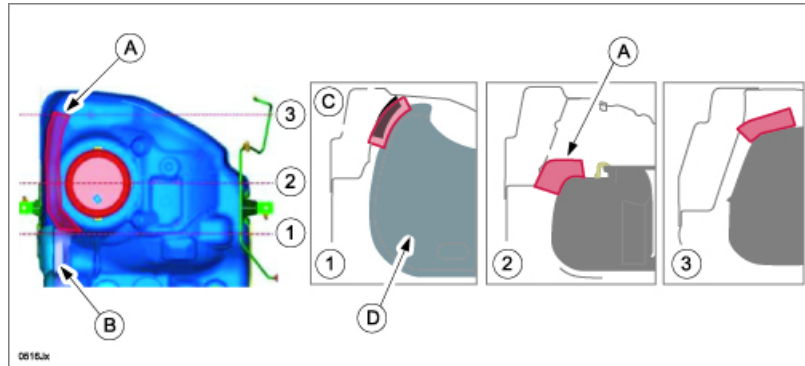
Attach the new pads (A) with the existing pad (B) as follows.

1	Attach the pad to the existing pad in the central portion of the tank.
2	Attach the pad between the body (C) and the fuel tank (D) so that there is no clearance between the body and the fuel tank.
3

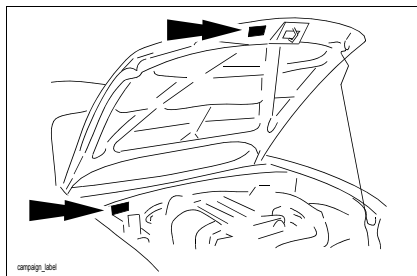
- 2. Affix it to the hood or bulkhead as shown:
