<b>Topic</b>	Seat assemblies and instrument panel - fastener torque over check (RE16/32)
<b>Market area</b>	Bentley: worldwide (2WBE),Hongkong-Macau (5HK)
<b>Brand</b>	Bentley
<b>Transaction No.</b>	2045534/1
<b>Campaign number</b>	RA70
<b>Note</b>	
<b>Type</b>	Recall campaign
<b>US code</b>

### Bentayga

During a routine system review missing torque data was discovered against a small number of bolts tightened during vehicle assembly. As a precaution, an overcheck is required on these joints to confirm correct tightening.

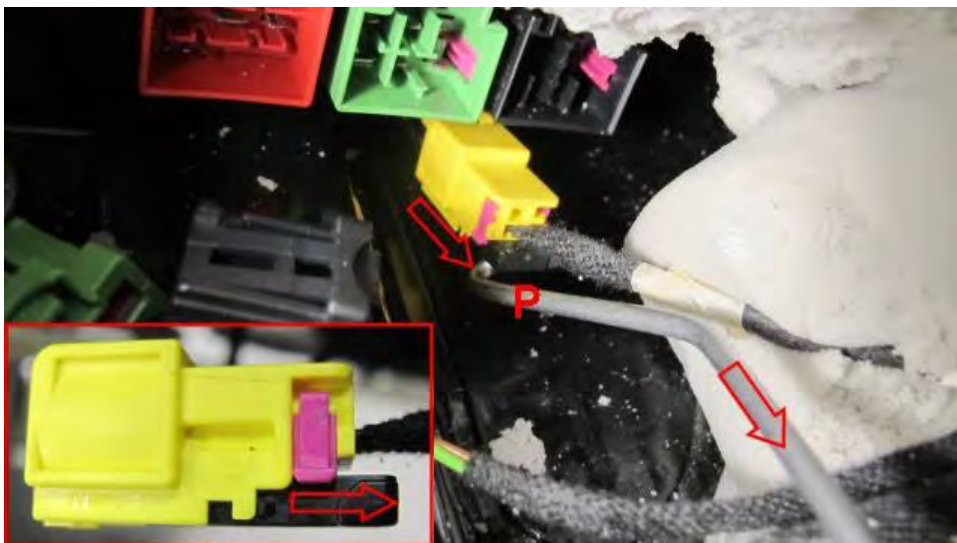
Figure 1

**Note:** Each car contains four thorax air bags. Each outer seat contains a thorax air bag

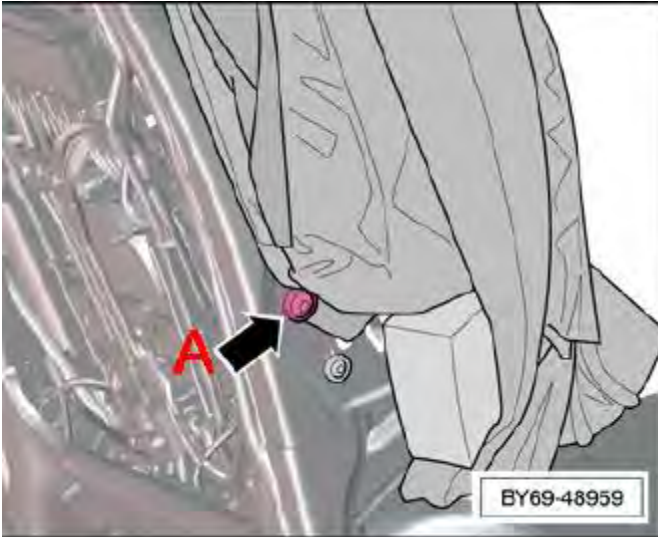
Figure 2

Airbag fastener part number N90737101 torque 9Nm location for all front seats (see Figure 2)

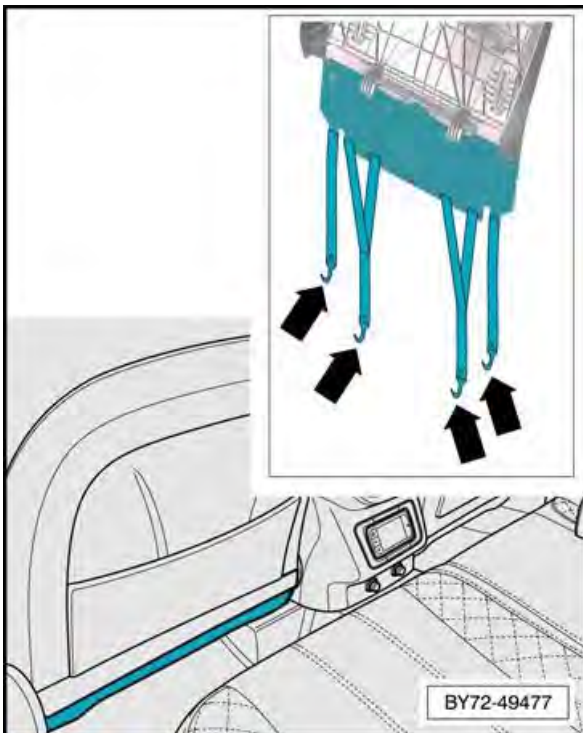
Figure 3

2. Unclip the four elasticated clips – arrows – from the underside of the seat – take note of the position of the clip anchor points to aid installation (see Figure 3)

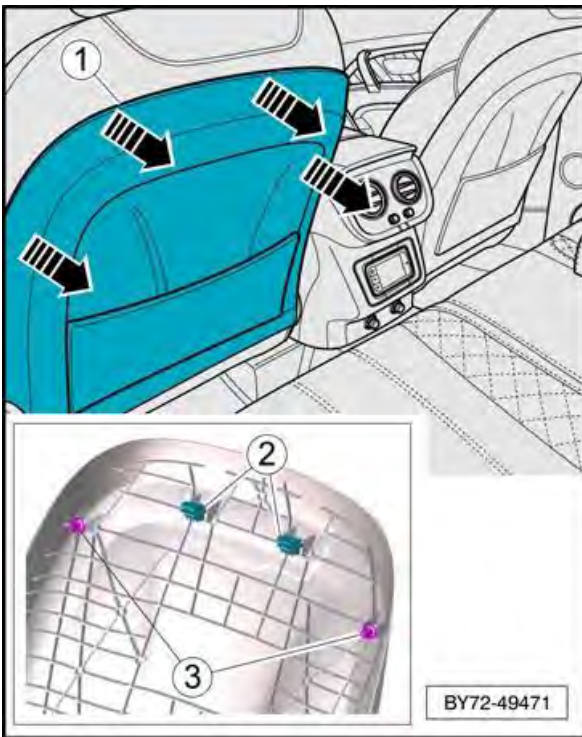
Figure 4

3. The upper section of the clamshell -1- is secured to the squab by two tabs -2- and two fir tree clips -3-. From the top of the clamshell, slide a thin bladed trim tool downwards, between the clamshell and the squab cover and release the tabs from the squab. Simultaneously pull rearwards to fully disengage the tabs

Note the fir tree clips -3- will deform during removal. Discard the fir tree clips (see Figure 4)

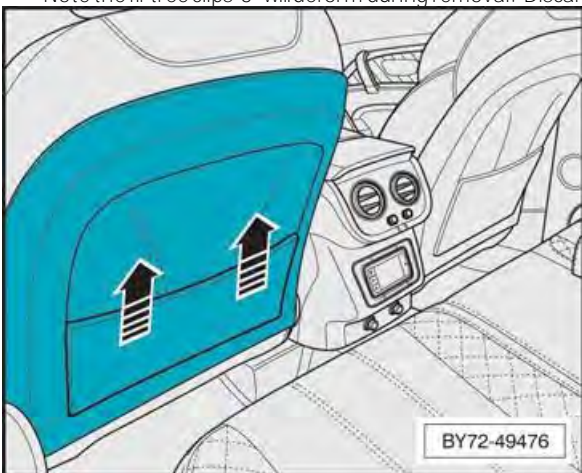
Figure 5

Lift the clamshell upwards – arrows - to release the lower tabs and remove clamshell (see Figure 5)

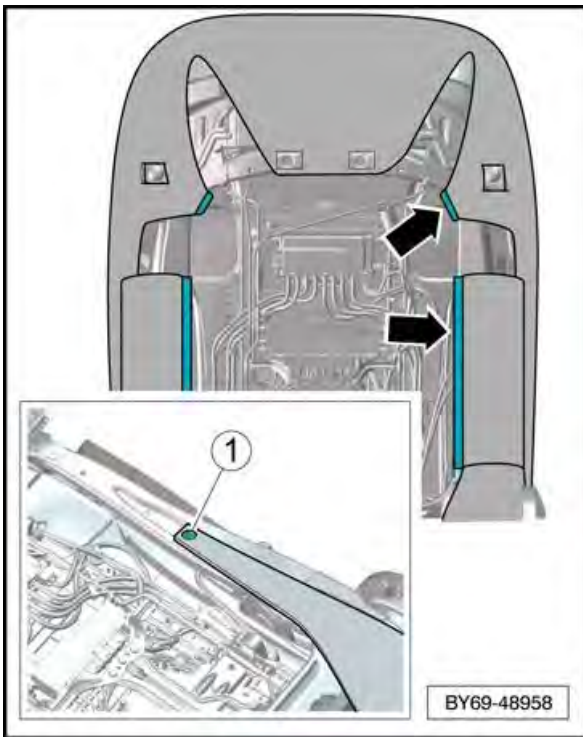
Figure 6

6. Release the squab cover clips—arrows— from the air bag side of the squab frame (see Figure 6)
7. Remove the clip -1- and remove the cover flap. Fold the flap through the underside of the squab and fold back the cover to expose the air bag (see Figure 6)

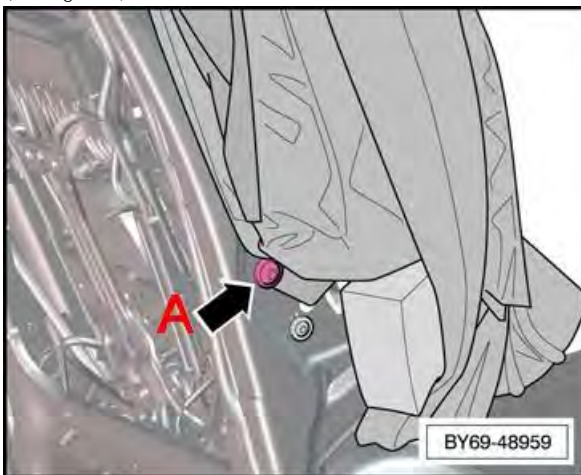
Figure 7

8. Using an in date calibrated torque wrench apply 9 Nm to fastener (A) (part number N90737101 - M6 X 12) for both front seats (see Figure 7)
9. Installation is the reverse of removal procedure, noting the following
  - Inspect the clamshell clipping points for signs of damage. If damage is evident the clamshell MUST be replaced
  - Fit NEW fir tree clips to the clamshell
  - Locate the lower tabs inside the seat squab frame
  - Locate the upper clips into the relevant slots and push inwards firmly to engage clips
  - Connect elasticated clips to the underside of the seat

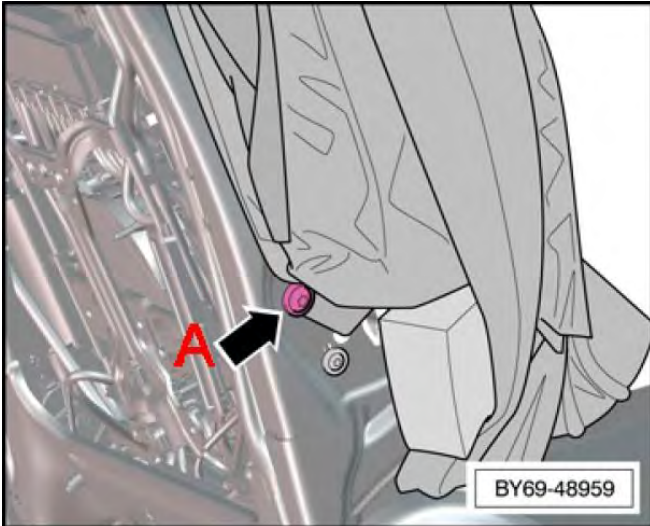
Figure 8

Front right hand seat thorax air bag fastener part number N90737101 torque 9Nm (see Figure 8)

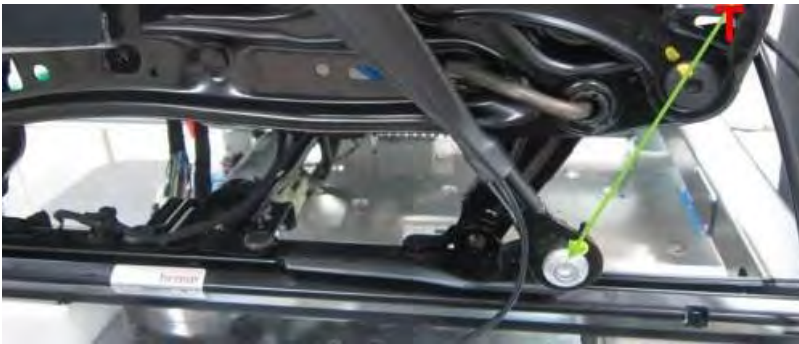
Figure 9

Front seat belt buckle fastener part number N98923602 torque 40Nm (see Figure 9)

1. Switch off ignition
2. Remove front seat Rep.Gr.72
3. Place the seat on the seat repair stand –VAS 6136- or a suitable secure surface. Refer to "Front seat repair stand – To repair" Rep.Gr.72
4. Using an in date calibrated torque wrench apply 40 Nm to fastener (T) (part number N98923602) (see Figure 9)

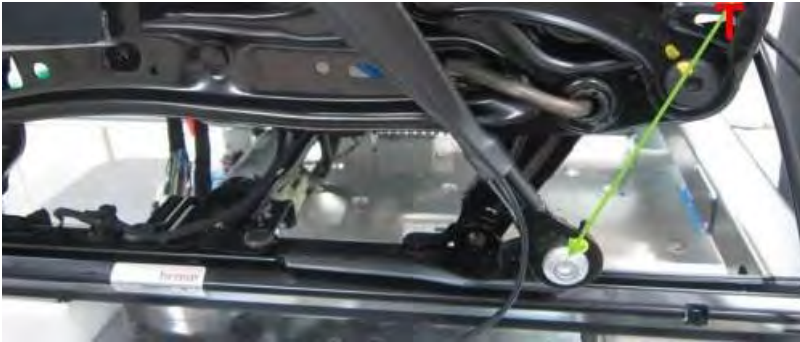
Figure 10

Front seat belt buckle fastener part number N98923602 torque 40Nm (see Figure 10)

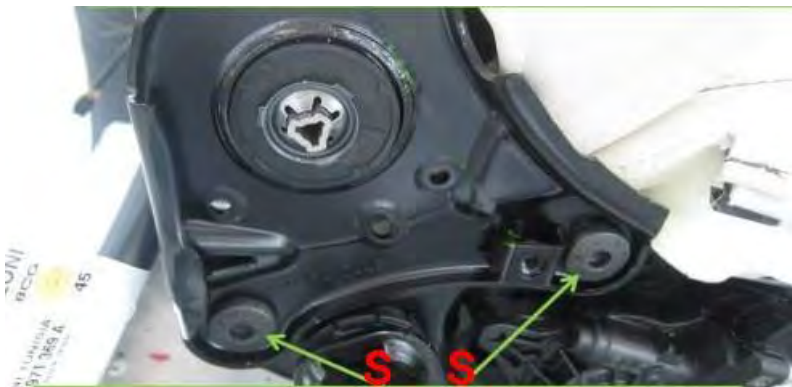
Figure 11

Front squab marriage fasteners part number WHT002796B torque 33Nm (see Figure 11)

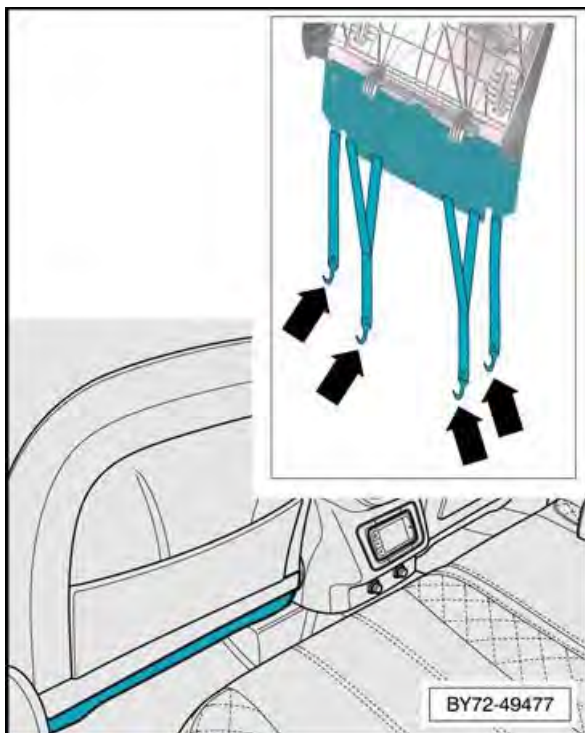
Figure 12

4. Unclip the four elasticated clips—arrows- from the underside of the seat—take note of the position of the clip anchor points to aid installation (see Figure 12)

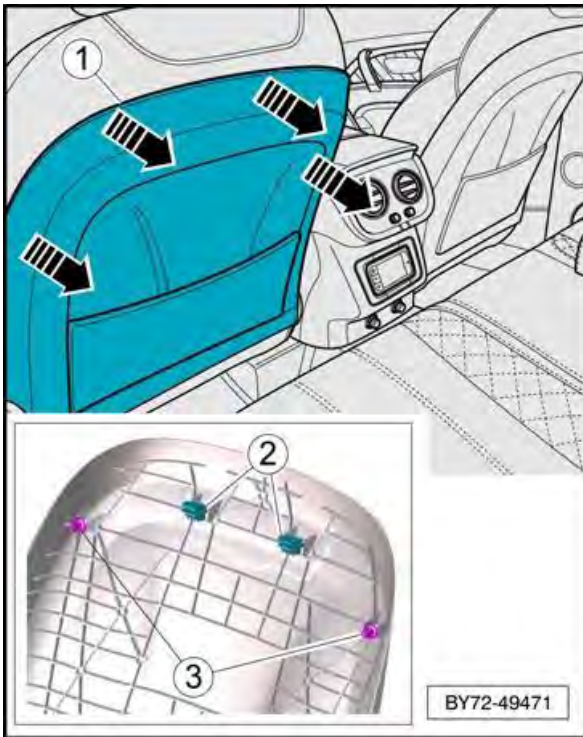
Figure 13

5. The upper section of the clamshell -1- is secured to the squab by two tabs -2- and two fir tree clips -3-. From the top of the clamshell, slide a thin bladed trim tool downwards, between the clamshell and the squab cover and release the tabs from the squab. Simultaneously pull rearwards to fully disengage the tabs  
Caution: Do not pull on the clamshell without releasing the upper tabs, this could cause irreparable damage to the tabs, requiring the clamshell to be replaced  
Note the fir tree clips -3- will deform during removal. Discard the fir tree clips (see Figure 13)

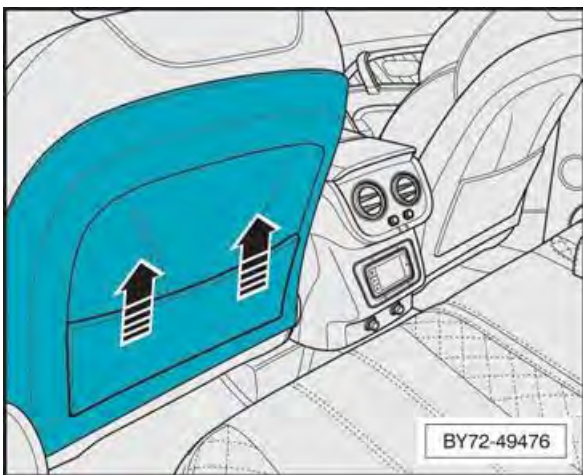
Figure 14

6. Lift the clamshell upwards—arrows- to release the lower tabs and remove clamshell (see Figure 14)

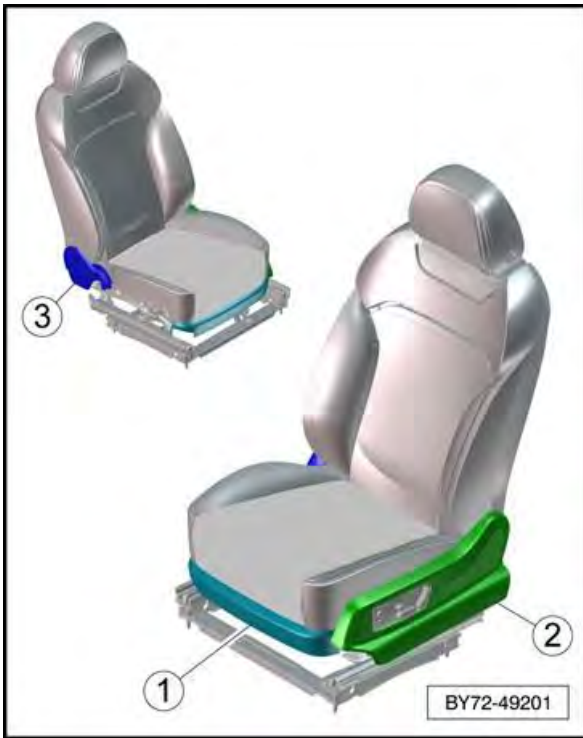
Figure 15

7. Remove sidevalance (2) (see Figure 15)

- To enable access to the outer front squab marriage fastener the side valance subframe fastener (R) should be released (see Figure 19)
- Remove the inner valance (3) (see Figure 15)

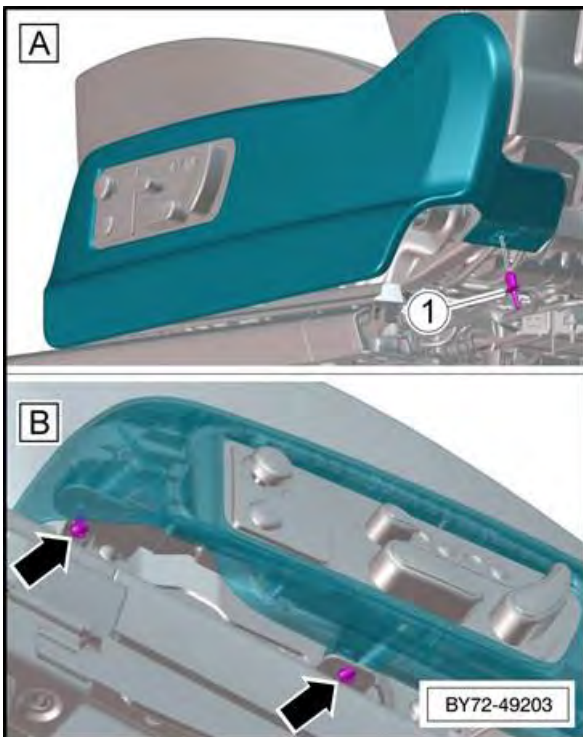
- Remove the expansion rivet -1- at rear of seat (see Figure 16 A). To remove the expansion rivet, push in the centre pin then remove rivet
- On the underside of the seat remove the two fixings—arrows- (2.5Nm) (see Figure 16 B)

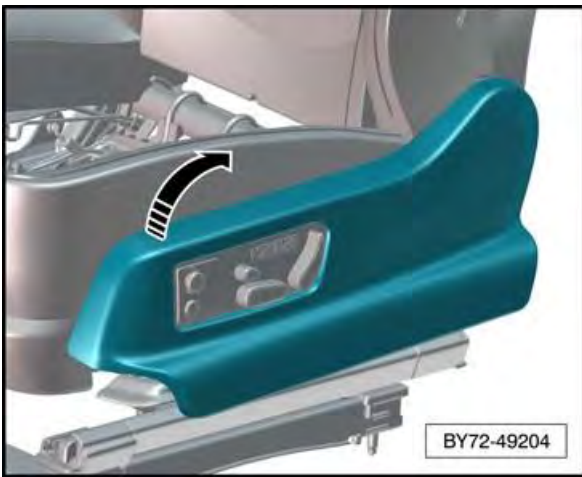
Figure 17

- From the front edge lift the valance up and back to release the side valance from the clipping points (see Figure 17)

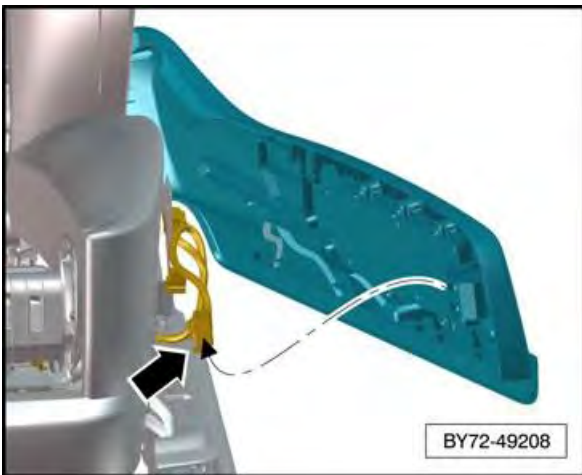
Figure 18

- Disconnect the electrical connector –arrow- for the switchpack and remove the side valance (see Figure 18)

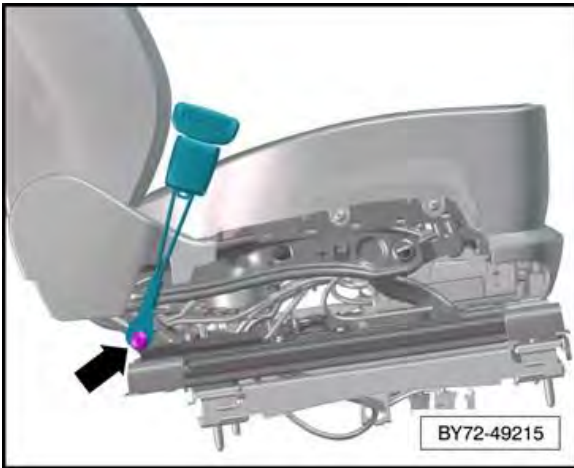
Figure 20

- Remove the fixing—arrow- (40Nm) and discard, fixing is single use, lower the seat belt buckle (see Figure 20)

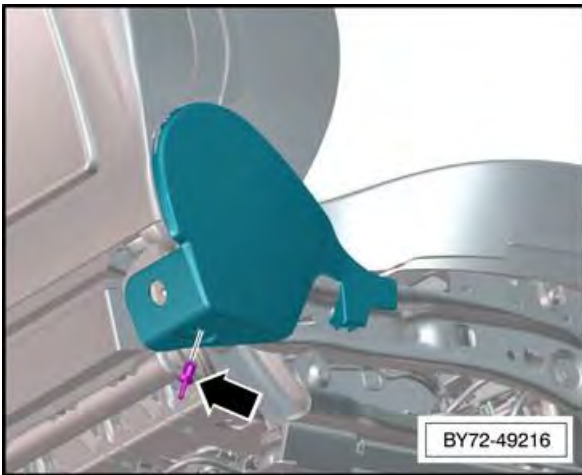
Figure 21

- Remove the expansion rivet -1- at the rear of the seat (see Figure 21)

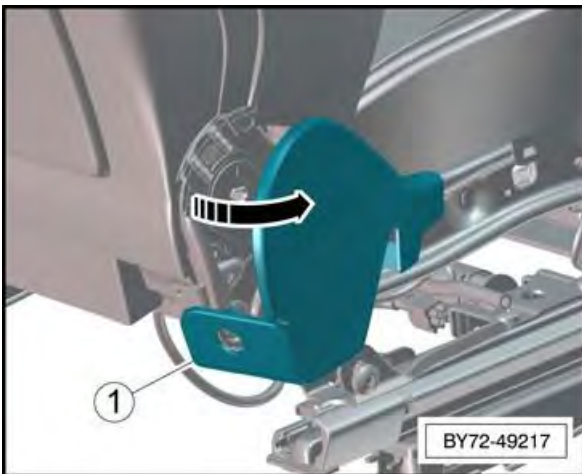
Figure 22

- From the rear edge of the valance, pull outwards—arrow- to release from the clipping points (see Figure 22)

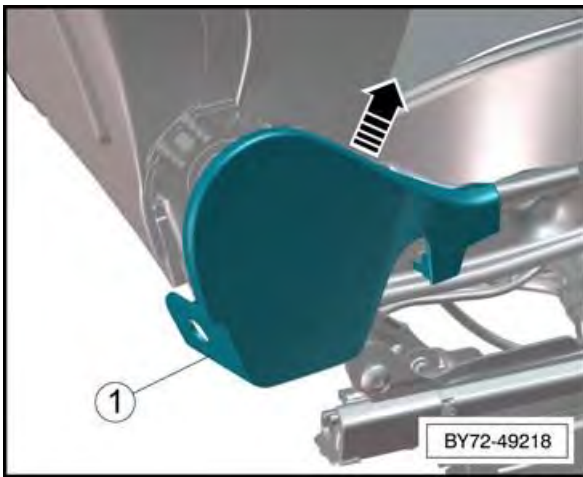
Figure 23

- Pull the valance upwards—arrow- and remove (see Figure 23)

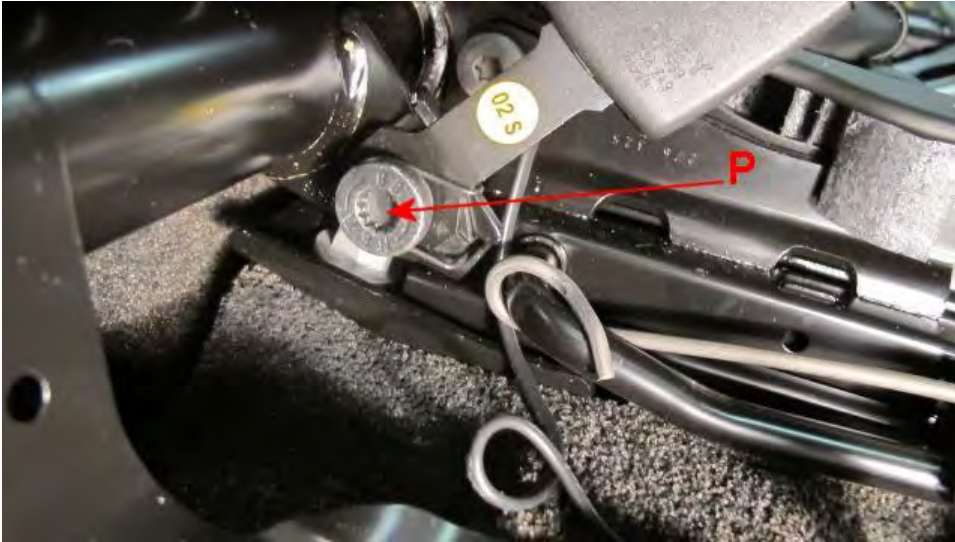
Figure 26

Rear seat belt buckle fastener torque 50Nm (see Figure 26)

1. Remove seat cushion from 40% rear seat assembly Rep. Gr.72 Rear seat cushion - To remove and fit
2. Using an in date calibrated torque wrench apply 50 Nm to fasteners (P), (see Figure 26x)

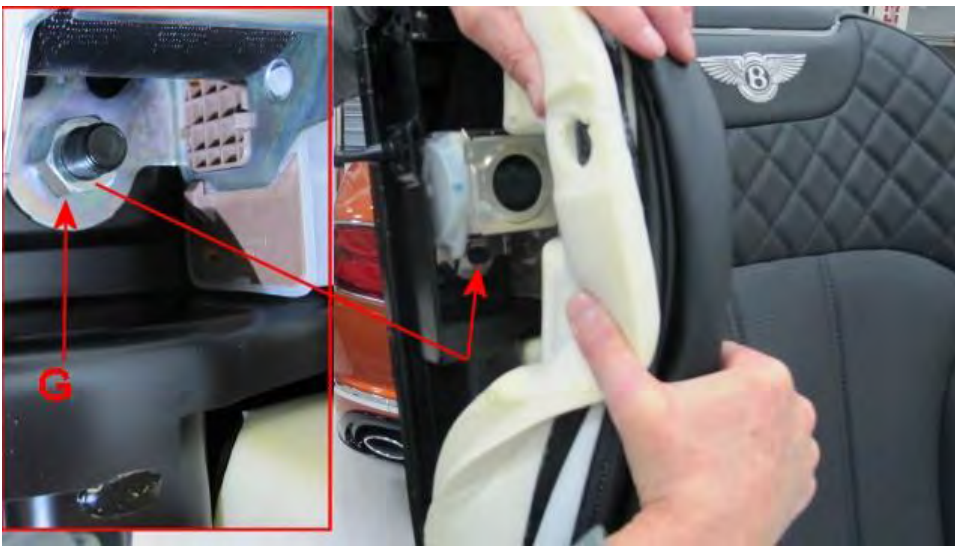
Figure 27

Rear 60% centre seat belt reel fastener part number N98991001 torque 50Nm (see Figure 27)

The seat belt reel fastener (G) is located on the back of the seat frame therefore the outer trim cover and foam sub structure has to be partially removed to gain access

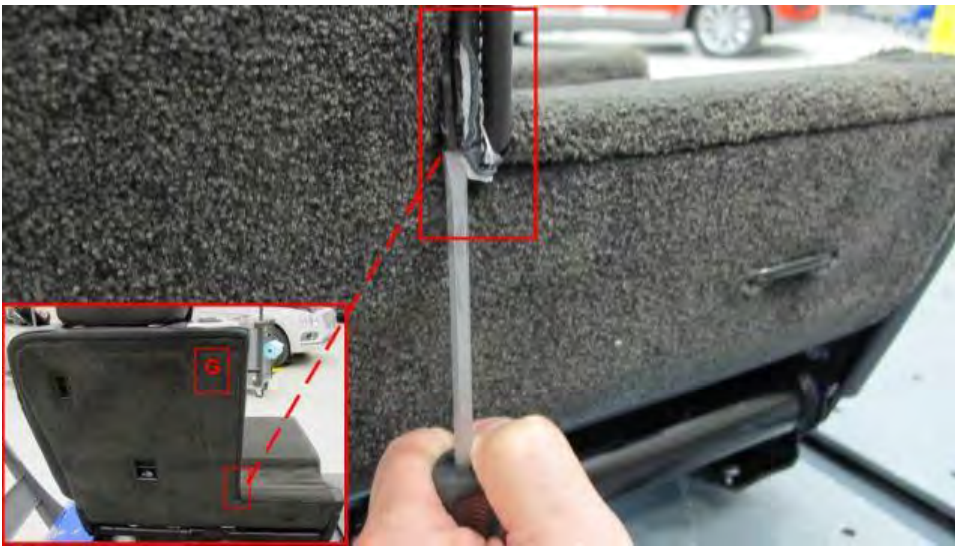
Figure 28

- Using a suitable trim tool, release plastic edge carrying outer leather cover from the vertical channel in the seat frame (see Figure 28)

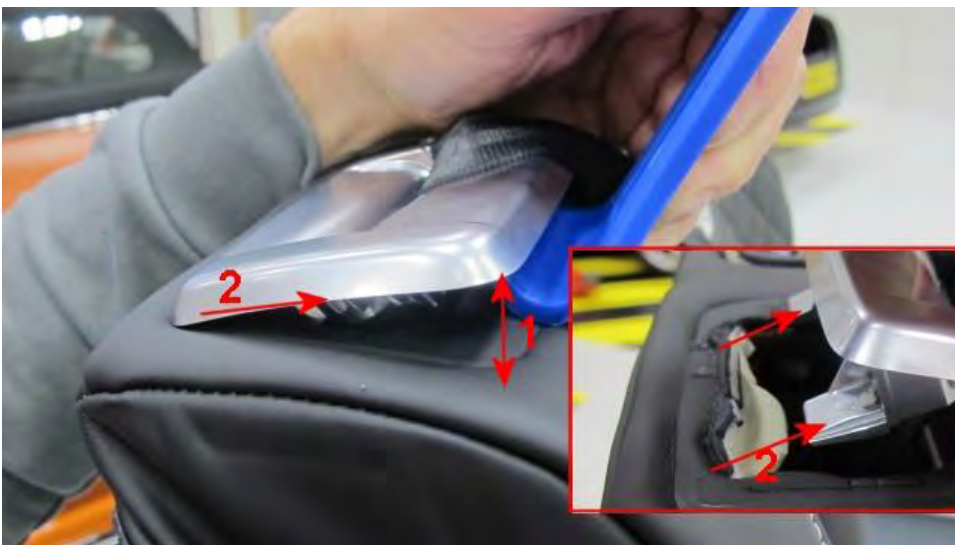
Figure 29

- Referencing figure 29 lift the front edge (1) of the chrome seat belt guide then pull the guide forward (2) to disengage from seat frame allow the guide to slide down the seat belt webbing. It is not necessary to remove the guide from the seat belt webbing

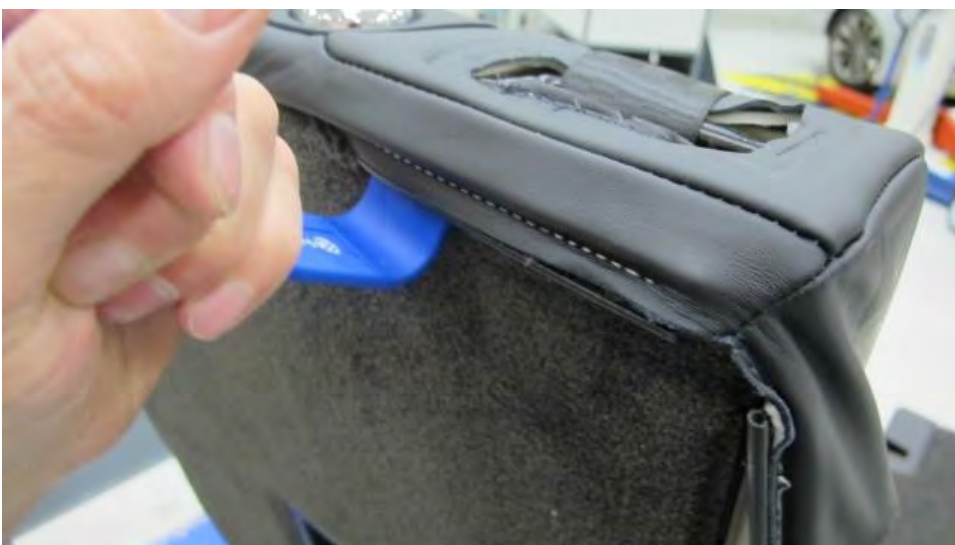
Figure 30

- Continue to lift out the plastic edge of the outer leather cover from the top of the seat frame adjacent to the seat belt assembly (see Figure 30)
- Partially fold back the leather outer cover and push back the foam sub structure in the vicinity of the seat belt reel to reveal fastener (G) (see Figure 31)

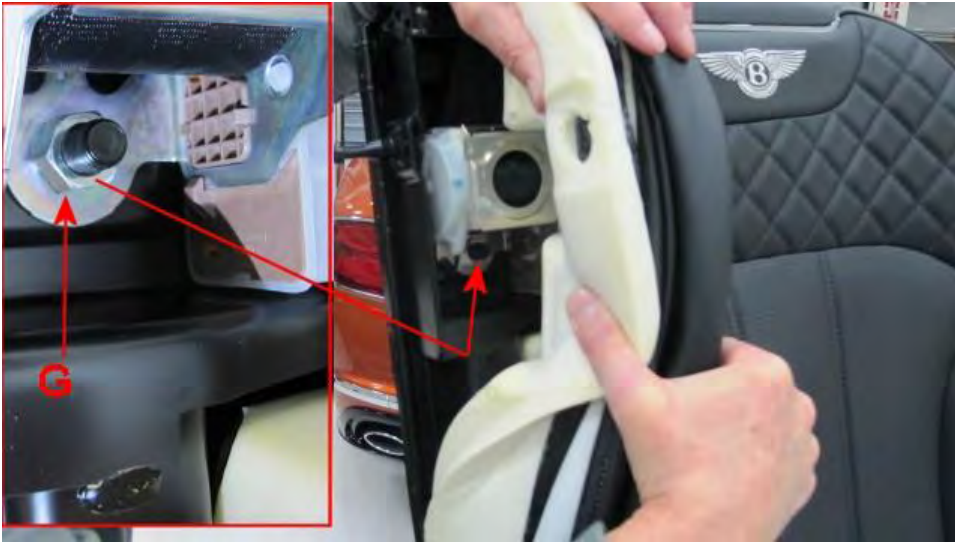
Figure 31

- Using an in date calibrated torque wrench apply 50 Nm to fasteners (G), (see Figure 31)

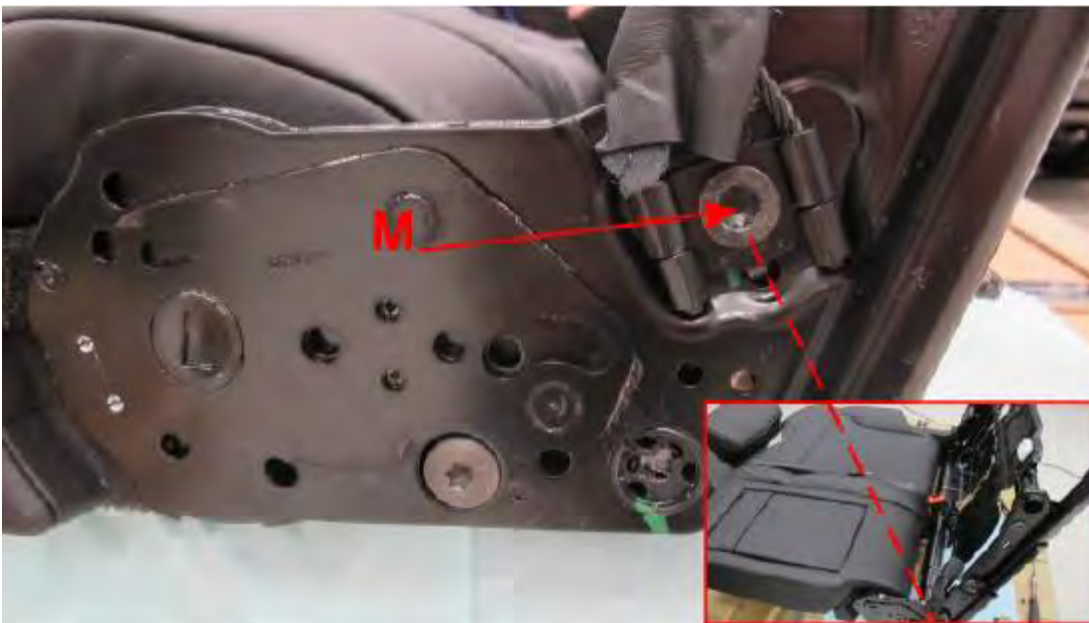
Figure 32

Rear 60% outer seat belt fastener torque 50Nm (see Figure 32)

3. Referencing figure 33 remove 60% rear seat outer valance (L)
  - Remove fastener (K) securing valance
  - Unlatch clip (J) at base of valance
  - Rotate valance to remove from seat frame
4. Using an in date calibrated torque wrench apply 50 Nm to fasteners (M), (see Figure 32)

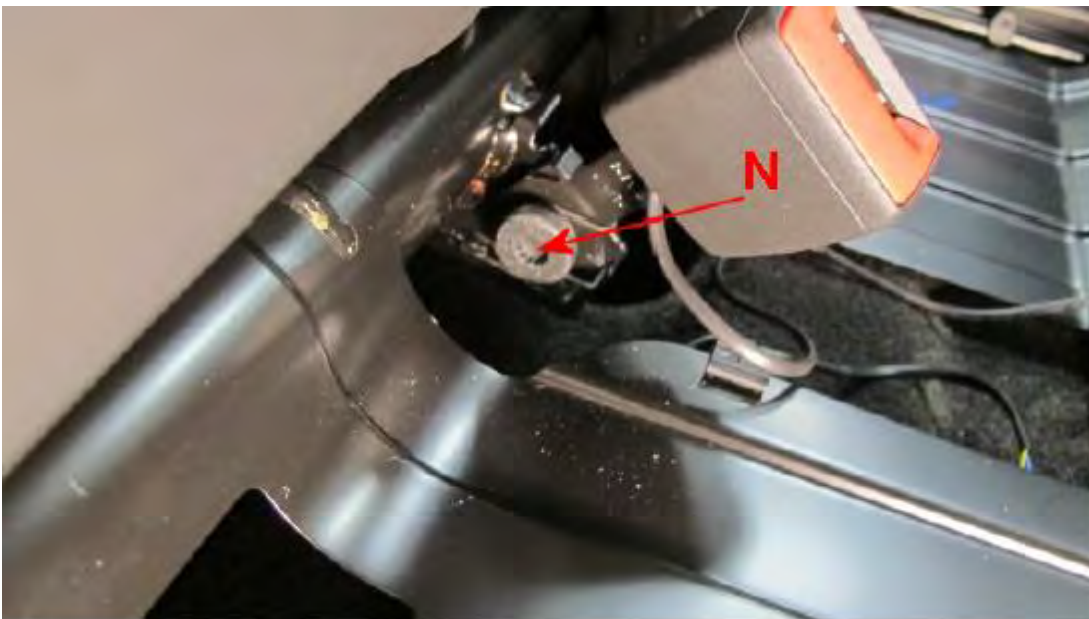
Figure 34

Rear 60% centre seat belt buckle fastener part torque 50Nm (see Figure 34)

1. Remove seat cushion from 60% rear seat assembly Rep. Gr.72 Rear seat cushion - To remove and fit
2. Using an in date calibrated torque wrench apply 50 Nm to fasteners (N), (see Figure 34)

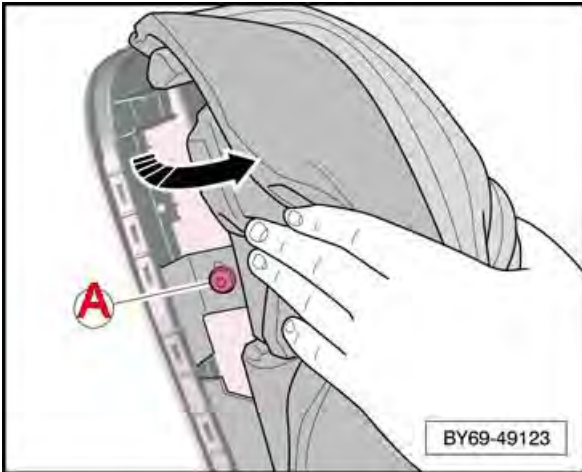
Air bag fastener part number N91042301 torque 9Nm fastener location for 5 seat rear only (see Figure 35)

- Pull back the squab foam to access the air bag fastener (see Figure 39)
- Using an in date calibrated torque wrench apply 9Nm to fastener (A) (part number N91042301 - M6 x 16) for rear seats on 5 seat option (see Figure 35 and 39)

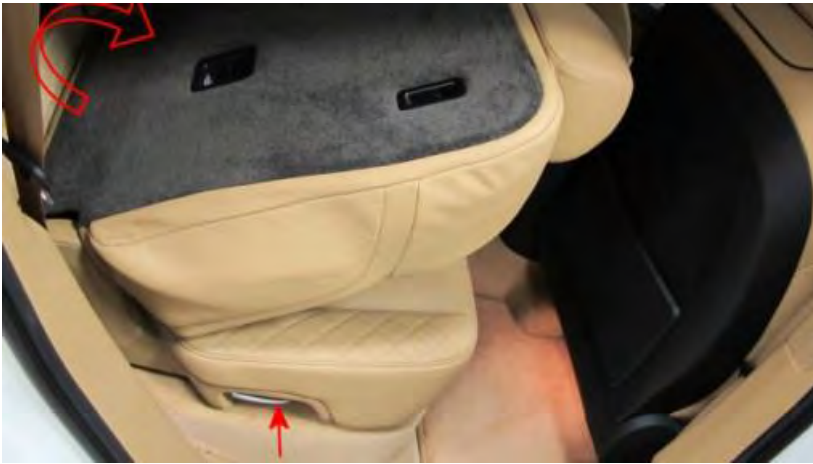
Figure 36

1. Fold the seat back to give access to the rear of the squab (see Figure 36)

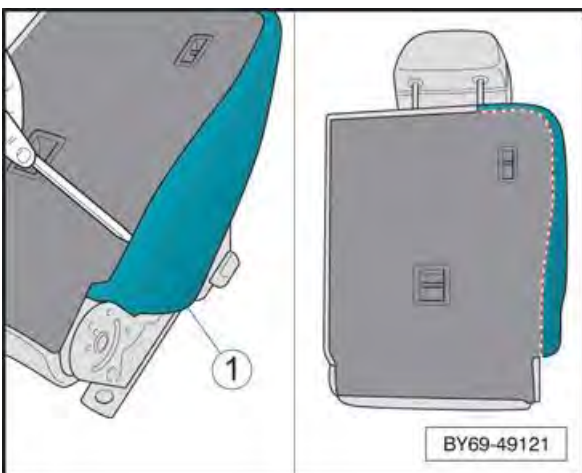
Figure 37

2. Using a suitable trim tool, release the outer and upper clipped edges –dotted line- of the seat cover - 1 - from the seat squab frame (see Figure 37)

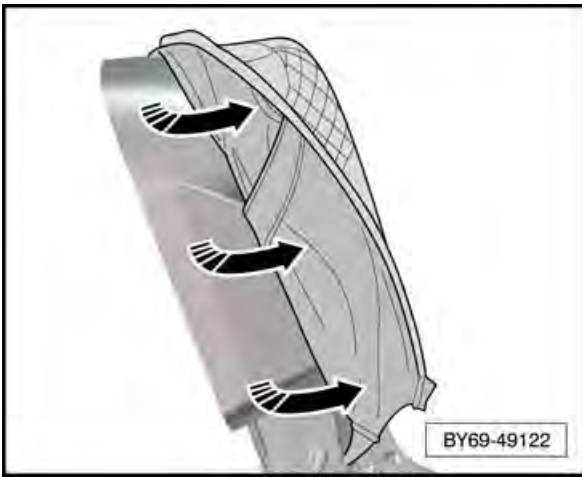
Figure 38

- Carefully fold back the trim cover (see Figure 38)

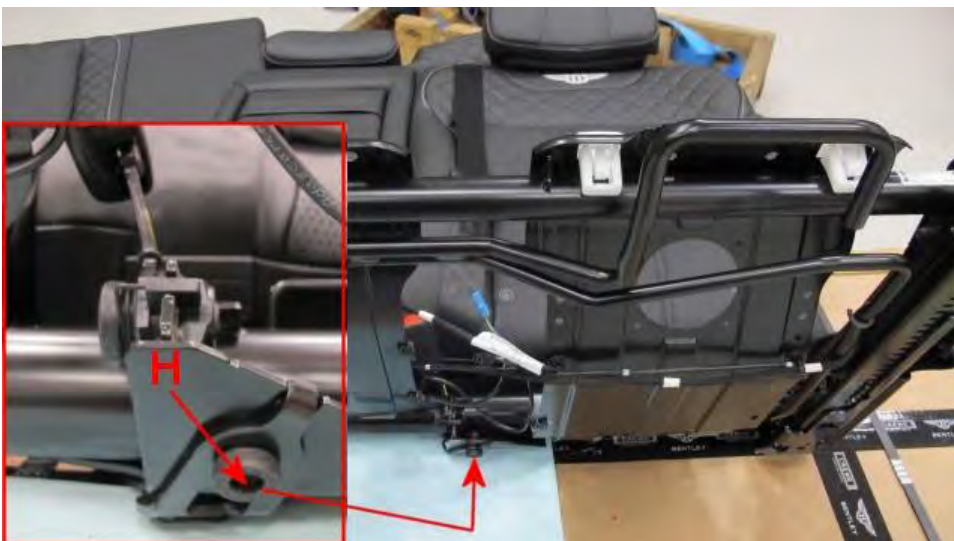
Figure 40

Rear 60% centre seat belt buckle fastener part number N98924701 torque 50Nm (see Figure 40)

1. Switch off ignition
2. Remove 60% rear seat assembly Rep.Gr. 72. **Note:** The front bolts securing the 60% rear seat to the vehicle tighten onto an end stop block (Part numbers 36A885968A and 36A885967A). These blocks are designated as single use therefore when refitting this seat new end stop blocks must be fitted
3. Using an in date calibrated torque wrench apply 50Nm to fastener (H) (part number N98924701 – 7/16 UNF ) (see Figure 40)

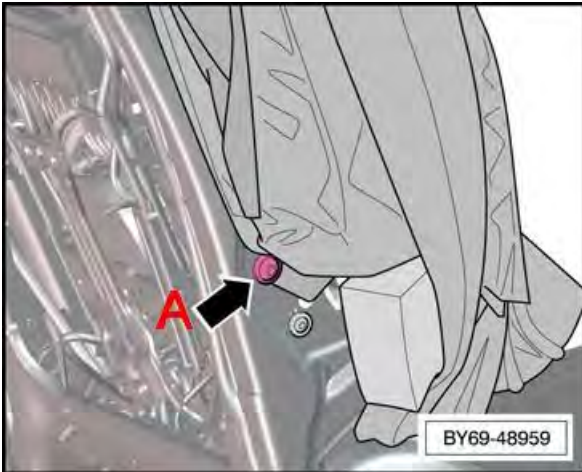
Figure 41

Air bag fastener part number N90737101 torque 9Nm location for 4 seat rear (see Figure 41)

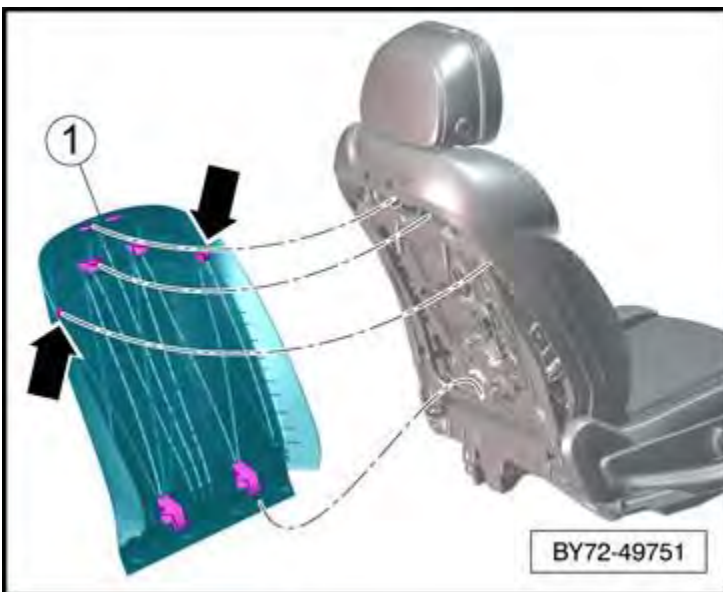
Figure 42

4. Remove the rear seat clamshell (see Figure 42)
  - The upper section of the clamshell -1- is secured to the squab by the tabs and two fir tree clips –arrow-
  - From the top of the clamshell, slide a thin bladed trim tool downwards, between the clamshell and the squab cover and release the tabs from the squab. Simultaneously pull rearwards to fully disengage the tabs
  - **Caution:** Do not pull on the clamshell without releasing the upper tabs, this could cause irreparable damage to the tabs, requiring the clamshell to be replaced
  - Note the fir tree clips -arrowed- will deform during removal. Discard the fir tree clips

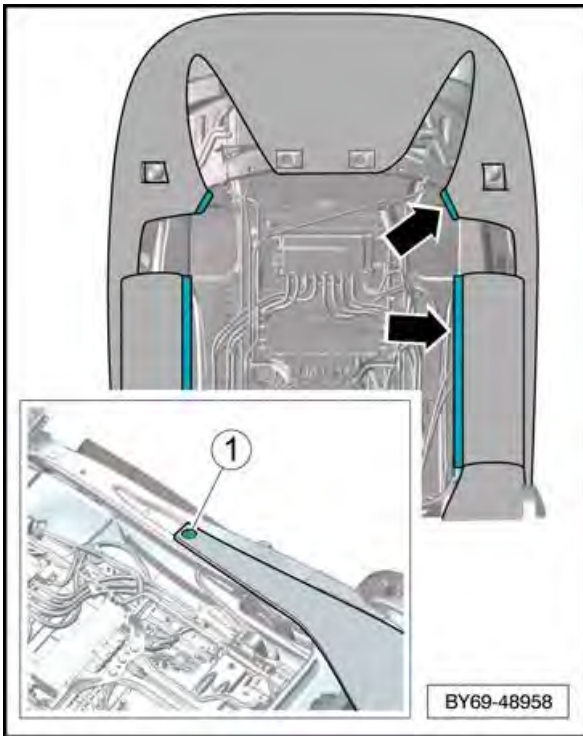
Figure 43

5. Release the squab cover clips—arrows—from the air bag side of the squab frame (see Figure 43)
6. Remove the clip -1- and remove the cover flap. Fold the flap through the underside of the squab and fold back the cover to expose the air bag (see Figure 43)

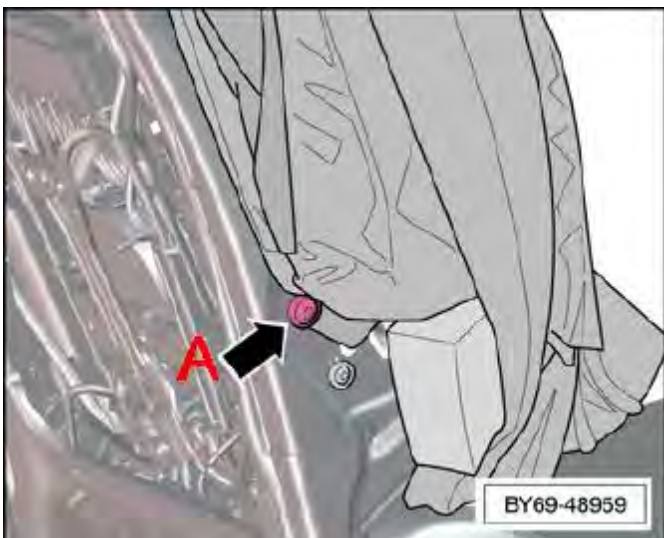
Figure 44

7. Using an in date calibrated torque wrench apply 9 Nm to fastener (A) (part number N90737101 - M6 X 12) for both front seats (see Figure 44)
8. Installation is the reverse of removal procedure, noting the following
  - Fit NEW fir tree clips to the clamshell
  - Locate the lower tabs inside the seat squab frame
  - Locate the upper clips into the relevant slots and push inwards firmly to engage the clips

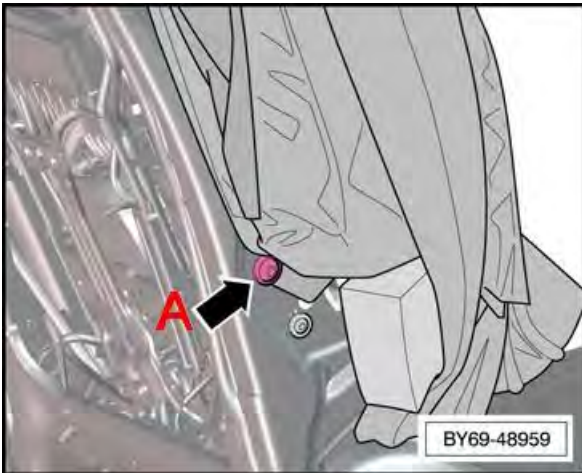
Figure 45

Air bag fastener part number N90737101 torque 9Nm location for 4 seat rear (see Figure 45)

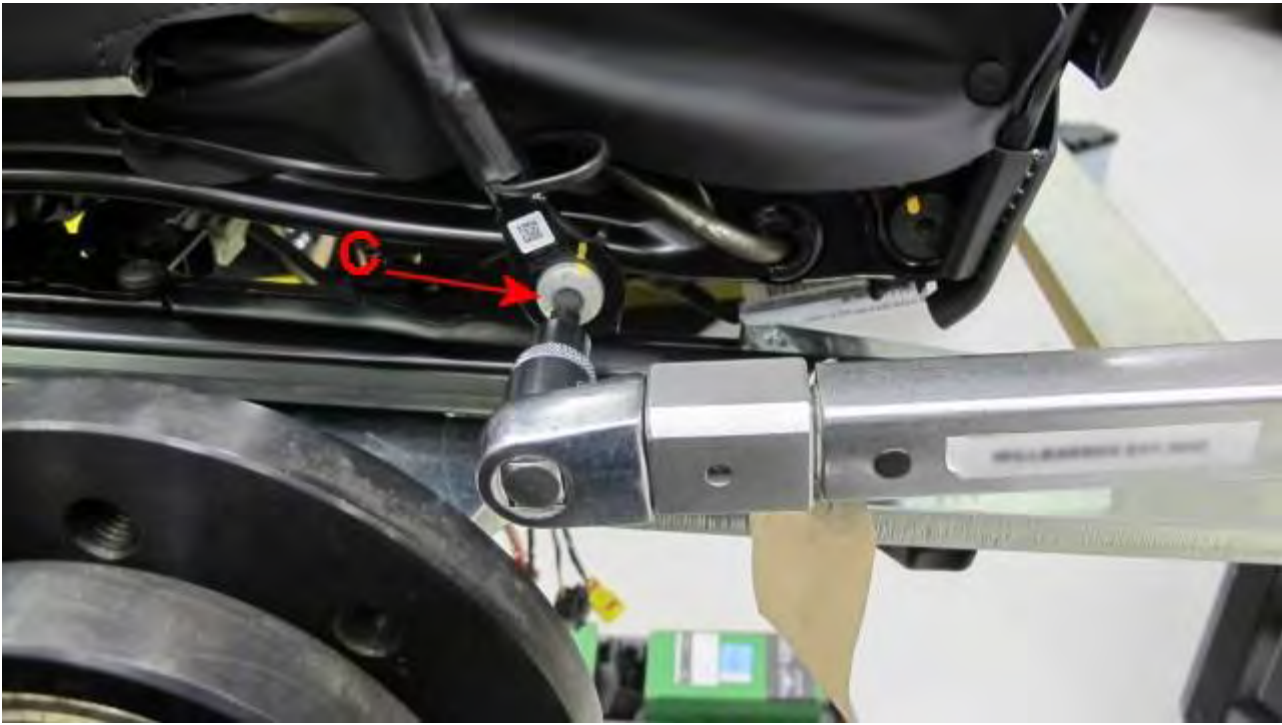
Figure 49

1. Switch off ignition
2. Remove rear seat Rep.Gr.72
3. Place the seat on the seat repair stand –VAS 6136- or a suitable secure surface. Refer to "Front seat repair stand – To repair" Rep.Gr.72
4. Using an in date calibrated torque wrench apply 40 Nm to fastener (C) (part number N98923602) (see Figure 49)

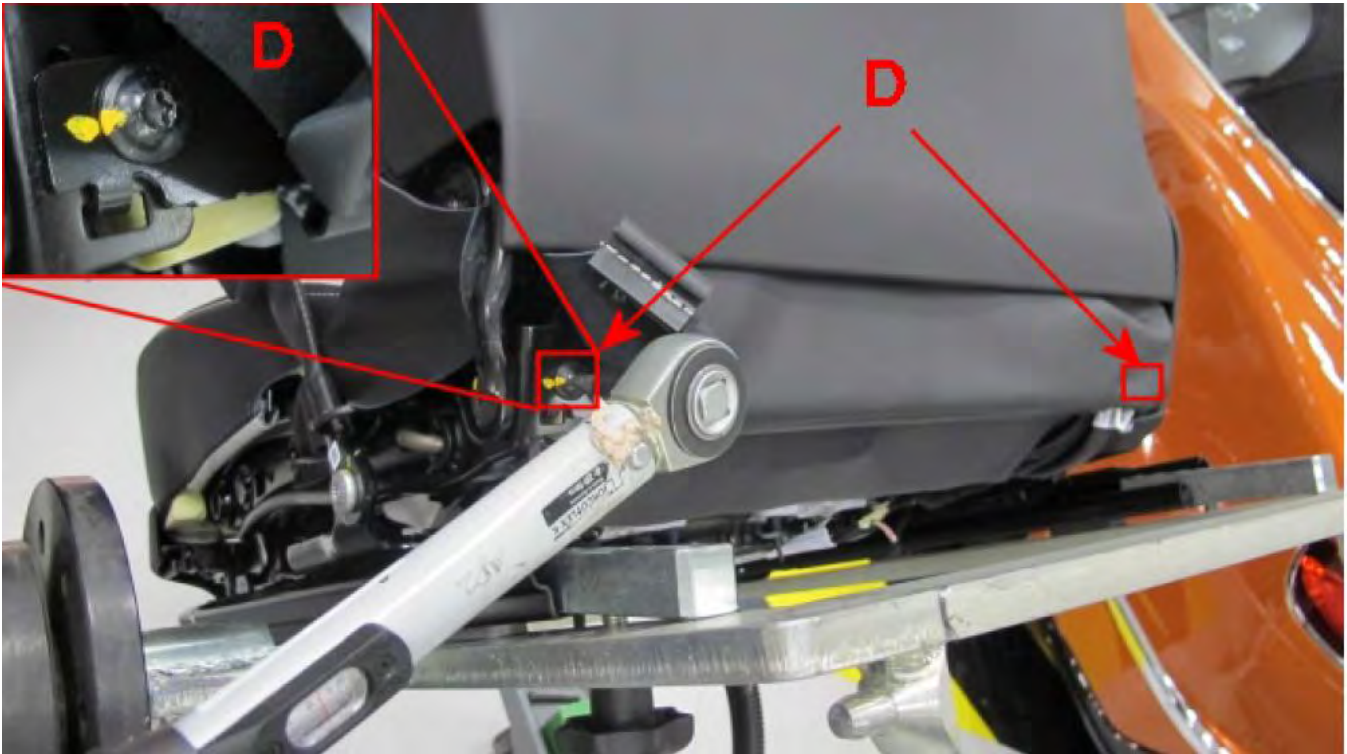
Figure 51

1. Rear seat ISO bar fastener part number N90737107 torque 8Nm (see Figure 51)
2. Switch off ignition
3. Remove rear seat Rep.Gr.72
4. Place the seat on the seat repair stand –VAS 6136- or a suitable secure surface. Refer to "Front seat repair stand – To repair" Rep.Gr.72

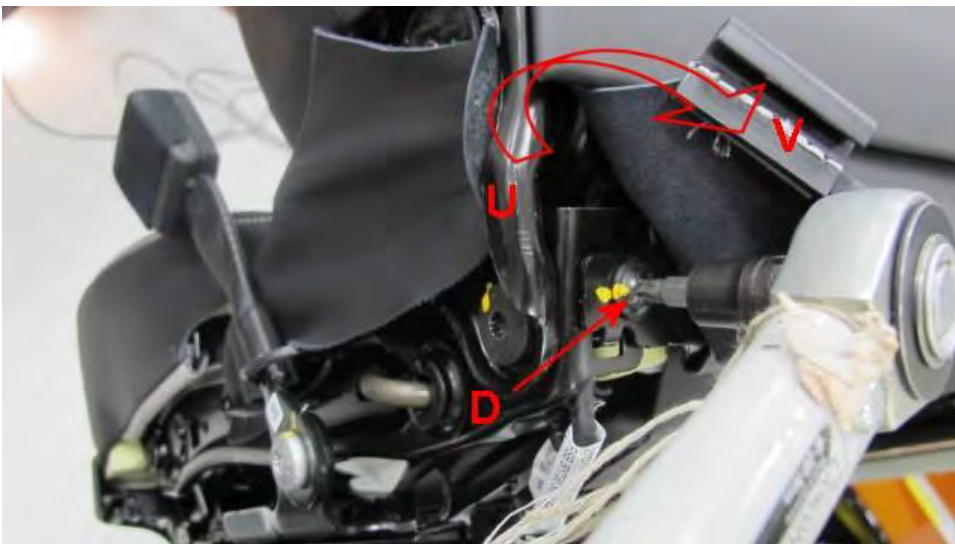
Figure 52

5. Referencing figure 52 unclip trim flap (V) from seat frame (U) to access inboard ISO bar fastener (D)

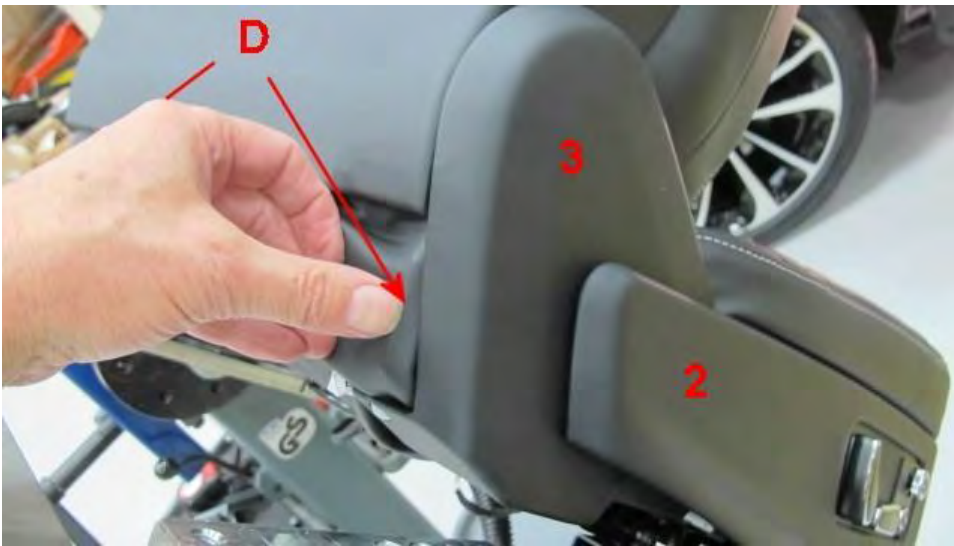
Figure 53

6. Remove rear seat side valance (2) (see Figure 53). Refer to Rear seat valance – To remove and fit Rep.Gr.72
7. Remove rear seat side valance (rear) (3) To access outboard ISO bar fastener (D) (see Figure 53). Refer to Rear seat valance – To remove and fit Rep.Gr.72
8. Unclip trim flap from seat frame to access outboard ISO bar fastener (D) (see figure 54)

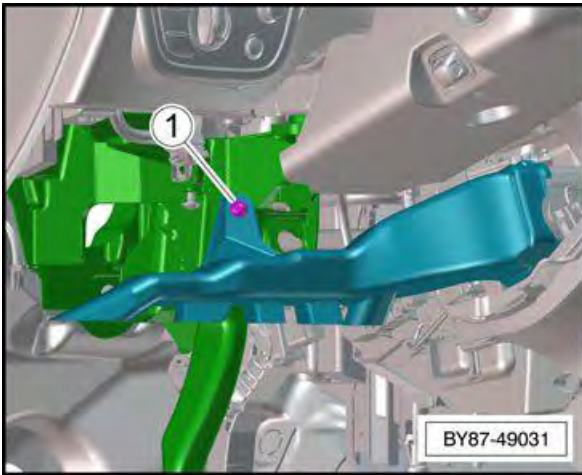
1. Remove the lower dashboard panel (drivers side) - Refer to workshop manual Rep. Gr 70
2. Remove the steering column lower cowl - Refer to workshop manual Rep. Gr 70
3. Remove the left hand side foot well vent fastener Figure 56 (point 1)

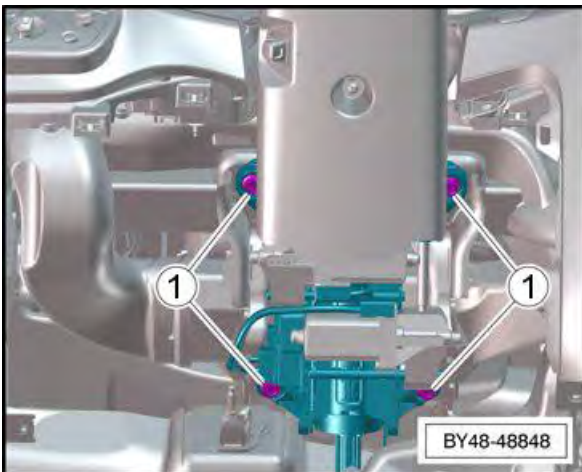
4. Referring to Figure 57 (points 1) check the torque of all 4 steering column fasteners part number N10665001 the torque of the fasteners is (20Nm)

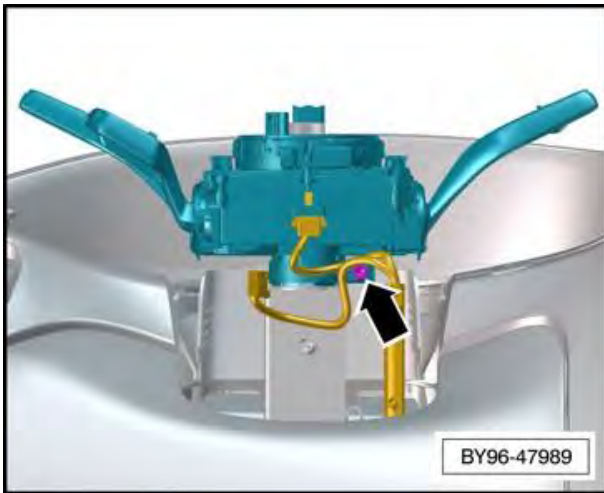
Figure 58

1. Check the security of the steering column multi-function clamp (Figure58) the torque of the fastener is 5Nm

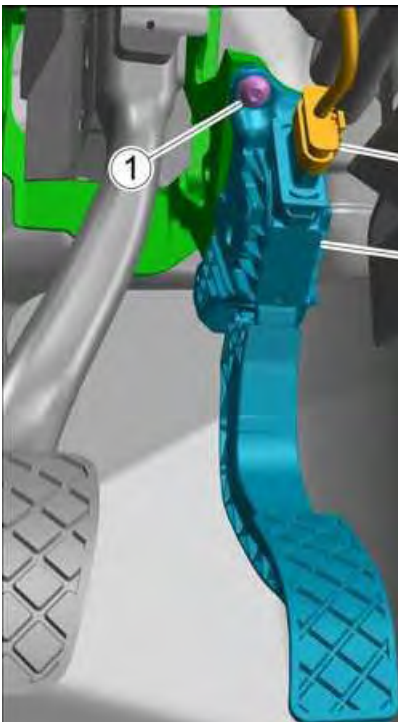
Figure 59

1. Check the security of the throttle pedal assembly fastener part number N10714801 (Figure59 point 1) the torque of the fastener is 8Nm
