<b>Topic</b>	Seat assemblies and instrument panel - fastener torque over check (RE16/32)
<b>Market area</b>	Bentley: worldwide (2WBE),Hongkong-Macau (5HK)
<b>Brand</b>	Bentley
<b>Transaction No.</b>	2045534/1
<b>Campaign number</b>	RA70
<b>Note</b>	
<b>Type</b>	Recall campaign
<b>US code</b>

### Bentayga

During a routine system review missing torque data was discovered against a small number of bolts tightened during vehicle assembly. As a precaution, an overcheck is required on these joints to confirm correct tightening.

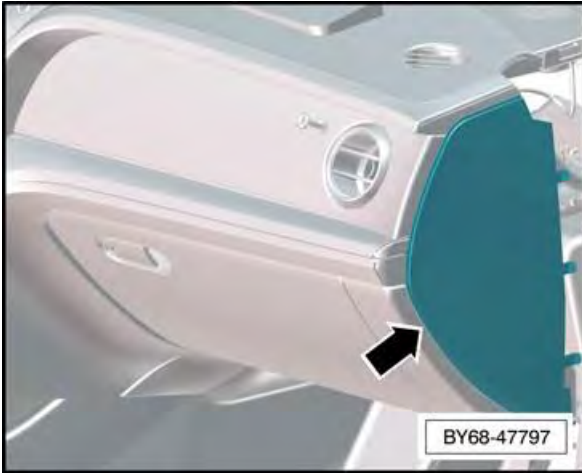
Figure 60

1. Remove the passenger side dashboard side trim panel Refer to workshop manual Rep. Gr 70 (Figure 60)

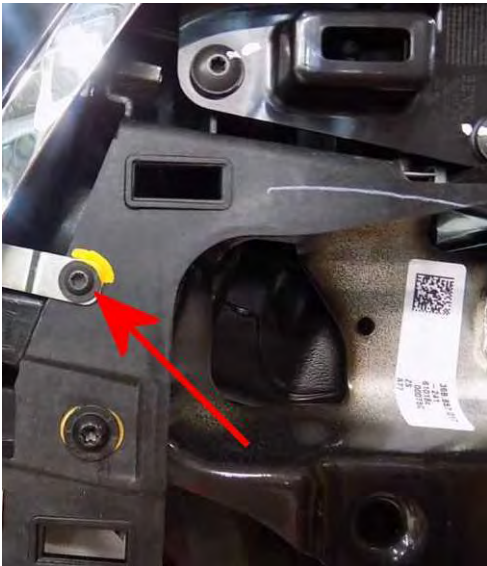
Figure 61

2. Check the security of the passenger side facia panel fastener N90918701 (Figure 61) torque check the fastener to 1.5Nm

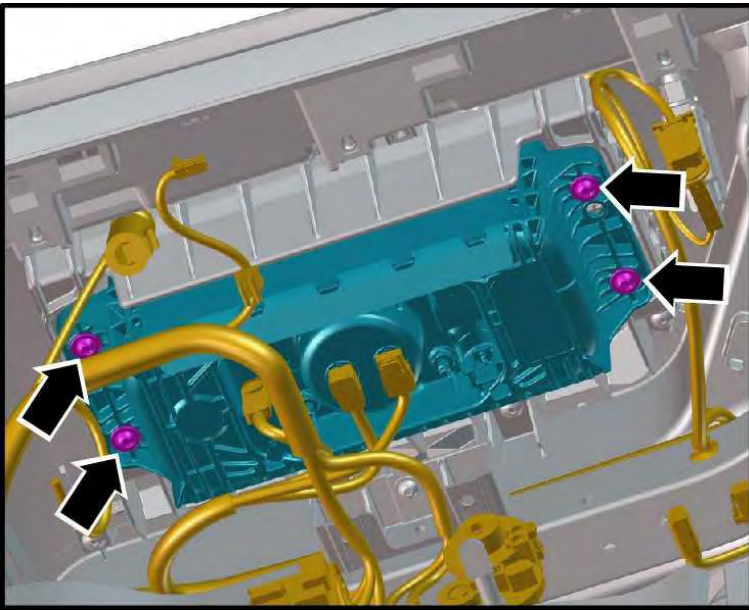
Figure 62

1. Access the Passenger air Bag , Refer to **Passenger's** airbag (NX3) –To remove and fit
2. Check the security of the four airbag retaining fasteners part number N91093502 (Figure 62) torque check the fasteners to 9Nm

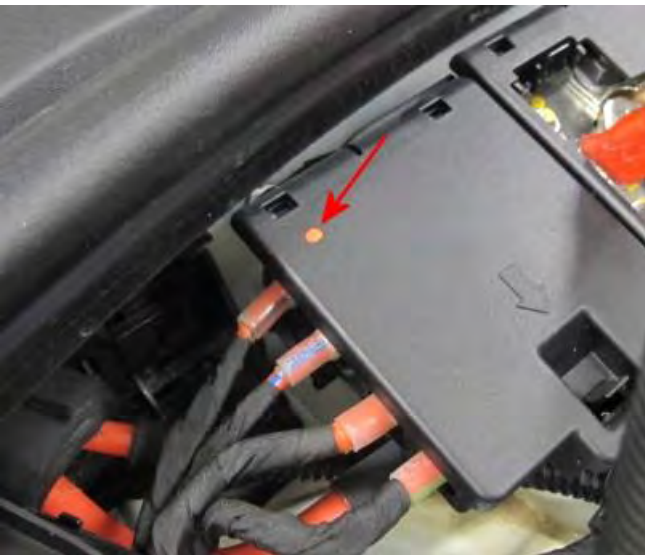
Figure 63

If the vehicle is not already listed as repaired in the "Repair history" (in Elsa pro), check for the presence of red campaign completion mark top of the main electrical junction box (see Figure 63), should neither be evident carry out the required work in accordance with these instructions.
