SAFETY ADVISORY # 16-269

Cougar FW Propane Manifold

Keystone RV Company is conducting a voluntary RECALL notification campaign in accordance with the National Traffic and Motor Vehicle Safety Act. It has been decided that during installation of the LP bottle propane manifold that the fasteners for the floor decking may have come in contact with the propane manifold. If the propane manifold is damaged and leaks in the presence of an ignition source, an increased risk of fire and/or explosion will result causing property damage and/or personal injury.

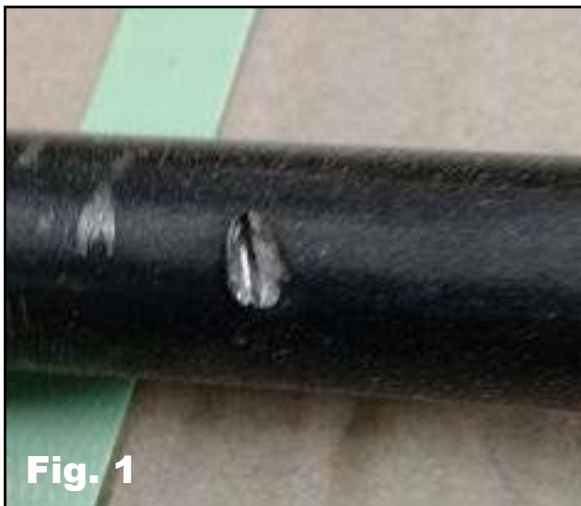
Fig. 1

Locate the LP manifold, black pipe, mounted between the LP bottles, Fig. 1. **NOTE:** *Only the manifold located between the bottles is affected.* If the gas line manifold is damaged, submit photos with pre-authorization request and proceed to Step 3. If the manifold is not damaged, proceed to **WARRANTY REIMBURSEMENT, INSPECTION.**
