# Keystone RV Company

## SAFETY ADVISORY # 16-267

### Christianson Folding Ladder

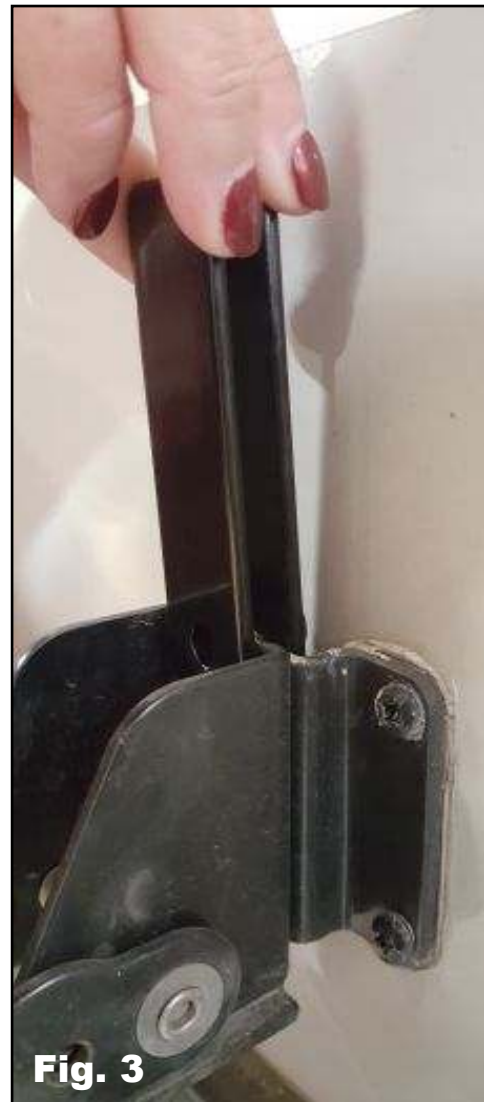
Insert repair kit brace over each of the standoff brackets, with welded nut on brace toward the wall, Fig. 3.

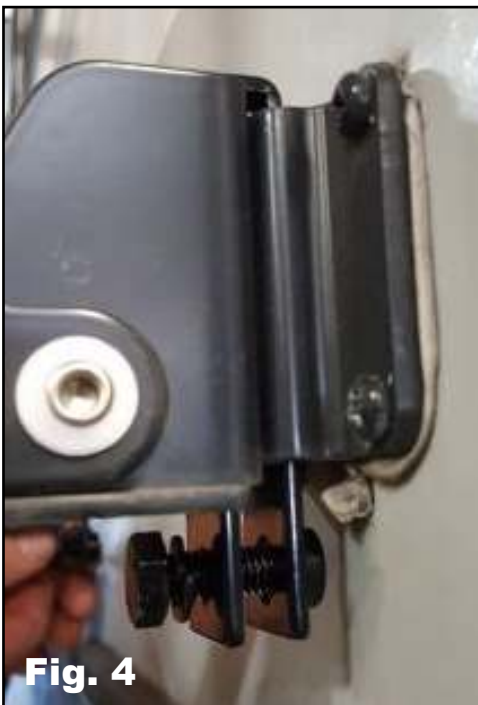
Insert bolt with lock washer supplied with kit, Fig. 4.

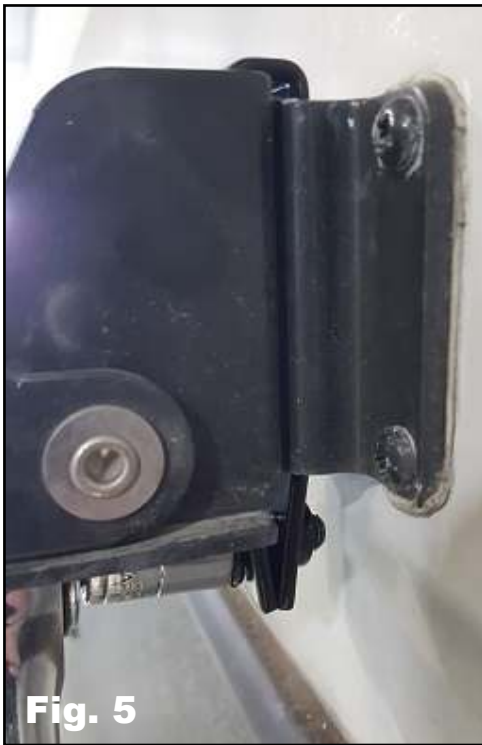
Tighten bolt until the bottoms of the repair brace come together snugly, Fig. 5. Torque should be between 12-ft lbs. and 15-ft lbs. Repeat on all 6 brackets. See warranty reimbursement below for time and codes. Picture of the bracket is required for warranty reimbursement.
