SAFETY RECALL BULLETIN

SUBJECT:			No: SR-16-011
LIFT GATE GAS SPRING CORROSION – SAFETY RECALL CAMPAIGN			DATE: January, 2017
			MODEL: 2011, 2012, 2016 Outlander Sport / RVR
CIRCULATE TO:	<input checked="" type="checkbox"/> GENERAL MANAGER	<input checked="" type="checkbox"/> PARTS MANAGER	<input checked="" type="checkbox"/> TECHNICIAN
<input checked="" type="checkbox"/> SERVICE ADVISOR	<input checked="" type="checkbox"/> SERVICE MANAGER	<input checked="" type="checkbox"/> WARRANTY PROCESSOR	<input checked="" type="checkbox"/> SALES MANAGER

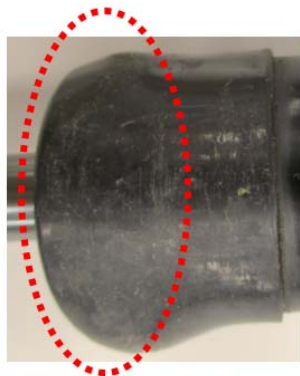
1. Raise the lift gate and inspect the gas springs' resin end caps for presence of swelling, whitening, or cracking. If any resin end cap is NG (swelling, whitening, or cracking is found), take photo for submission to Photos Required Condition (PRC), then proceed to **step 3**.

Swelling

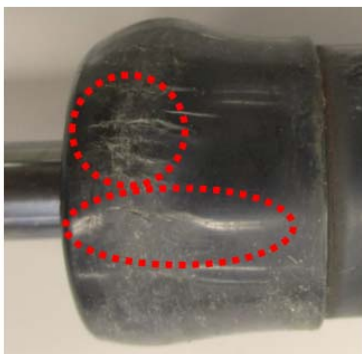
Whitening

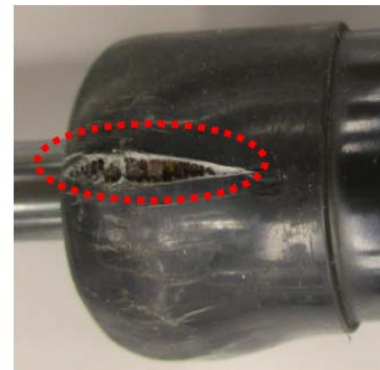
Cracking

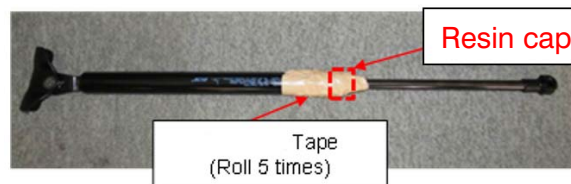
- a. Make a mark at 4 in (100 mm) from the end of the resin cap.

NOTE: Gas spring removed from vehicle for illustration purposes.

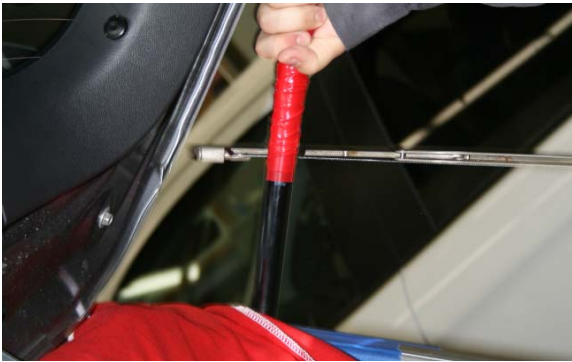
- e. Using a hand saw, make a small incision, just enough to relieve the gas, at the mark made in **step 3a**.
- f. Lightly cover the incision point with tape or rags to reduce the gas expulsion distance.

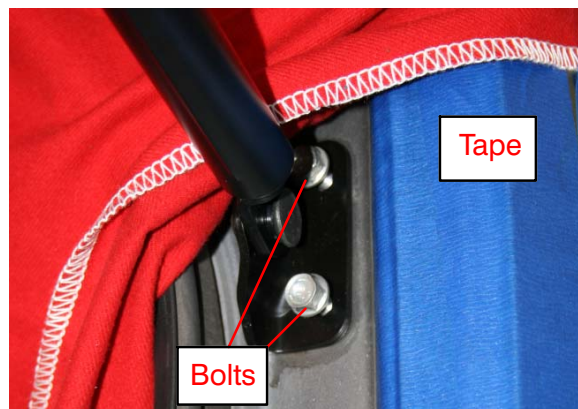
1. Support the lift gate.
2. Tape the body panel near the gas springs to prevent accidental damage during gas springs removal.
3. Lightly loosen, but do not remove, 2 bolts on the body side.
