TECHNICAL INSTRUCTIONS
FOR
SAFETY RECALL G05
PASSENGER KNEE AIRBAG BOLT FASTENER INSPECTION
CERTAIN 2016 MODEL YEAR AVALON

During vehicle assembly, it is possible that incorrect fasteners were used to install the front passenger knee airbag assembly. This could affect its performance, increasing the risk of injury in a crash.

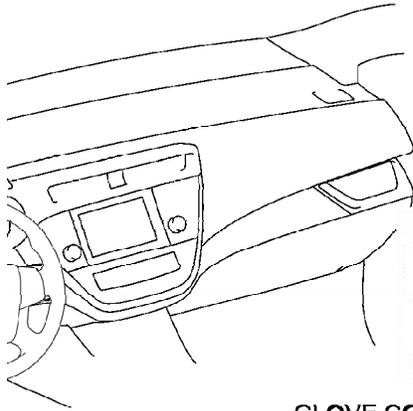
GLOVE COMPARTMENT PLATE

2. REMOVE THE FOLLOWING COMPONENTS TO ACCESS THE KNEE AIRBAG BOLTS FOR INSPECTION.

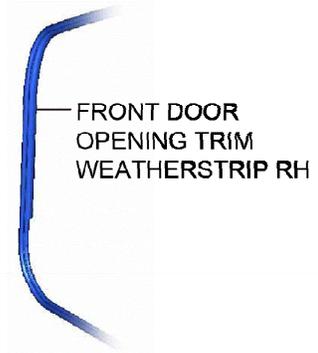
FRONT DOOR
OPENING TRIM
WEATHERSTRIP RH

INSTRUMENT SIDE
PANEL RH

COWL SIDE TRIM
SUB-ASSEMBLY RH

FRONT DOOR
SCUFF PLATE RH

These components must be removed to ensure the correct bolts are inspected during the inspection process.

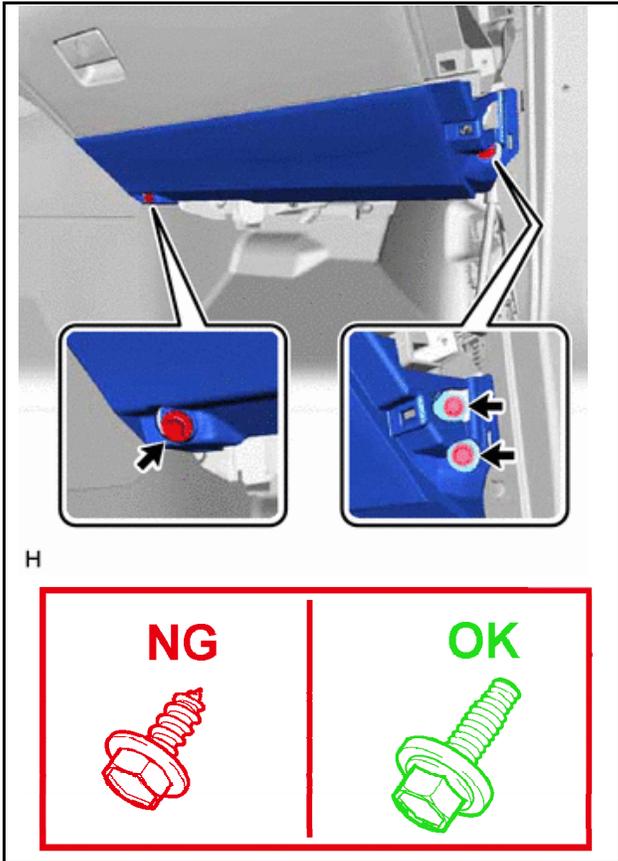
3. REMOVE THE KNEE AIRBAG BOLTS

- a) Remove each passenger knee airbag bolt one at a time and confirm the correct bolt is installed.

Note: If any bolt is judged NG both brackets must be replaced.

- b) Reinstall the bolt if OK and torque to spec.
Torque: 7 ft.lbs (10Nm, 102 kgf-cm)

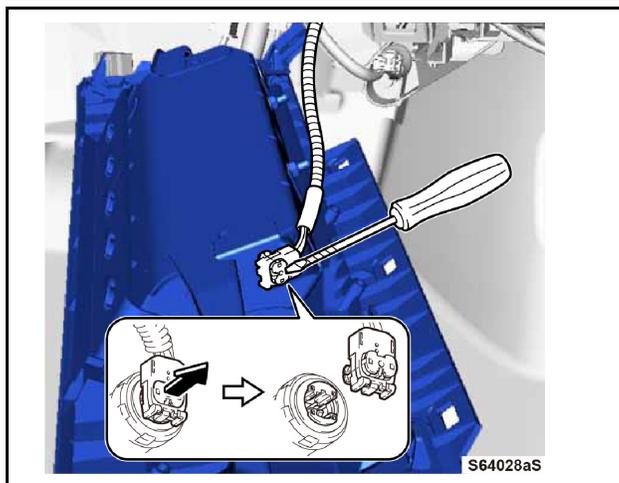
- a) Using a screwdriver with its tip wrapped in protective tape, release the airbag connector lock and disconnect the connector.

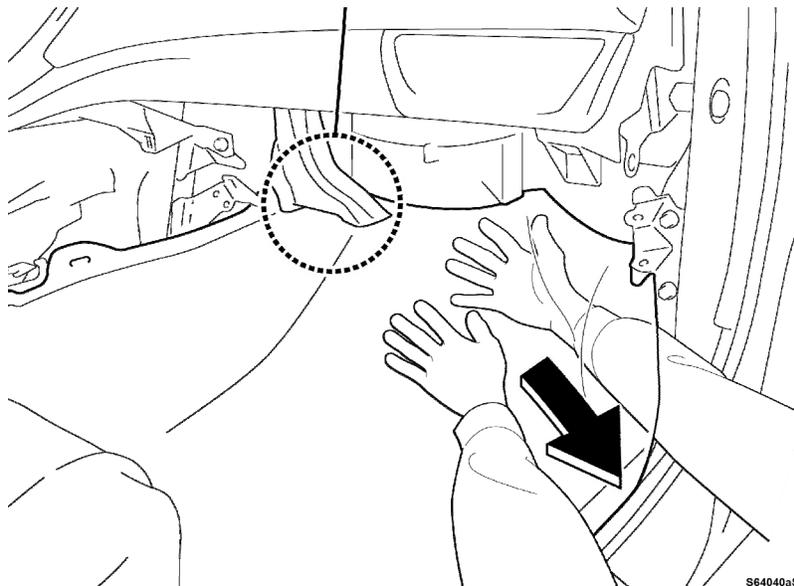
- a) Apply protective tape to the area indicated in the illustration.
- b) Remove the 2 floor carpet hooks by disengaging the 2 claws in each hook.
- c) Disengage the floor carpet RH from the hook.
- d) Pull the floor carpet RH in the direction shown in the illustration and partially detach it from the vehicle.

- e) Place your hand beneath the floor carpet RH, and then pull the carpet up and toward the door opening while preventing it from coming into contact with the rear No.3 air duct sub-assembly.

- **DO NOT** allow the floor carpet to come into contact with the air duct.
- **DO NOT** cause any foamed polypropylene material to peel away from the back surface of the carpet.

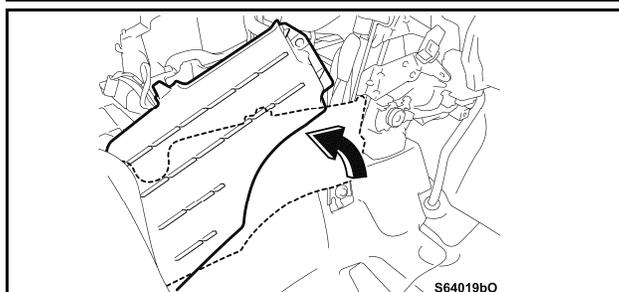
- a) Remove the clip.
b) Disengage the guide to detach the floor carpet bracket RH.

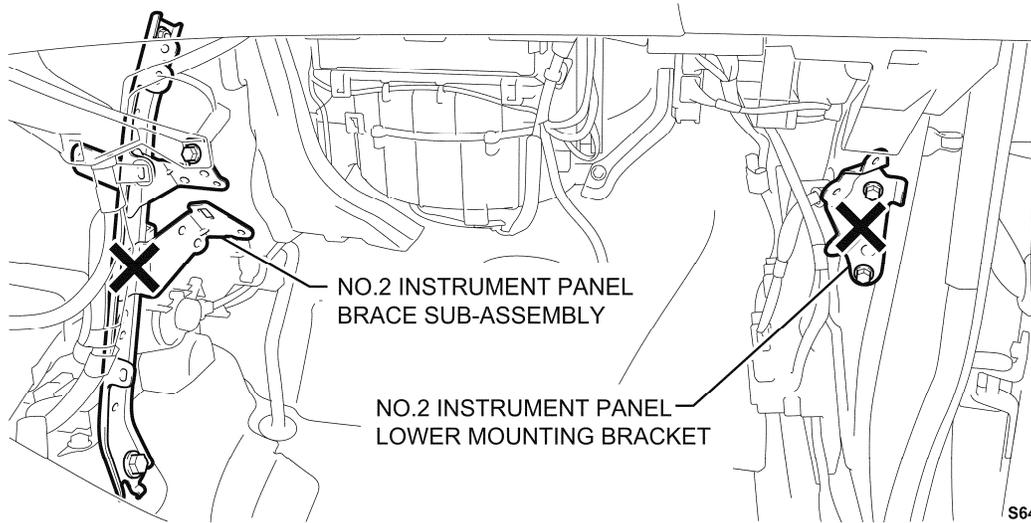
- a) Mark the No.2 instrument panel brace sub-assembly and No.2 instrument panel lower mounting bracket so as not to reinstall them in error.

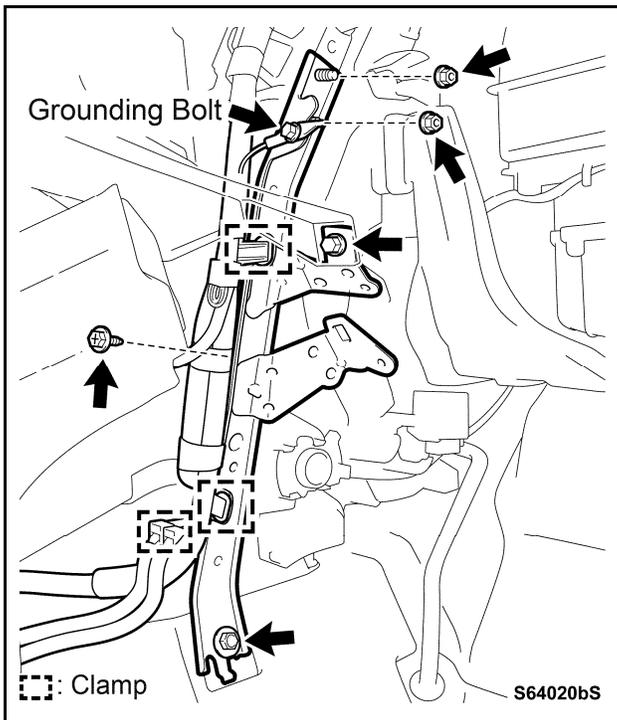
- b) Remove the No.2 instrument panel brace sub-assembly.

- 1) Disengage the wire harnesses from the 3 clamps, and then remove the grounding bolt.
- 2) Remove the 2 bolts, 2 nuts, screw, and No.2 instrument panel brace sub-assembly.
- 3) Store the removed No.2 instrument panel brace sub-assembly in a separate container so as not to reinstall it in error.

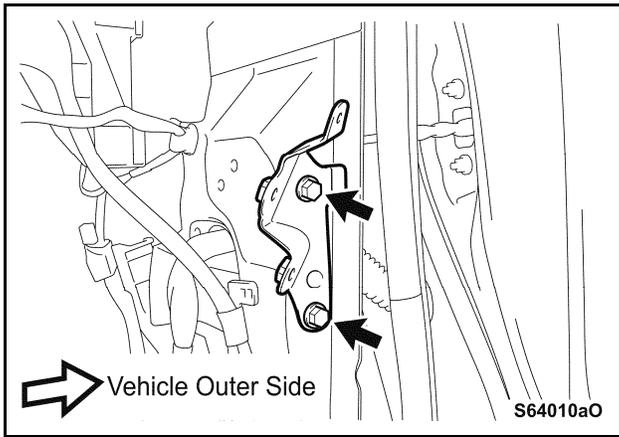
- c) Remove NO.2 instrument panel lower mounting bracket.
- 1) Remove the 2 bolts and No.2 instrument panel lower mounting bracket.
 - 2) Store the removed No.2 instrument panel lower mounting bracket in a separate container so as not to reinstall it in error.

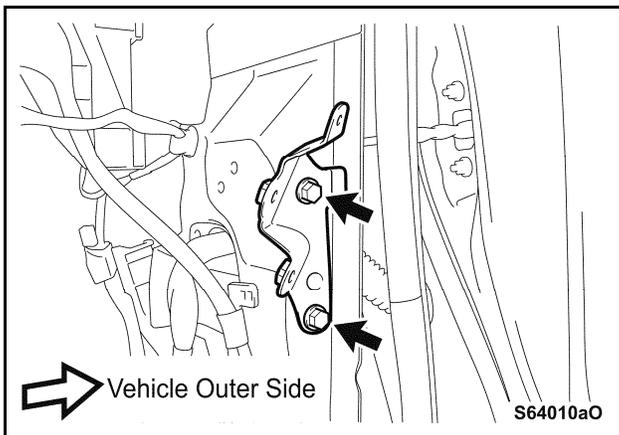
- a) Install a **NEW** No.2 instrument panel lower mounting bracket.
- 1) Install a **NEW** No.2 instrument panel lower mounting bracket with the 2 bolts.

Specified torque:

10 N*m (102 kgf*cm, 7 ft.*lbf)

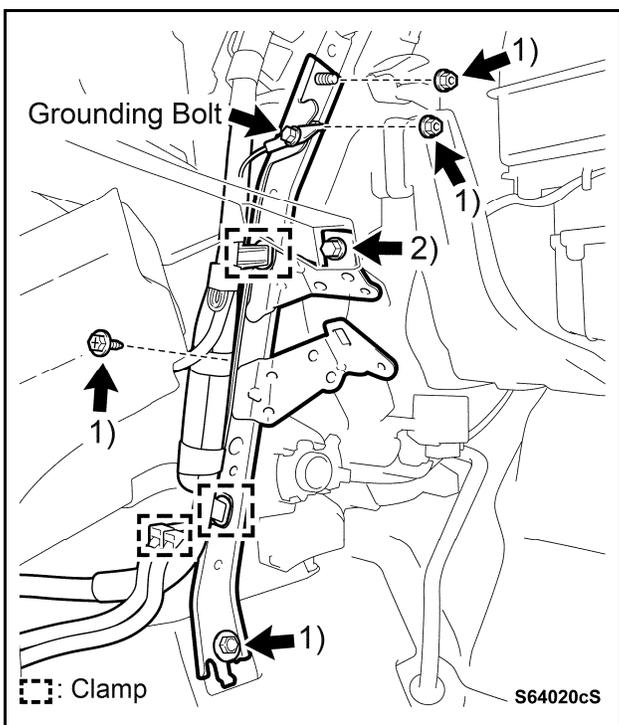
- b) Install a **NEW** No.2 instrument panel brace sub-assembly.

- 1) Temporarily install a **NEW** No.2 instrument panel brace sub-assembly with the bolt, 2 nuts and screw.

Specified torque:

Bolt: 15 ft.*lbf (20 N*m 204 kgf*cm)

Nuts: 15 ft.*lbf (20 N*m 204 kgf*cm)

- 2) Reinstall the bolt.
- 3) Re-engage the wire harnesses with the 3 clamps.
- 4) Reinstall the grounding bolt.

71 in.*lbf (8.0 N*m, 82 kgf*cm)

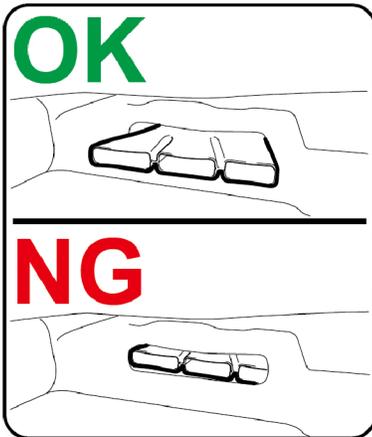
Ensure that the rear air duct guide RH is positioned properly by checking its outlet from the rear to confirm that it is protruding outside the floor carpet as shown.

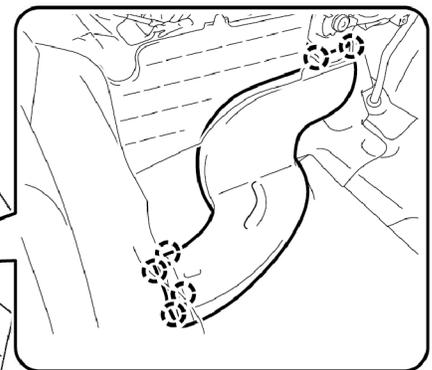
Requires 2 Workers

- Re-engage the 6 claws and reinstall the rear No.2 air duct.

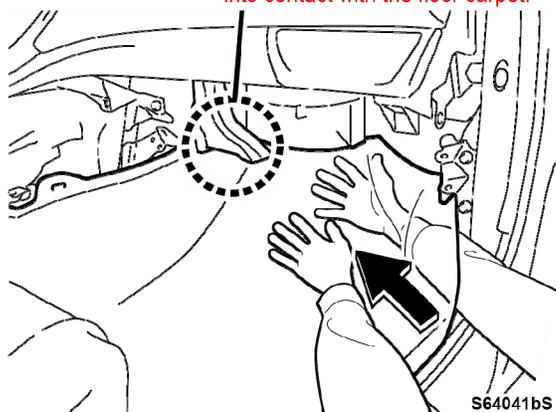
Be careful! *DO NOT* allow the air duct to come into contact with the floor carpet.

15. REINSTALL FRONT FLOOR CARPET RH

- Unfasten the seat belt and remove the seat cover from the floor carpet RH.
- Place your hand beneath the floor carpet RH and push the carpet toward the center of the vehicle while preventing it from coming into contact with the No.1 air duct sub-assembly.

- DO NOT* allow the floor carpet to come into contact with the air duct.
- DO NOT* cause any foamed polypropylene material to peel away from the back surface of the floor carpet.

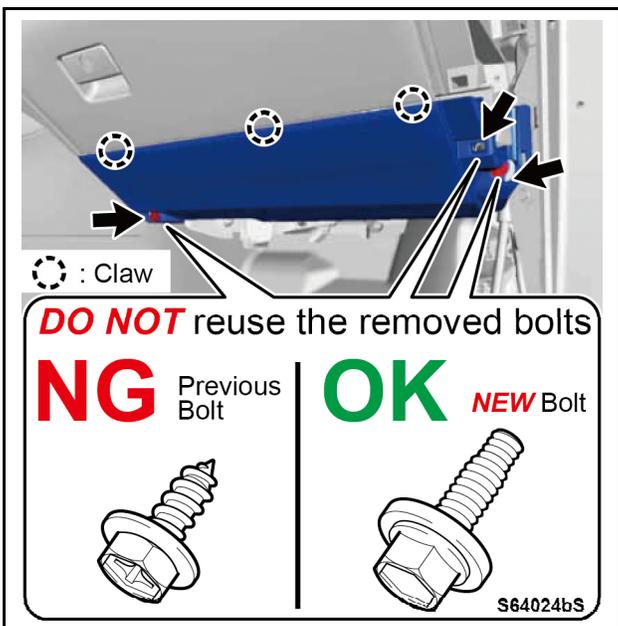
- c) Re-engage the 3 claws to temporarily reinstall the lower No.2 instrument panel airbag assembly.
- d) Install the supplied 3 **NEW** bolts to reinstall the lower No.2 instrument panel airbag assembly.

Specified torque:
7 ft.*lbf , (10 N*m, 102 kgf*cm)
