Keystone RV Company

SAFETY ADVISORY # 16-274

MORryde Ramp Door

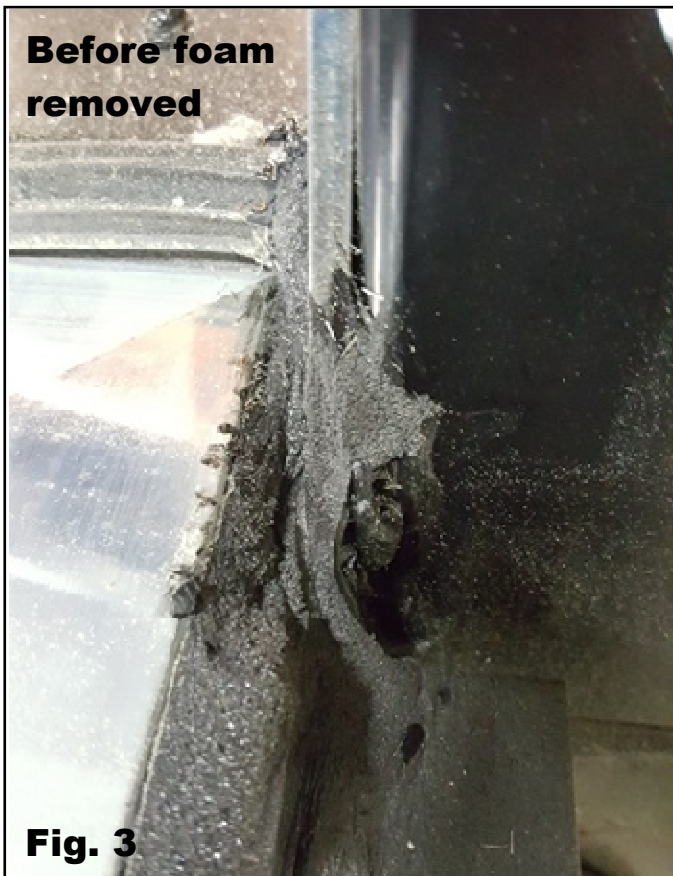
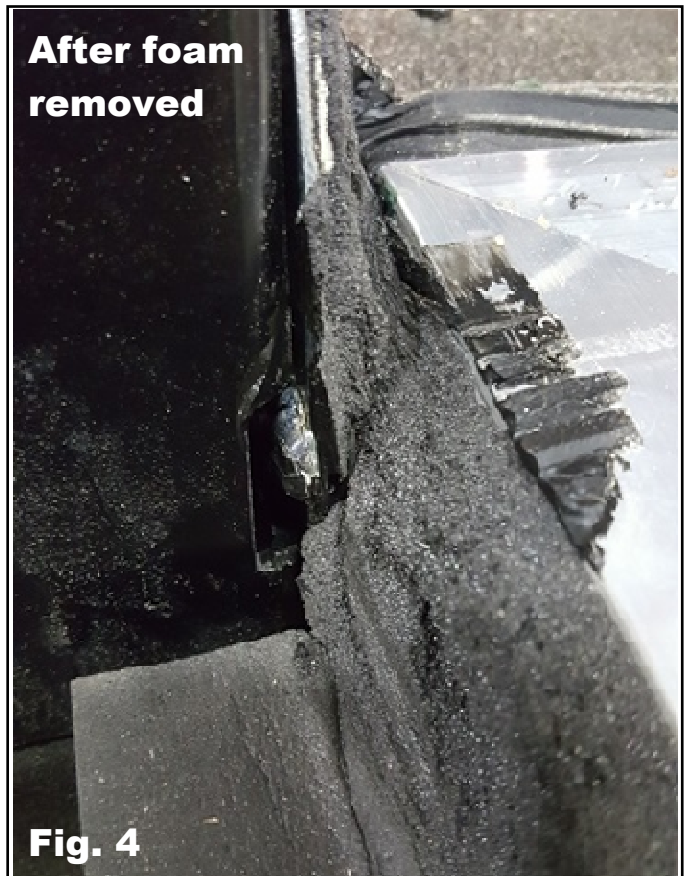
Open door and clear any black caulk or foam from the bottom of the hinge to allow access to the back side of the hinge, exposing the weld, Figures 3 and 4.

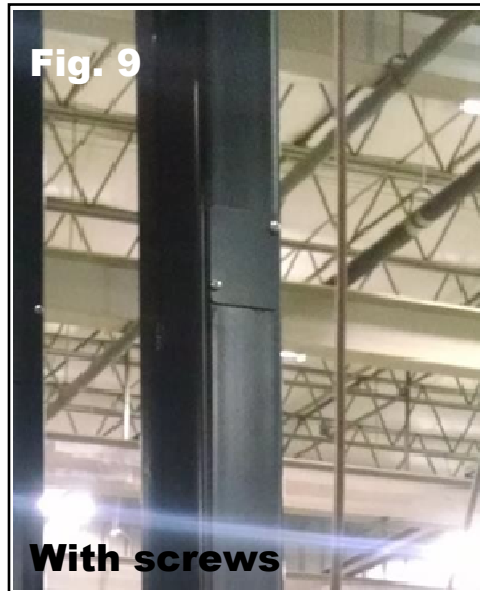
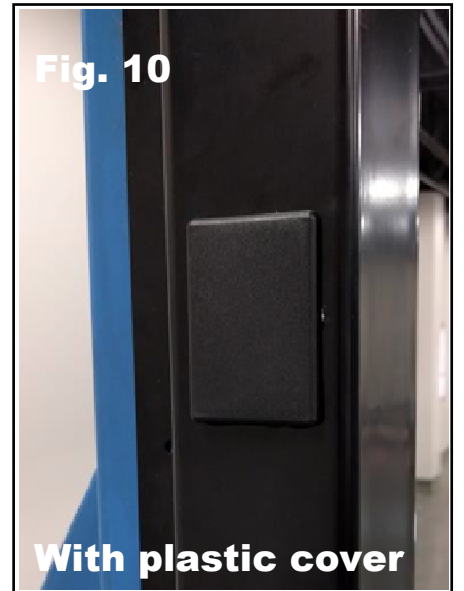
MORryde Hinge Replacements - Open rear ramp door and remove covers over the spring adjusting bolts on both sides of frame. There are two different versions of these covers as shown in Figures 9 and 10.

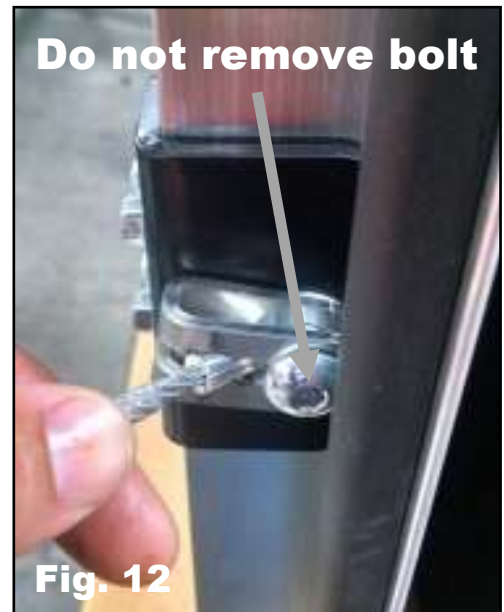
To unhook the cable from the door, close the door until the cable no longer has tension on it. With a pair of needle nose pliers, push the end of the cable into the clip and pull the cable end out first, Figure 12. **Do not remove the cable bracket.** Repeat on opposite side. **Warning!** At this point, you have all the weight of the door to control.

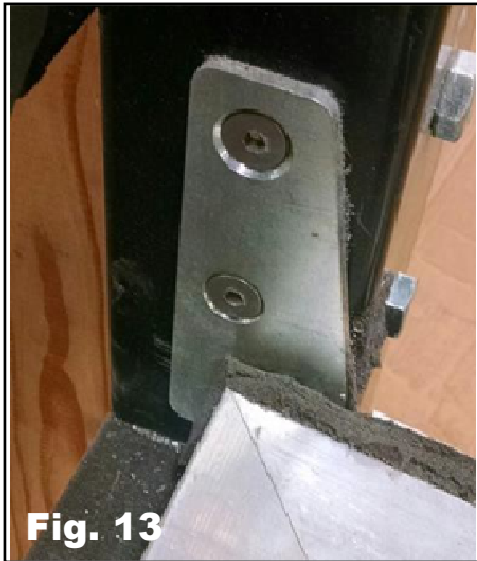
Carefully lower the door down to the ground supporting the door and being careful not to damage the door or the frame. Starting with the bottom bolt, remove the hinges and replace with new, Figure 13. Replace both hinges.

Using the MORryde Hinge Replacement steps above in reverse, reinstall the door and adjust tension to original marked position of the hook. Reseal the hinge using black silicone.
