RECALL CAMPAIGN 16V-914: AUTOLIV AIR BAG MODULE(S)

This Service Information bulletin replaces SI M72 01 16 **dated December 2016**

MODEL

F54 (Clubman)	F55 (Hardtop 4-door)	F56 (Hardtop 2-door)	F57 (Convertible)
---------------	----------------------	----------------------	-------------------

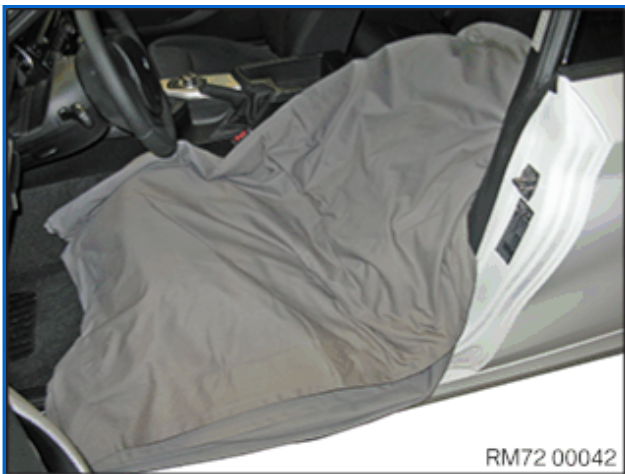
Lay out protective mats to protect the interior equipment against swarf from the drilled-out rivet and damage.

Use special tool [2 230 142](#) to unlock the clamp (1).

special tool 83 30 2 230 142 does not properly engage the release tabs within the spring clips. A revised special tool is under development. Until this is available a straight pick tool can be used. Insert pick directly in center hole of spring clip. Two release tabs have to be pried inward to release clip.

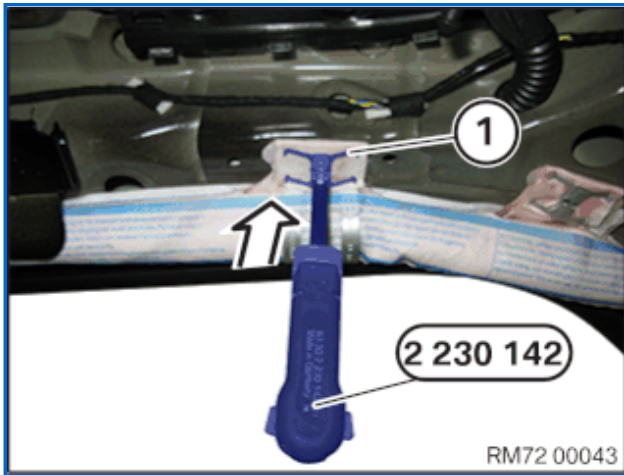
Unlock the clamps (1) using special tool [2 230 142](#) and remove.

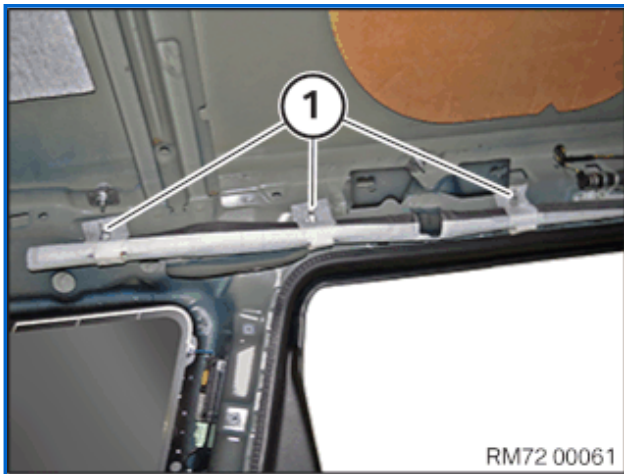
Unlock the clamps (1) using special tool [2 230 142](#) and remove.

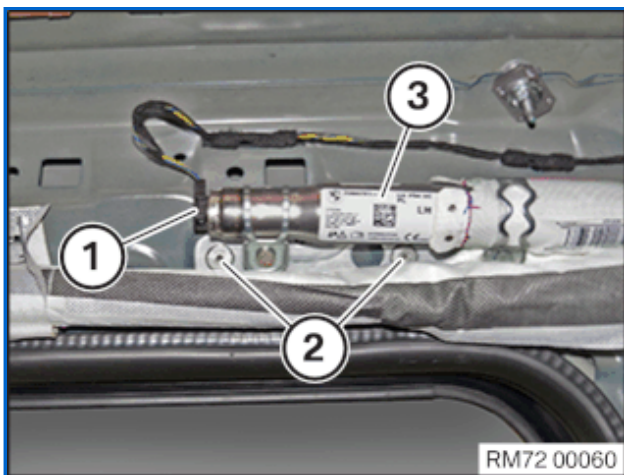
Mount gas generator (3).

Secure gas generator (3) with the rivets (2).

Follow [instructions](#) for riveting gas generators.

Connect and lock plug connection (1).

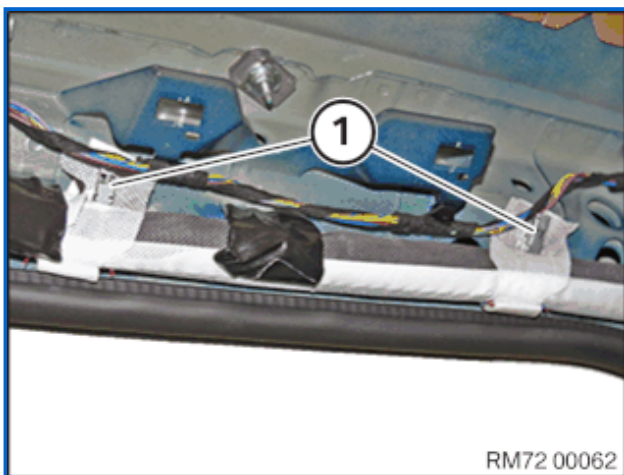
Secure clamps (1) to the body.

Clamps (1) must not be damaged or missing.

Replace defective retainers (1).

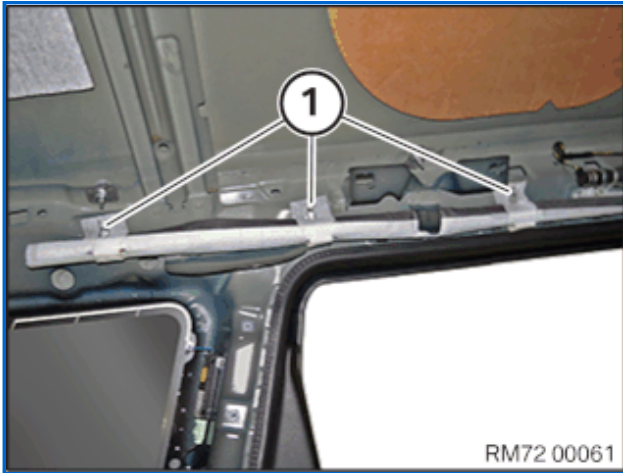
Secure clamps (1) to the body.

Clamps (1) must not be damaged or missing.

Replace defective retainers (1).
