December 21, 2016

05504 Version 1

## Non-Compliance Recall: Second Row Center Seat

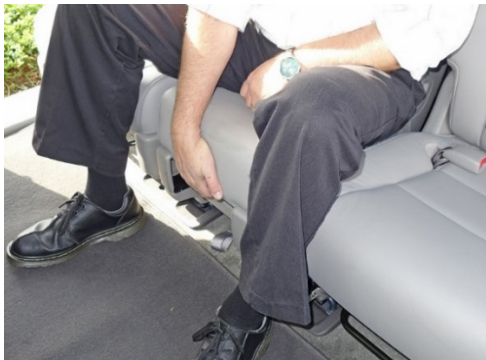
1. Sit in the second row center seat, lift the slide lever and slide the seat all the way back toward the rear of the vehicle.

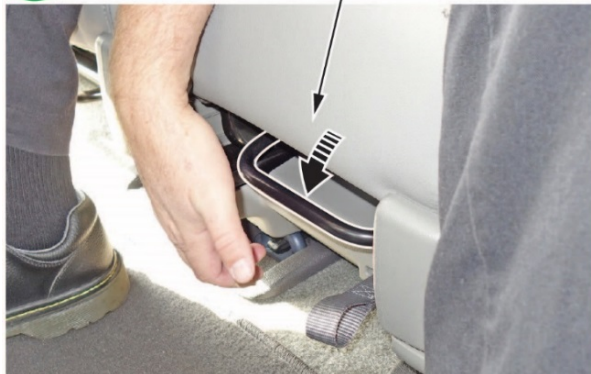
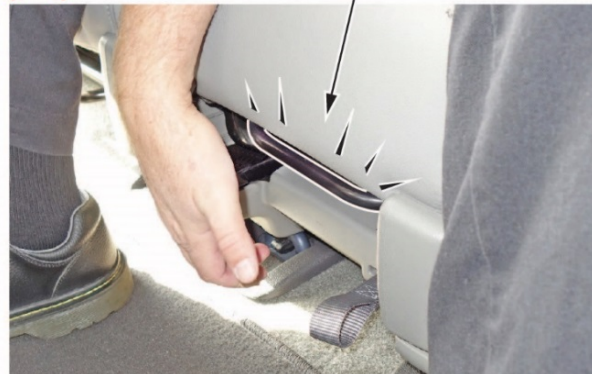
2. Slowly lower your hand to release the slide lever, then slide the seat forward to the first latching point.
  - If the slide lever returns to the original (lowest) position under its own force and the seat locks into place, the vehicle is OK.
  - If the slide lever is stuck in the up position, does not return to its original position under its own force, or doesn't lock, go to REPAIR PROCEDURE A.

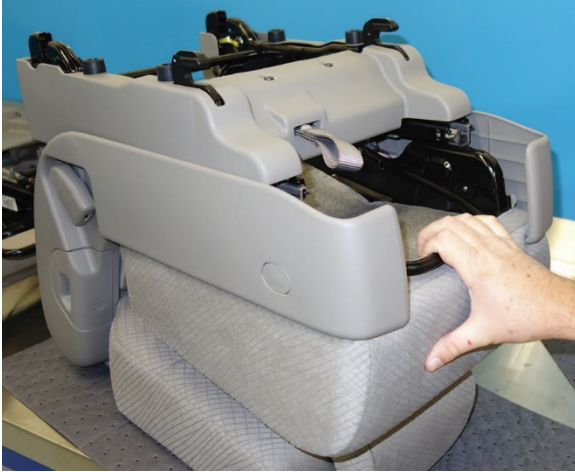
1. Fold the second row center seat and unlatch it from the floor.
2. Place the center seat upside down on a clean surface.

NOTE: You can either work on the bench or in the vehicle. Make sure you protect the seat from getting dirty by using clean shop towels, plastic sheet, etc.

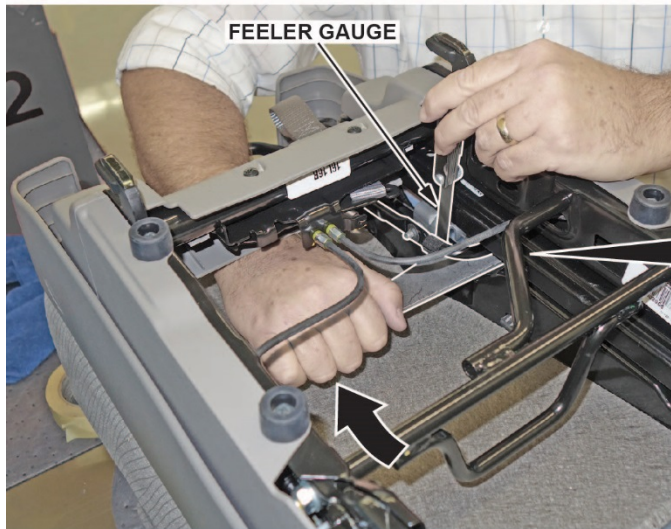
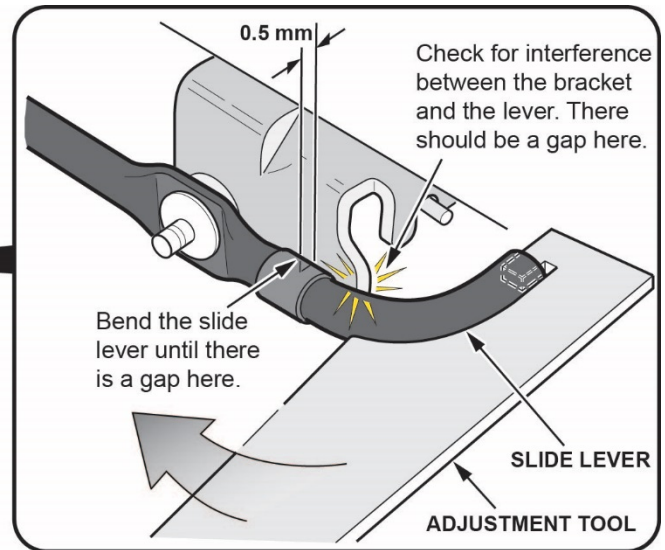
3. Using the seat slide lever adjuster and a feeler gauge, bend the slide lever to create 0.5 mm of space between the lever and the bracket as shown.

NOTE: Do not use too much force and do not bend the slide lever to more than 0.5 mm of clearance.

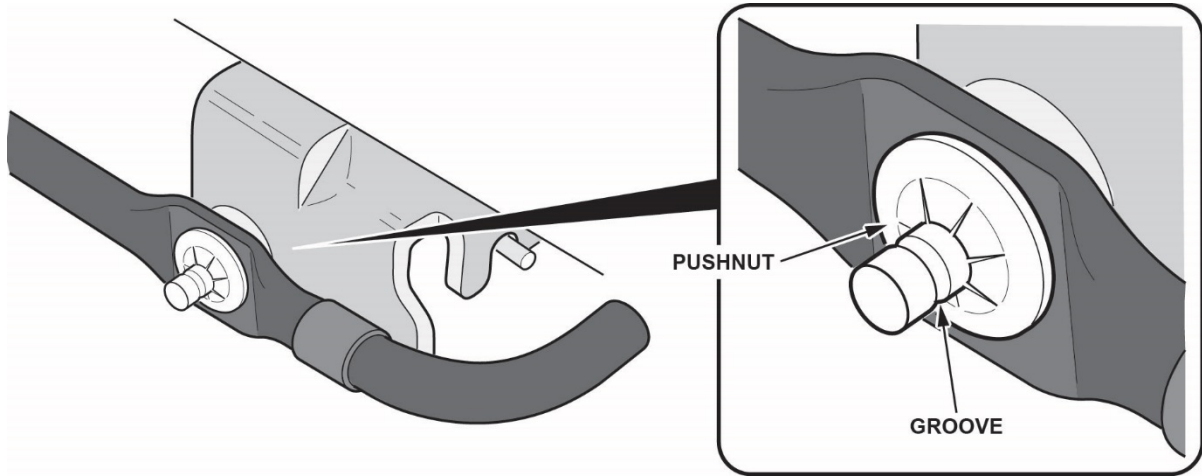
- Once there is 0.5 mm of clearance, check that the 6 mm push nuts are secure and they are pushed past the groove on the stud as shown.

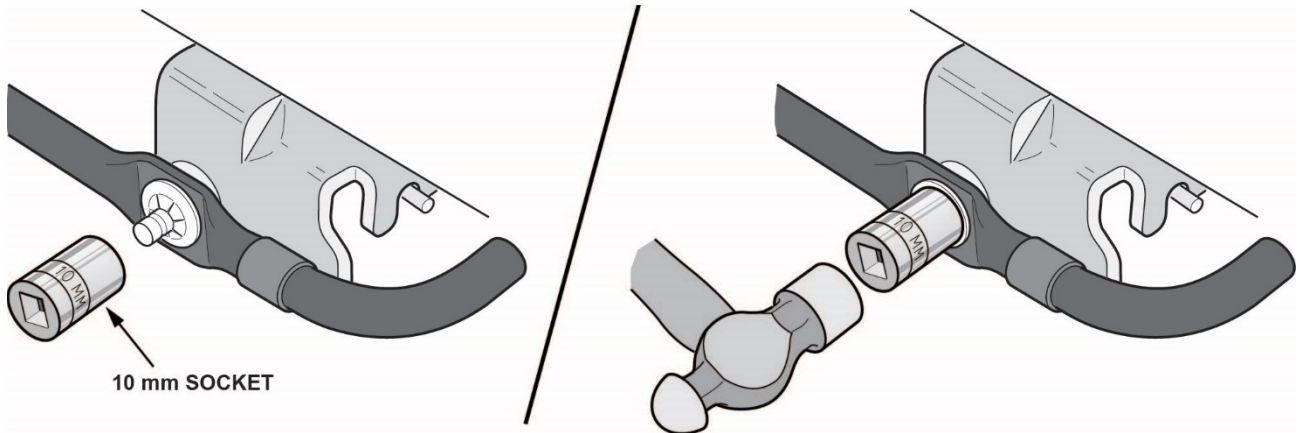
- If the push nuts are secure and pushed past the groove, go to step 5.
- If the push nuts are not secure or not pushed past the groove, use a 10 mm socket and small hammer to gently tap the push nut past the groove.

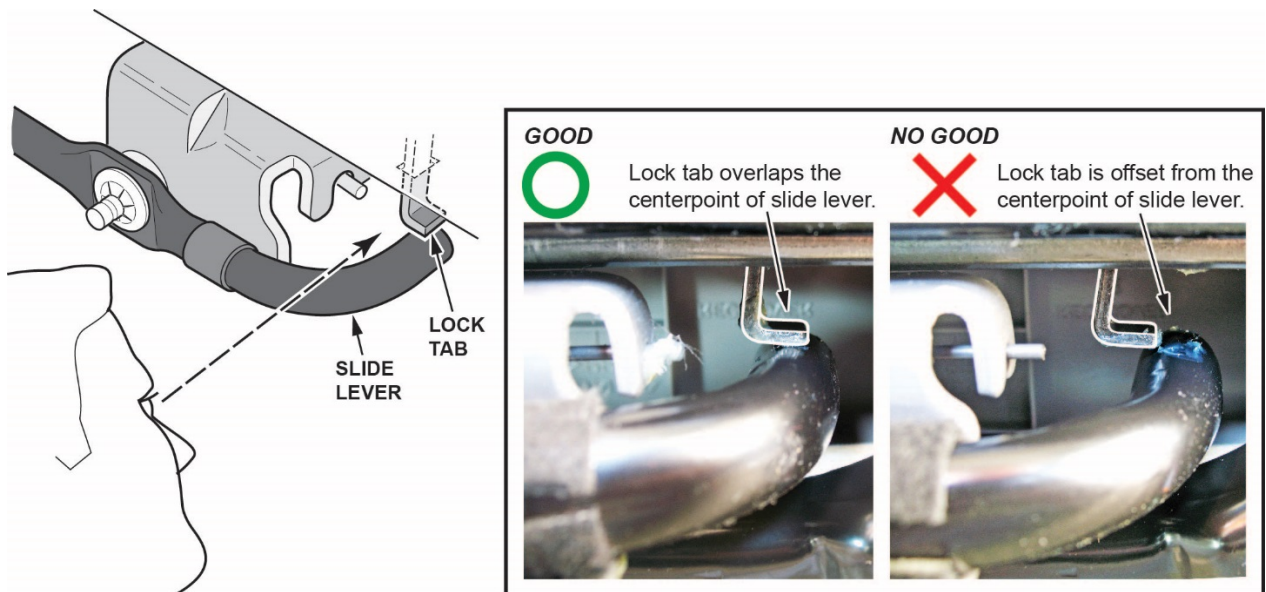
- Check that the ends of the slide lever properly overlap the lock tabs as shown.

- If the slide lever position is OK, go to step 6.
- If the slide lever position is no good, replace the slide lever. Go to REPAIR PROCEDURE B - SLIDE LEVER REPLACEMENT.

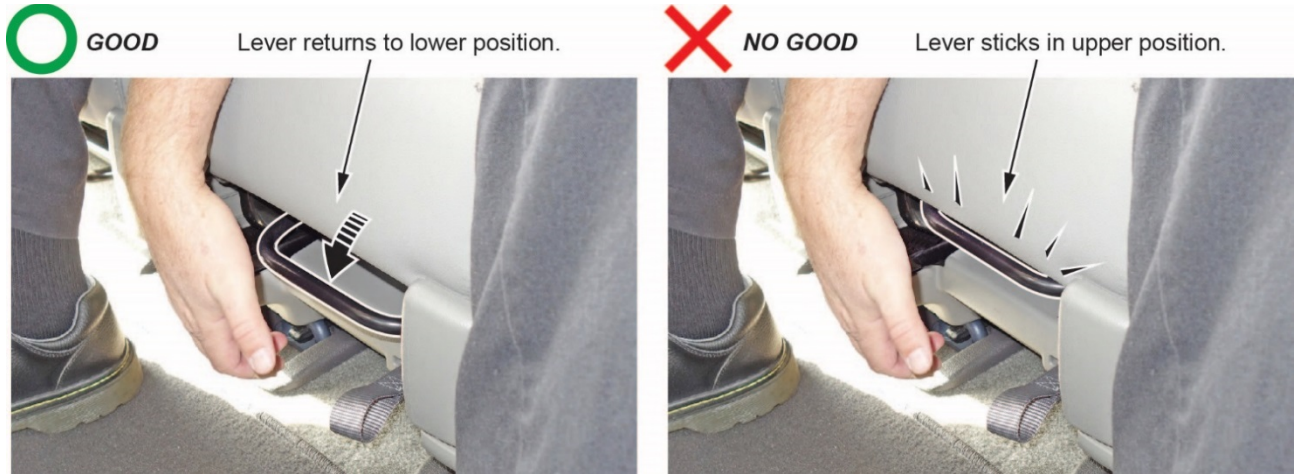
6. Install the center seat in the vehicle.
7. Sit in the second row center seat, lift the slide lever and slide the seat all the way back toward the rear of the vehicle.
8. Confirm the slide lever works properly by slowly lowering your hand to release the slide lever, then slide the seat forward to the first latching point. Verify that the seat locks into place and the slide lever returns to the original down position under its own force.

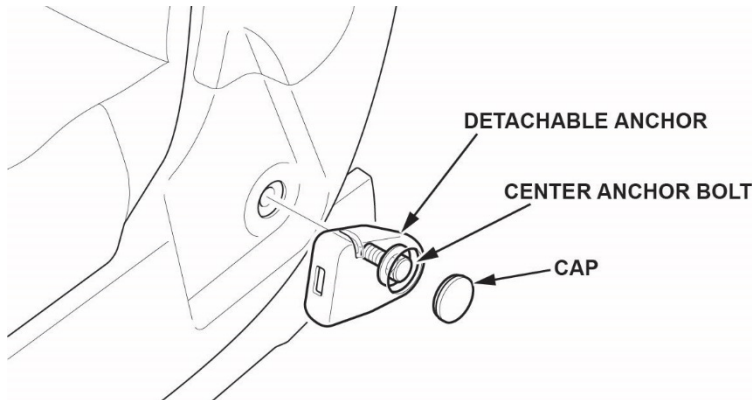
1. Remove the seatbelt detachable anchor.

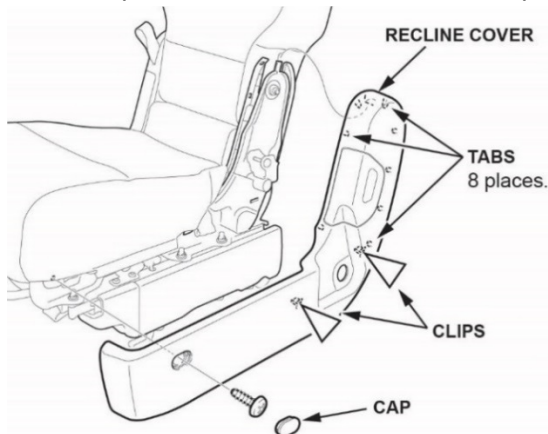
2. Remove the recliner cover.

- Remove the cap, then remove the screw.
- Pull up on the cover, then detach the clips and release the tabs.

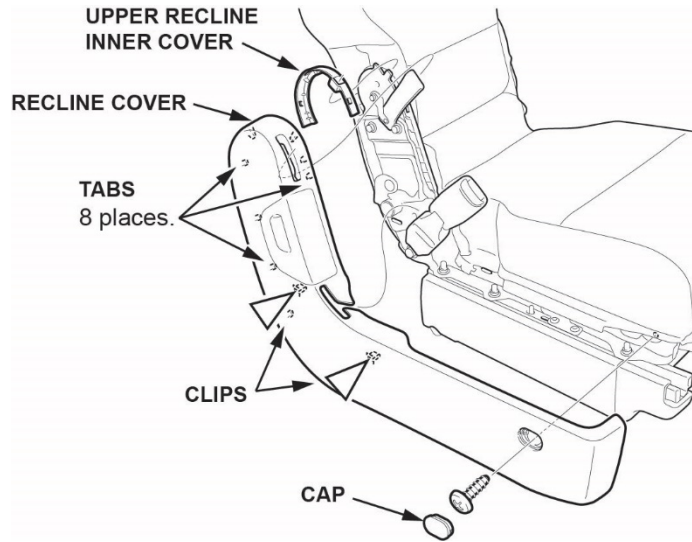
3. Remove the center cover.
- Remove the cap, then remove the screw.
  - Pull up the cover, then detach the clips and release the tabs.
  - If necessary, remove the upper recline inner cover.

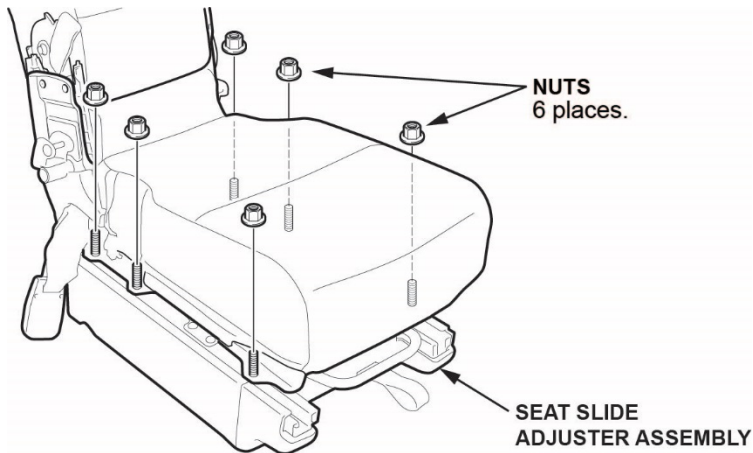
4. Remove the seat slide adjuster assembly by removing the 6 nuts.

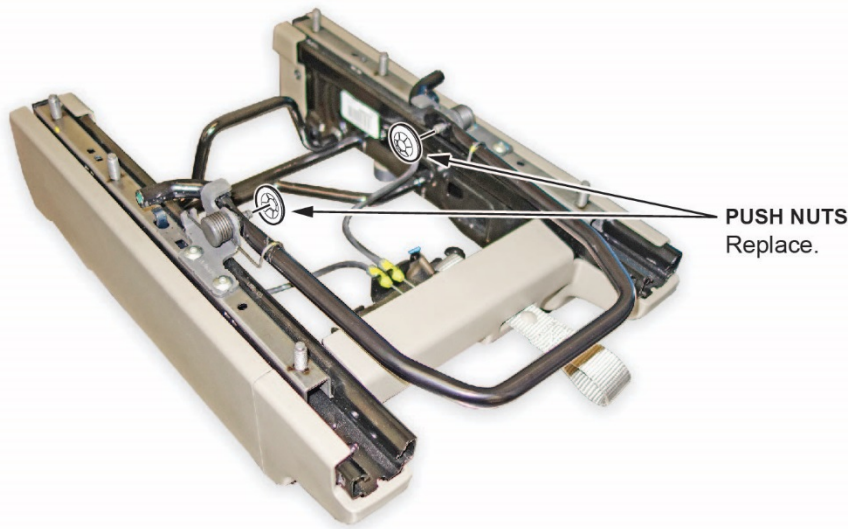
5. Remove the 6 mm push nuts using a grommet puller or a small screwdriver.

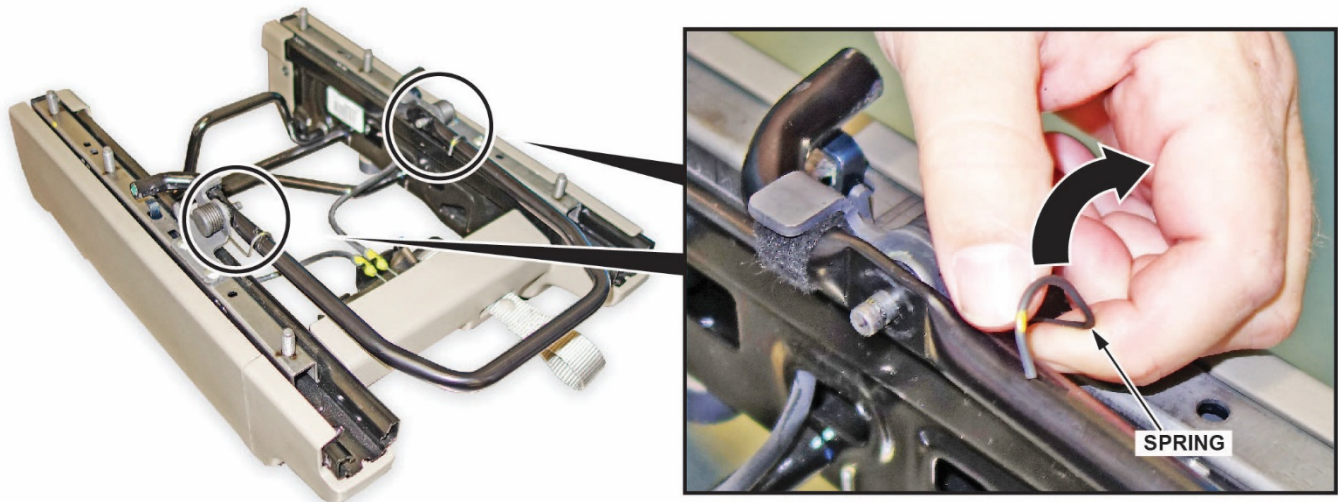
6. Release the springs from the slide lever.

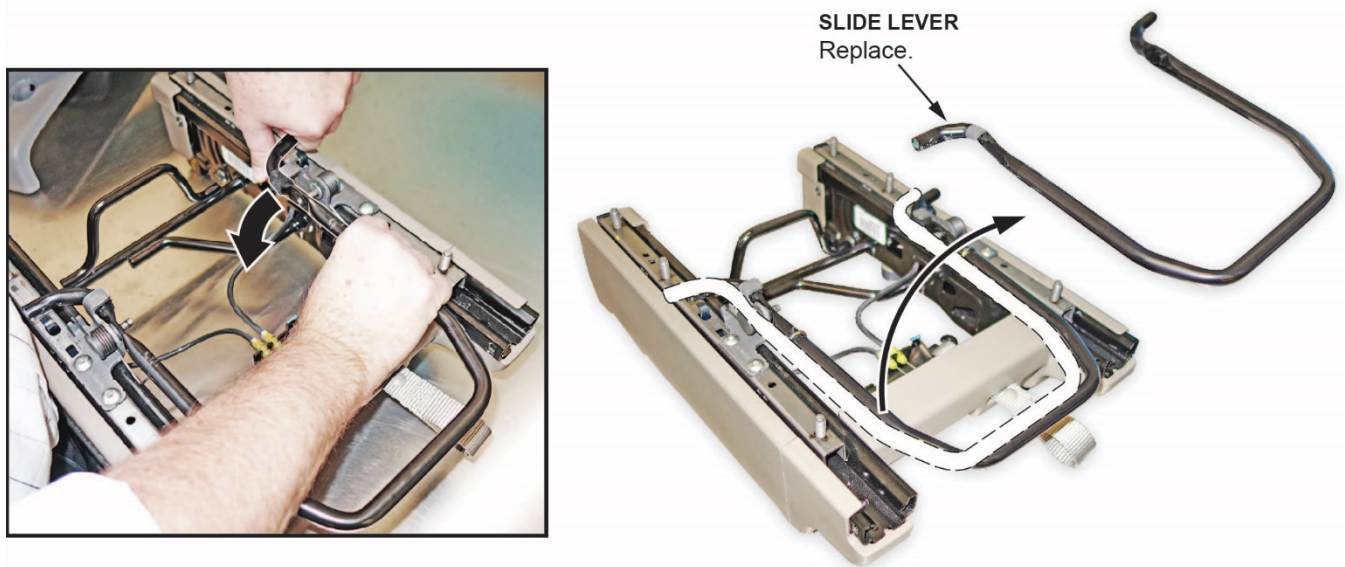
7. Pull or flex the slide bar to remove it.

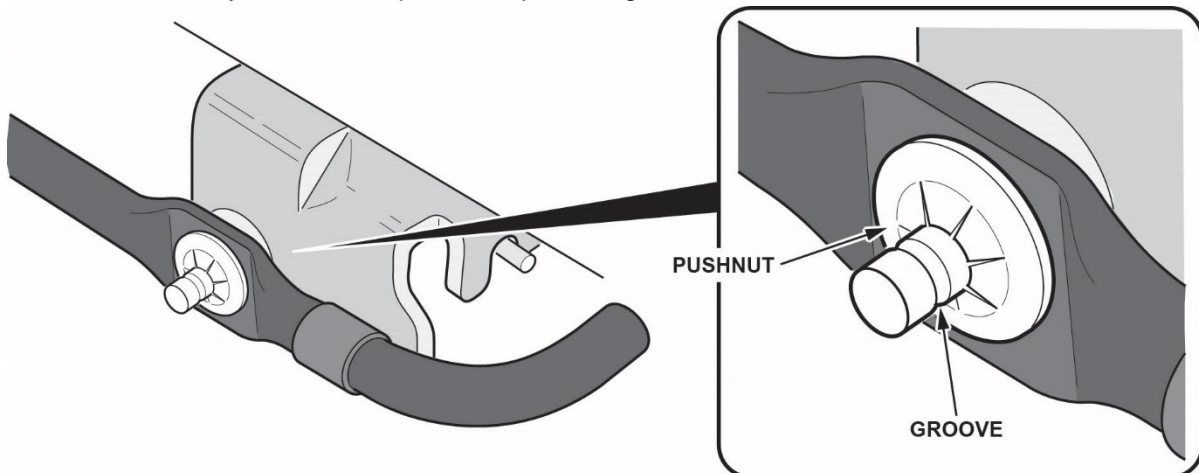
8. Install the new slide lever using new 6 mm push nuts and re-engage both springs.

NOTE: Make sure you install the push nuts past the groove.

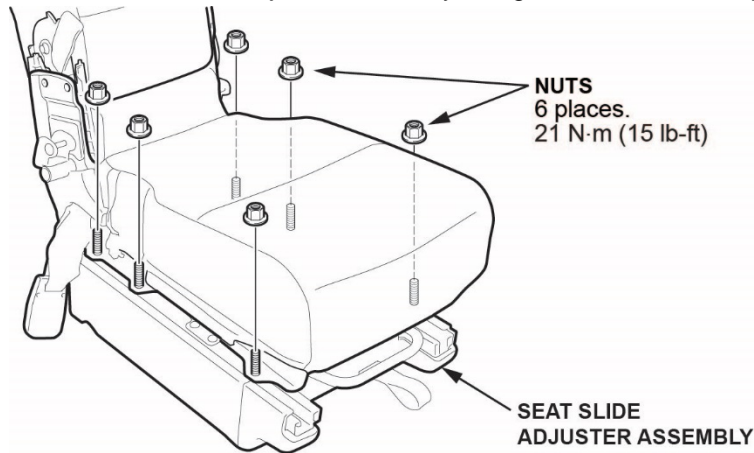
- Install the slide adjuster assembly using the 6 nuts and torque them to **21 N·m (15 lb-ft)**.

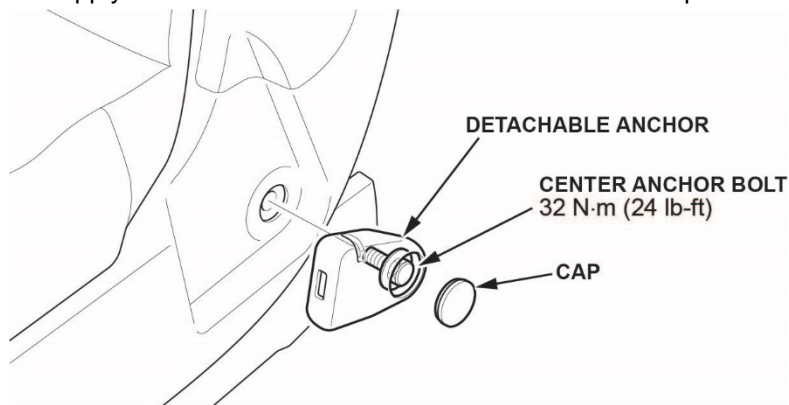
- Apply thread-lock to the seat belt anchor bolt and torque it to **32 N·m (24 lb-ft)**.

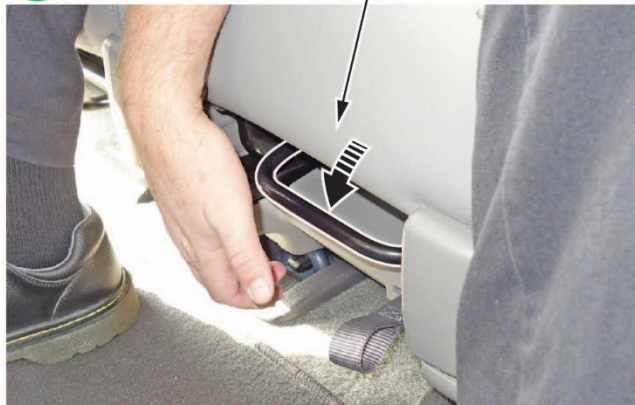
**GOOD** Lever returns to lower position.

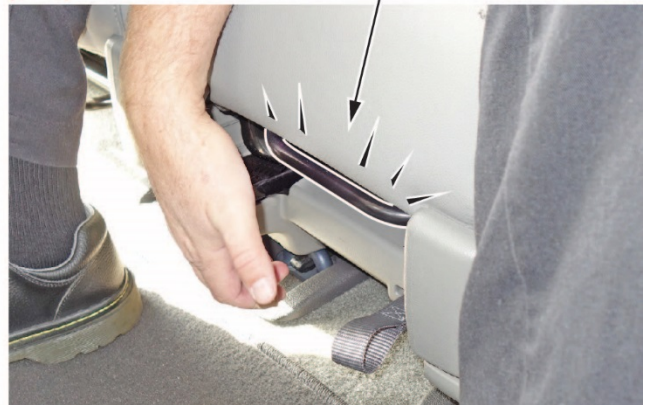
**NO GOOD** Lever sticks in upper position.
