07097 Version 4

Safety Recall: Second Row (Both Outer) SeatsSupersedes 16-108, dated January 27, 2017, to revise the information highlighted in **yellow****AFFECTED VEHICLES**

Year	Model	Trim	VIN Range
2011–16	Odyssey	ALL	Check the iN VIN status for eligibility

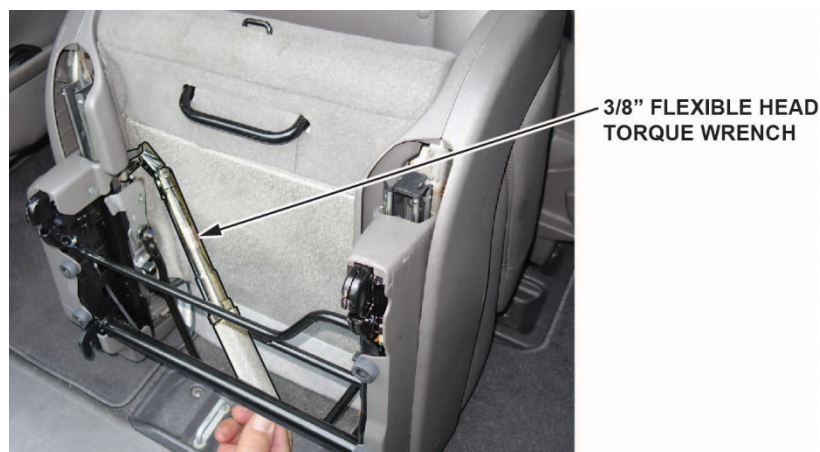
6. Reinstall the original 12 mm nut using a 3/8 in. flexible head torque wrench. Torque the nut to **20 N·m (15 lb-ft)**.

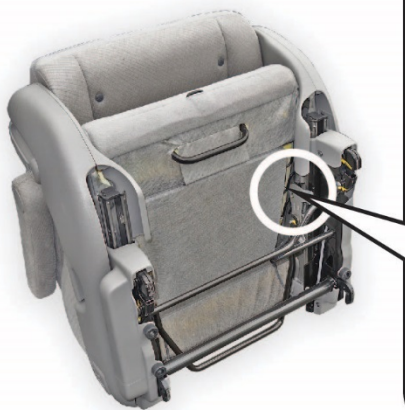
8. Install the other end of the spring onto the bracket hook as shown.
9. Repeat steps 2 through 7 on the opposite slide rail.

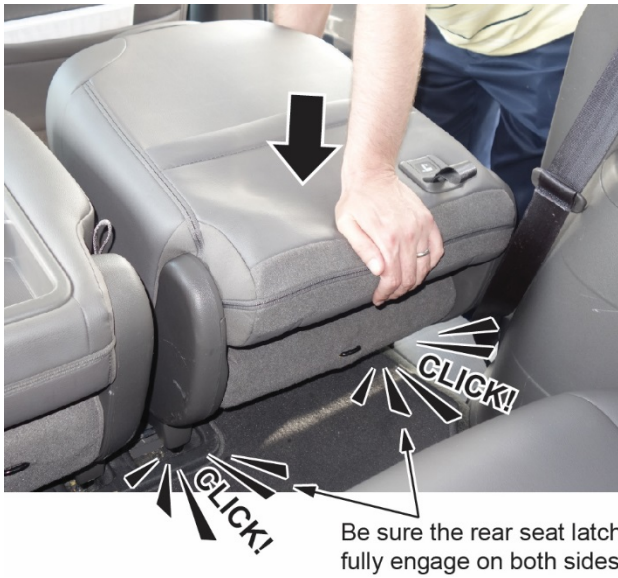
11. Once in position, push down the rear of the seat-back and make sure it latches in place.

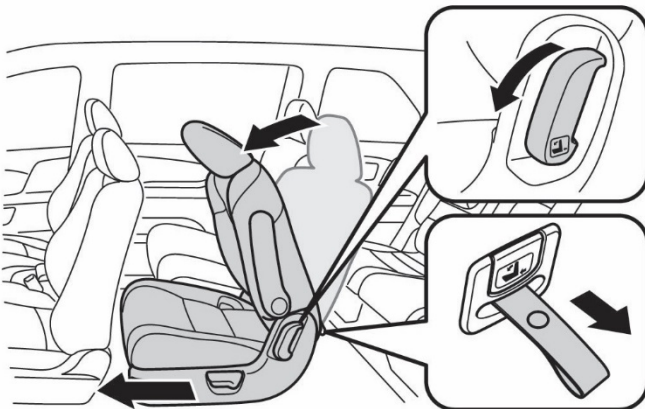
12. Return the seat-back to the upright position and confirm the seat locks properly.

- Pull the walk-in lever or strap and check the seat-back tilts forward and the entire seat slides forward.
- Push the seat-back towards the rear of the vehicle and confirm the seat-back locks into place and the entire seat slides and locks into position.
