05417 Version 1

Safety Recall: Second Row (Both Outer) Seats

Year	Model	Trim	VIN Range
2011–16	Odyssey	ALL	Check the iN VIN status for eligibility

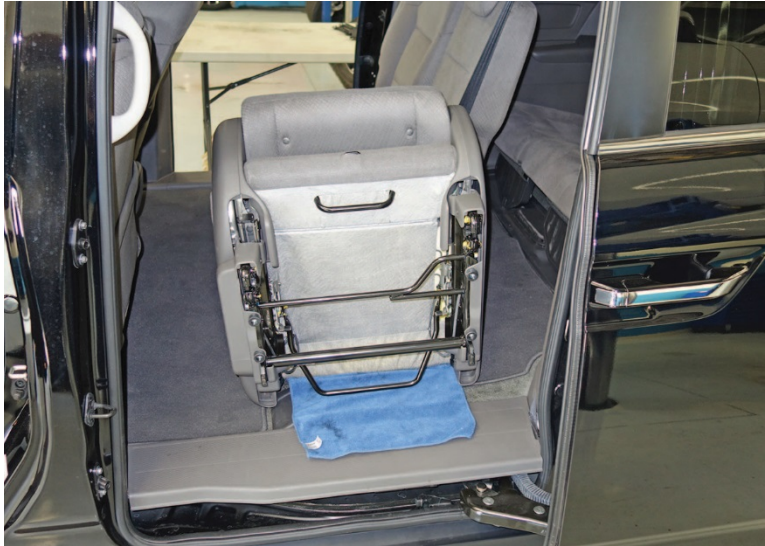
1. Remove the second row seat headrest and fold the seat-back down.
2. Release the second row seat from the floor. Position the seat in the door opening as shown to access the seat slide rails.
