May 14, 2019

Version 6

Safety Recall: 2011-16 Odyssey Second Row (Both Outer) SeatsSupersedes 16-108, dated April 24, 2018, to revise the information highlighted in **yellow****AFFECTED VEHICLES**

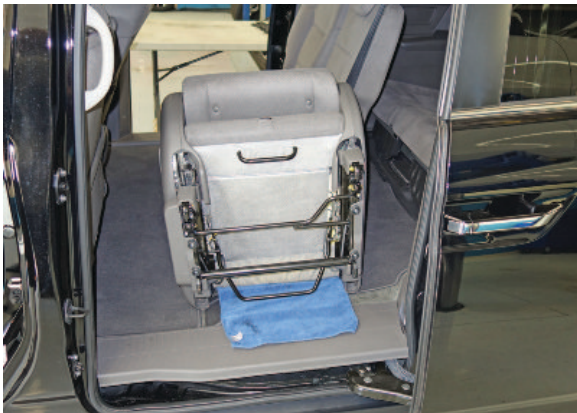
2. Remove the second row outer seat headrest, and fold the seat-back down.
 3. Release the second row outer seat from the floor. Position the seat in the door opening as shown to access the seat slide rails.

Use shop towels or a disposable mat to protect the seat cover from any dirt or grime that may be on the vehicle's floor.

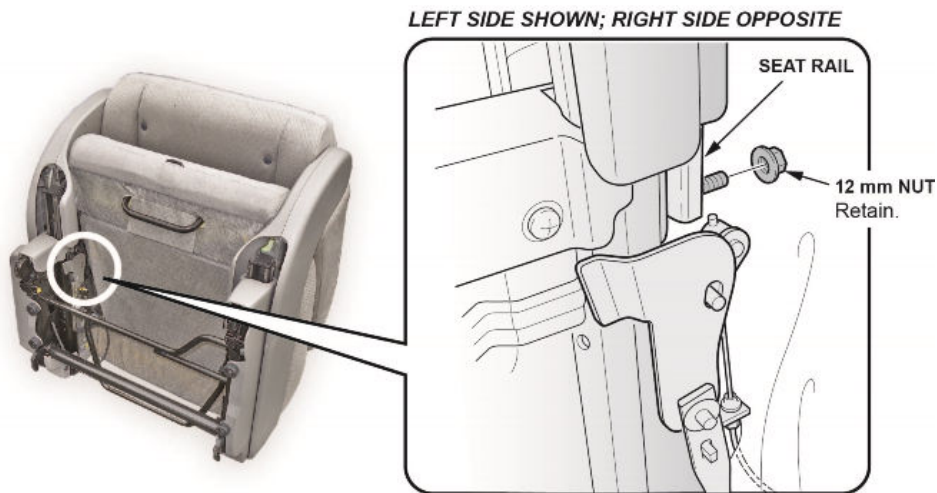
4. Remove the 12 mm nut on the back of the seat rail.

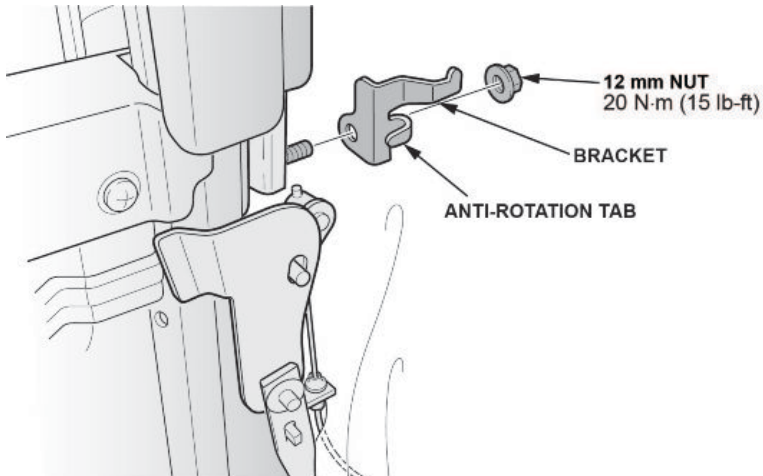
5. Install a bracket from the kit over the stud as shown. Make sure the hook part of the bracket faces the back of the seat and the anti-rotation tab contacts the seat rail.

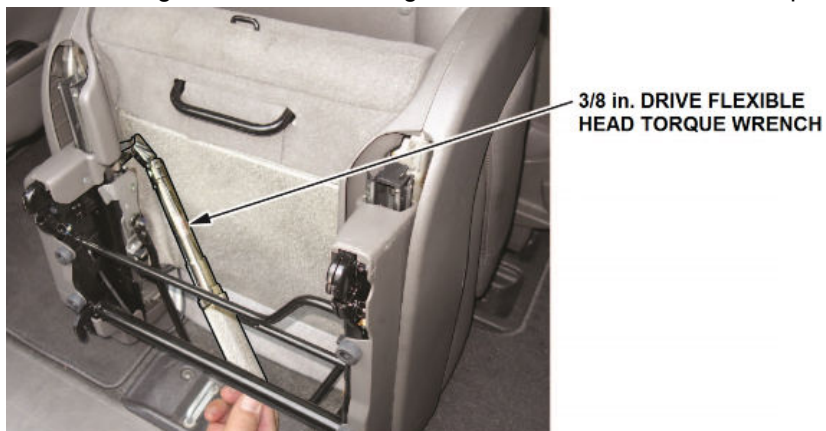
6. Install the original 12 mm nut using a 3/8 in. drive flexible head torque wrench. Torque the nut to **20 N·m (15 lb-ft)**.

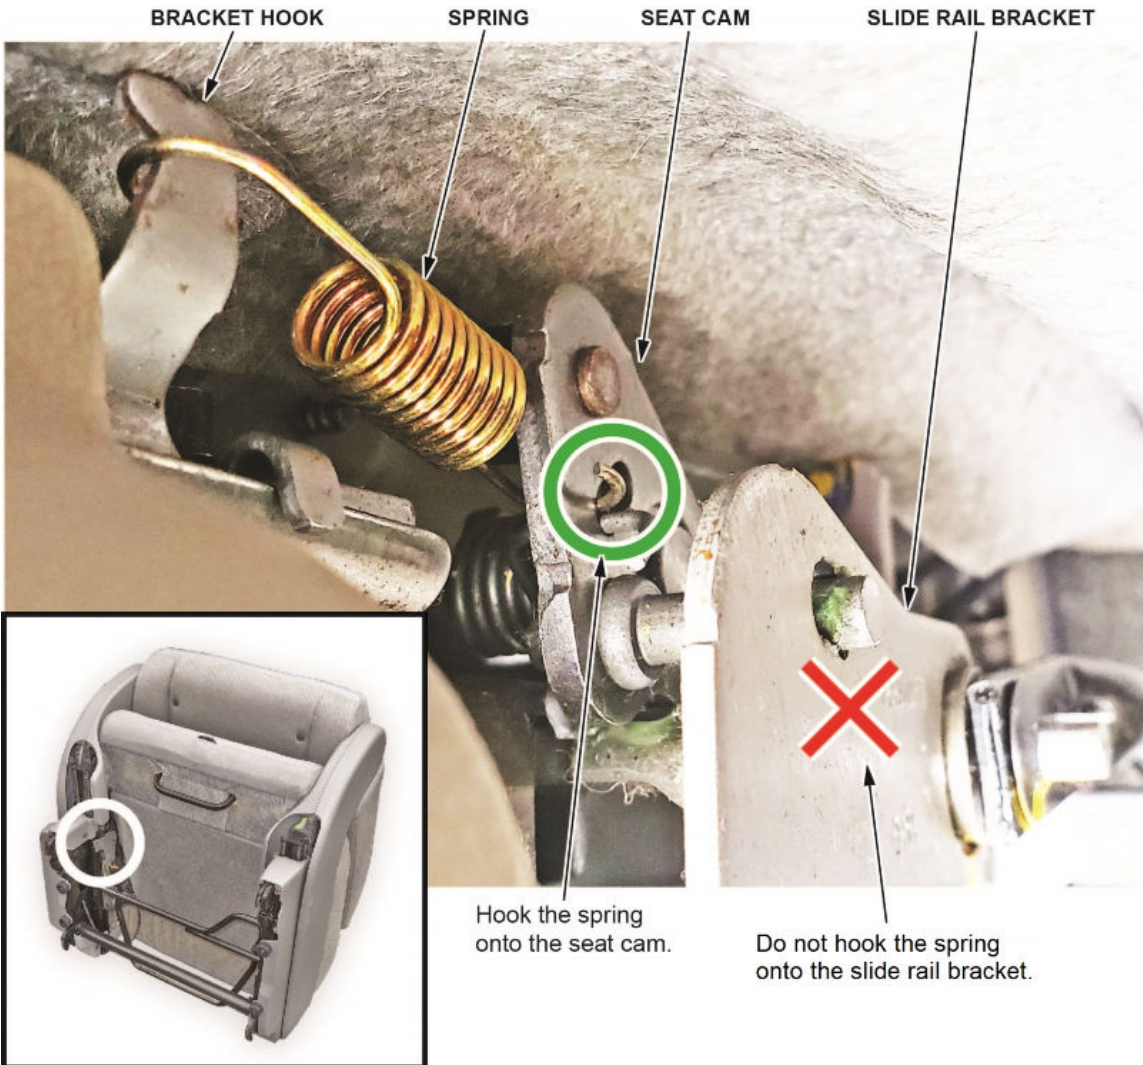
7. Install the spring from the kit through the back of the seat cam as shown.

Make sure the spring is attached to the seat cam, **not** the slide rail bracket.

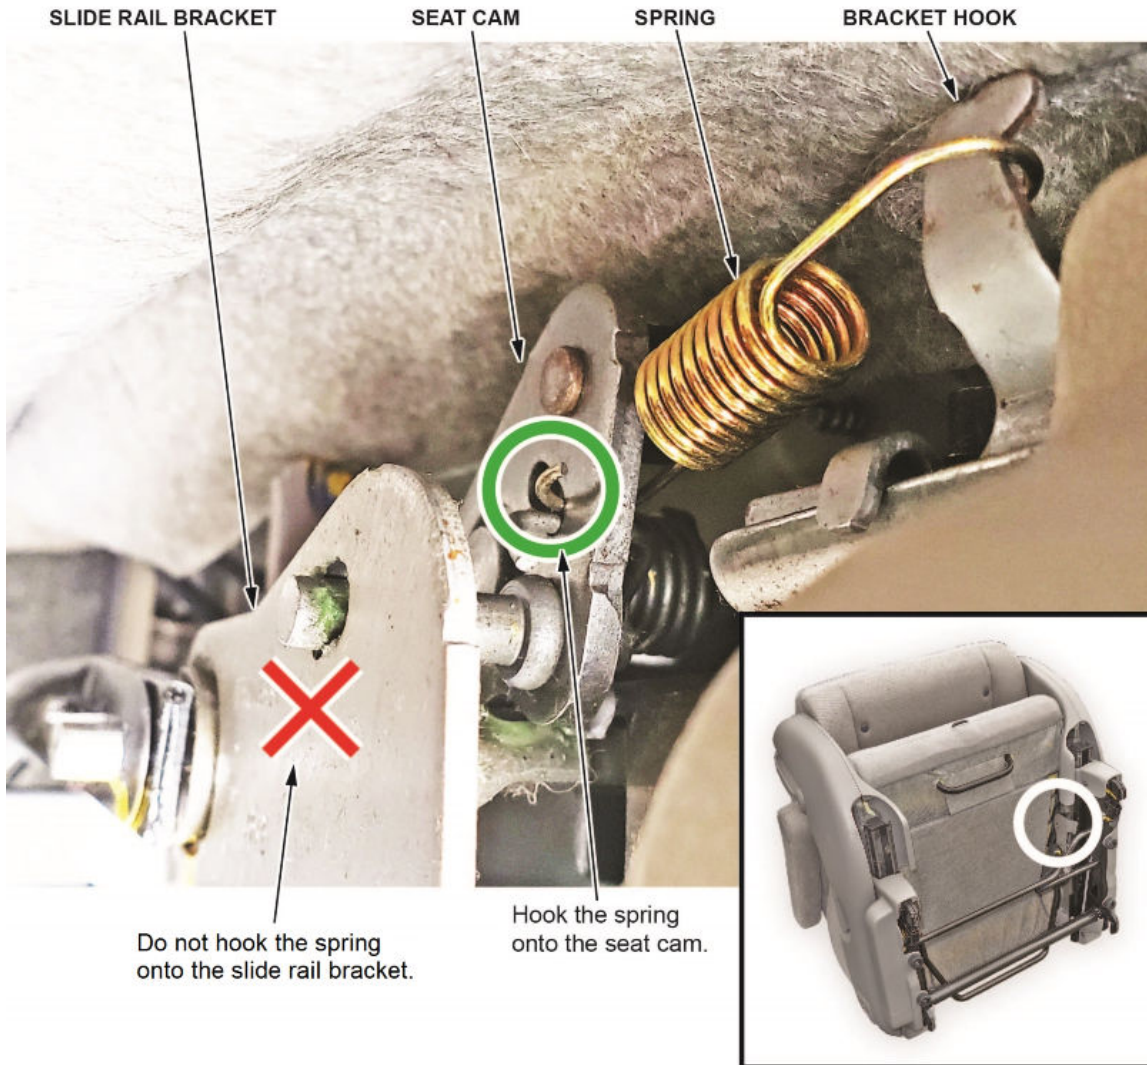
8. Hook the other end of the spring over the bracket hook as shown.

Make sure the spring is attached to the seat cam, **not** the slide rail bracket.

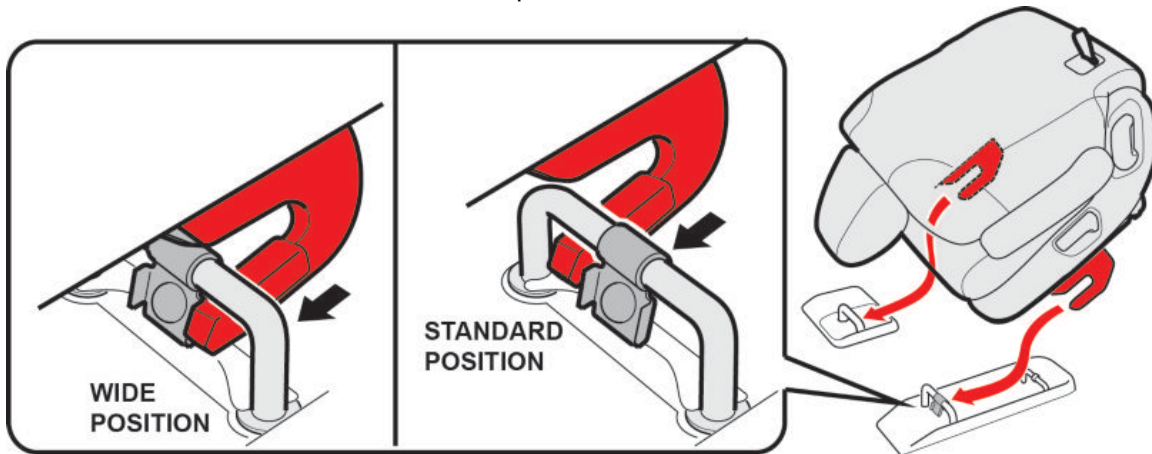
10.1. With the seat-back folded down and adjusted to the rearmost position, insert the hooks into the floor strikers with the outer hook in the standard or wide position.

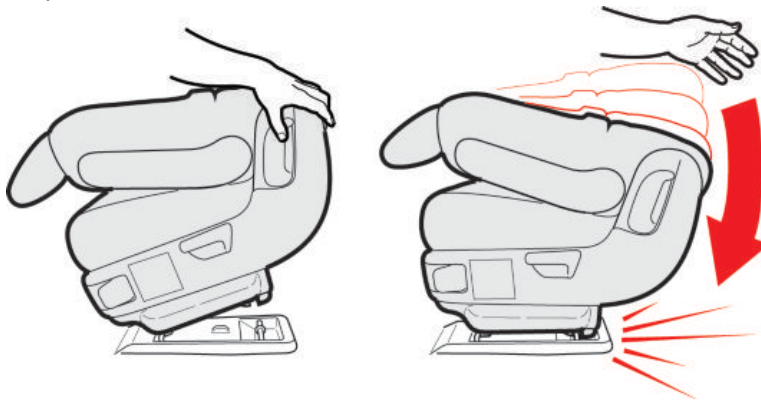
10.2. After confirming both front hooks are fully inserted into the front strikers, begin to lower the seat then allow it to drop and lock to the rear floor strikers.

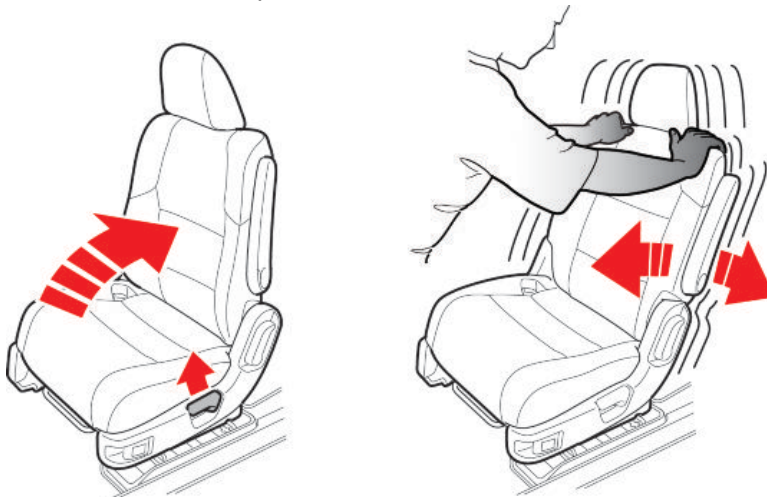
10.3. Raise the seat-back to an upright position, then rock it back and forth, and make sure both the inner and outer latches are locked in position.
