**December 16, 2017**

07725 Version 5

**Safety Recall: Second Row (Both Outer) Seats Walk-in Function**

Year	Model	Trim	VIN Range
2011–16	Odyssey	ALL	Check the iN VIN status for eligibility

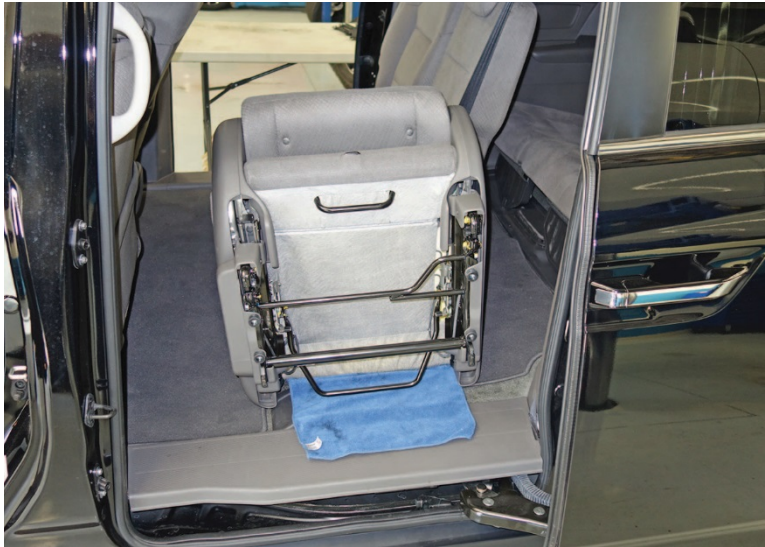
1. Remove any child or booster seats that are installed in the second row seats and place them in the cargo area for the customer to reinstall.
2. Remove the second row seat headrest and fold the seat-back down.
3. Release the second row seat from the floor. Position the seat in the door opening as shown to access the seat slide rails.

NOTE: Use shop towels or a disposable mat to protect the seat cover from any dirt or grime that may be on the vehicle's floor.

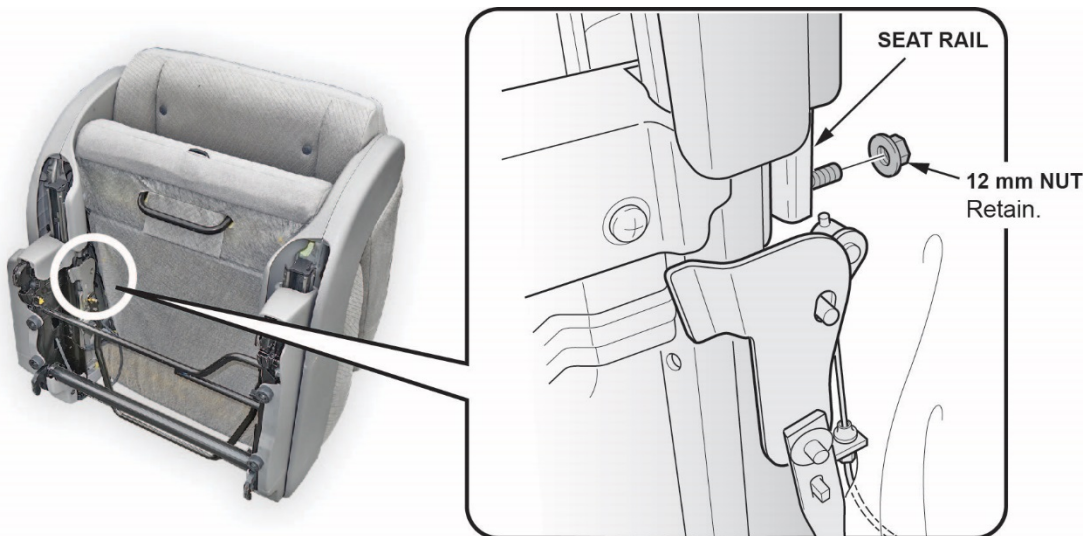
4. Remove the 12 mm nut located on the back of the seat rail (left side second row outer slide rail shown, others are similar).

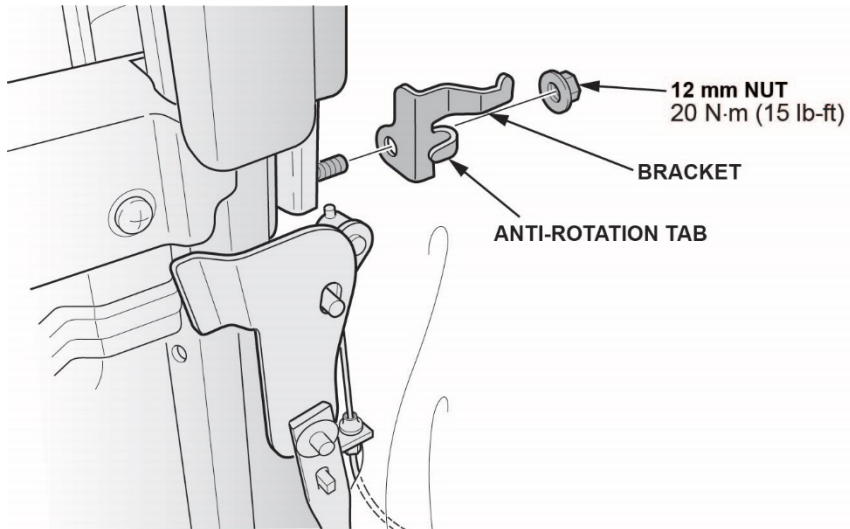
5. Install a bracket from the kit over the stud shown. Make sure the hook part of the bracket faces the back of the seat and the anti-rotation tab contacts the seat rail.

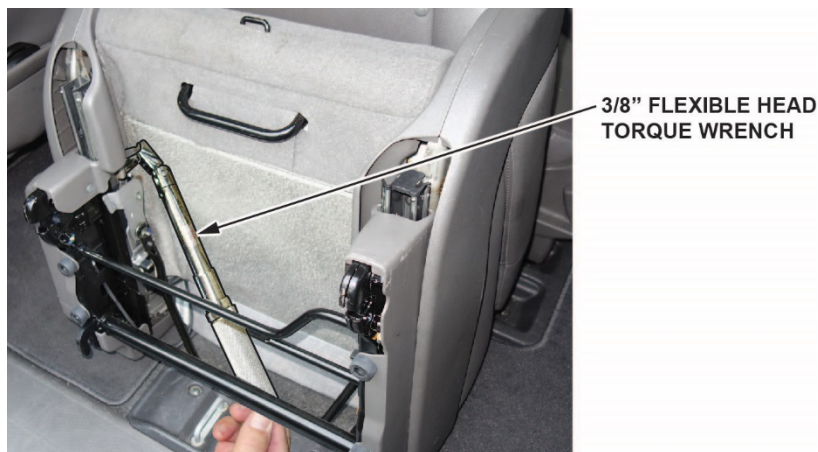
6. Reinstall the original 12 mm nut using a 3/8 in. flexible head torque wrench. Torque the nut to **20 N·m (15 lb-ft)**.

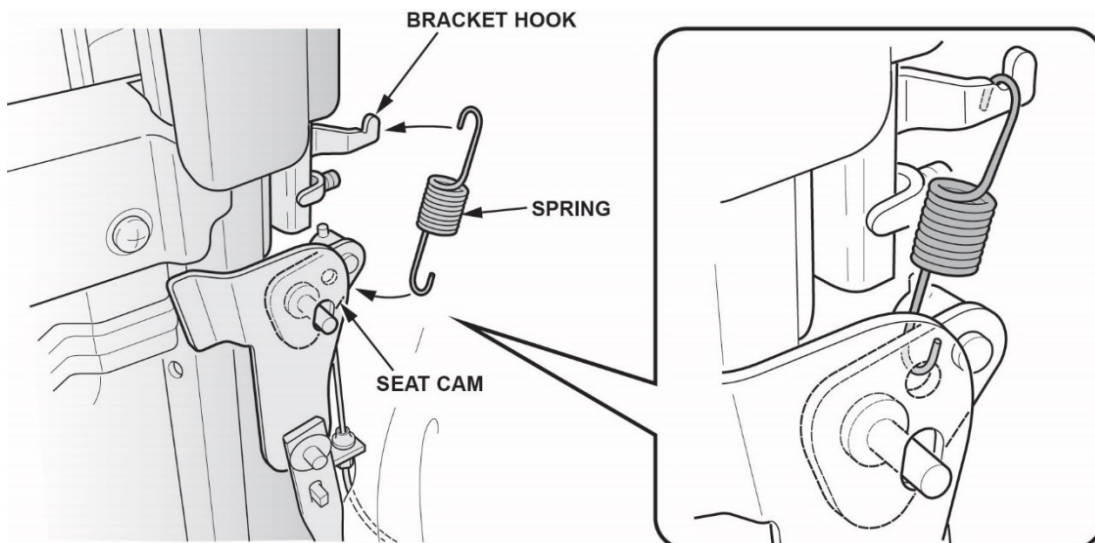
7. Install the spring from the kit through the back of the seat cam as shown.

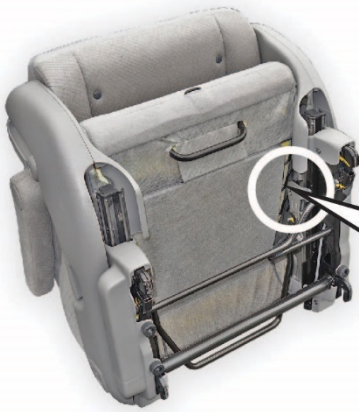
8. Install the other end of the spring onto the bracket hook as shown.

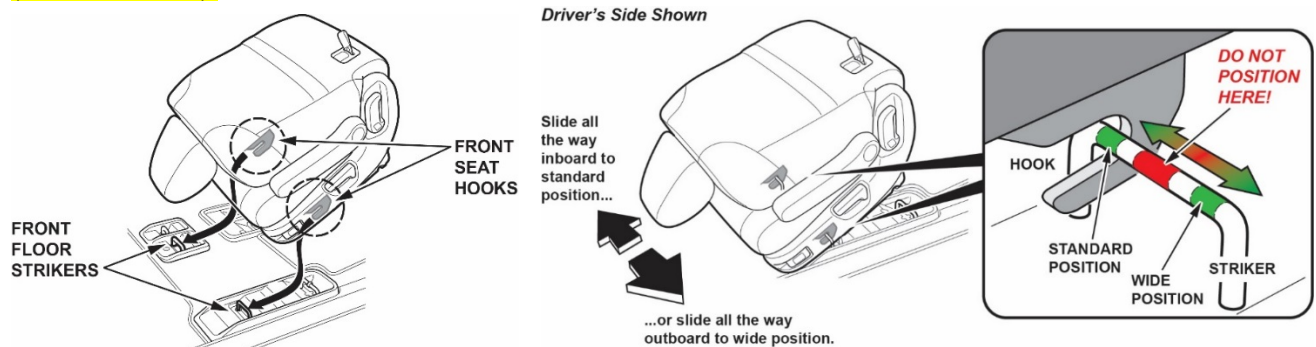
10. Insert the front seat hooks into the front floor strikers and slide the seat into either the Standard or Wide position until it stops (identified in green).

**NOTE:** Do not position the seat hooks in the middle of the striker. The seat will not lock into position (identified in red).

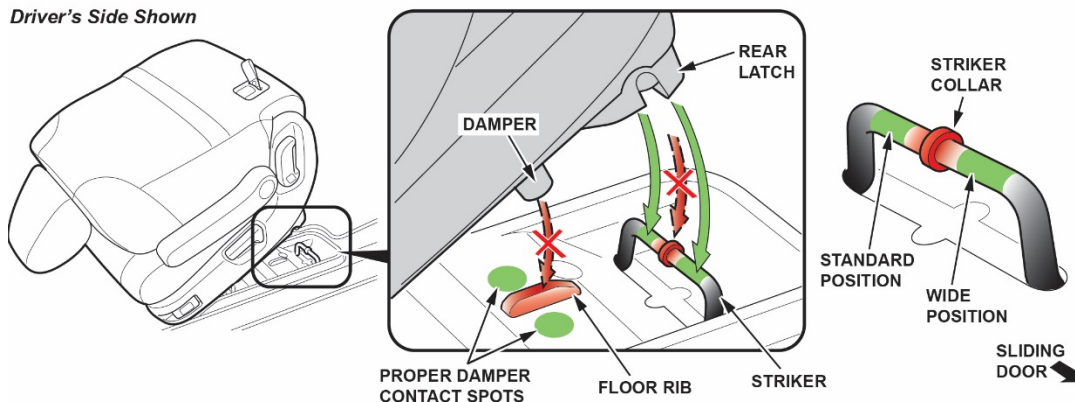
Driver's Side Shown

11. Lower the rear part of the seat. There is both a rib on the striker cover and a collar on the rear metal striker. Check that the rear latch and damper are on one side of the rib and collar, which is identified in green.

- The rib and collar separate the standard and wide seat positions.
- Do not latch the seat in the middle (identified in red), the damper and rear latch will rest on the rib and collar, and will not lock.

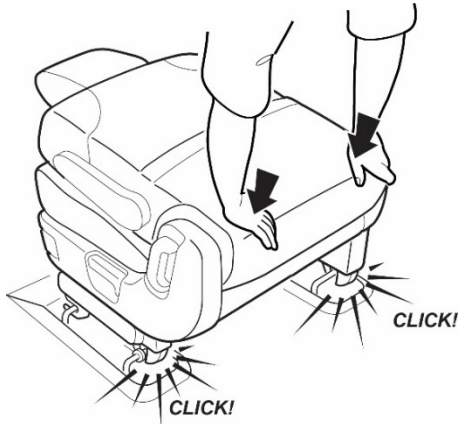
12. Once in position, push down the rear of the seat to set both rear latches. The latches click as they engage the floor strikers.

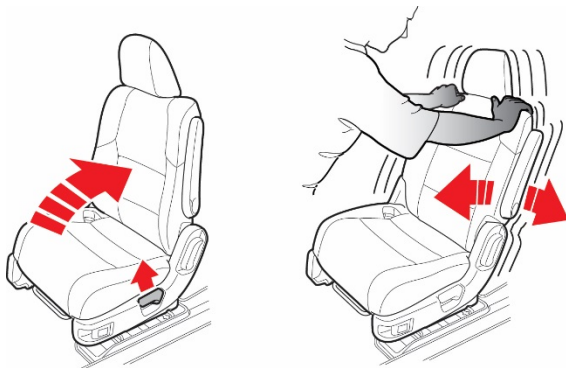
13. Raise the seat back into an upright position. Rock the seat back and forth to make sure both the inner and outer latches are locked in place.

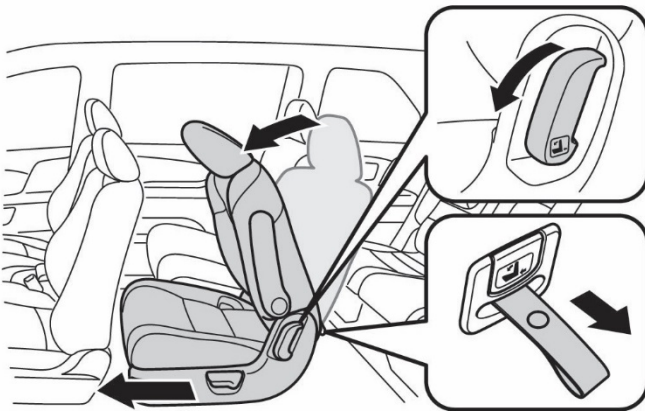
14. Confirm the seat locks properly.

- Pull the walk-in lever or strap and check the seat-back tilts forward and the entire seat slides forward.
- Push the seat-back towards the rear of the vehicle and confirm the seat-back locks into place and the entire seat slides and locks into position.
