Safety Recall: Second Row (Both Outer) Seats

Supersedes 16-108, dated July 29, 2017, to revise the information highlighted in **yellow**

Year	Model	Trim	VIN Range
2011-16	Odyssey	ALL	Check the iN VIN status for eligibility.

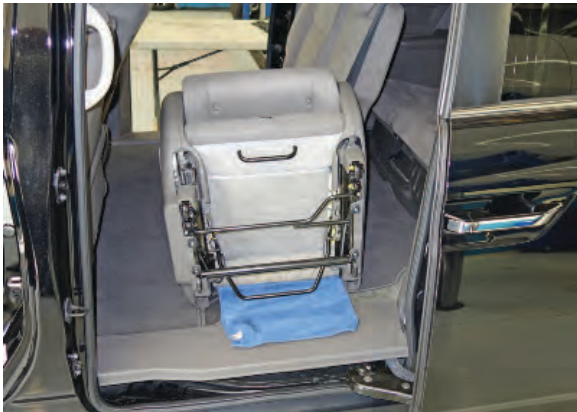
1. Remove any child or booster seats that are installed in the second row center and left seats, and place them in the cargo area for the customer to install. **Note which position the seat is installed; Standard (inner) or Wide (outer) position, and reinstall it in the same position before returning the vehicle to the customer for their convenience.**
2. Remove the second row seat headrest and fold the seat-back down.
3. Release the second row seat from the floor. Position the seat in the door opening as shown to access the seat slide rails.

Use shop towels or a disposable mat to protect the seat cover from any dirt or grime that may be on the vehicle's floor.

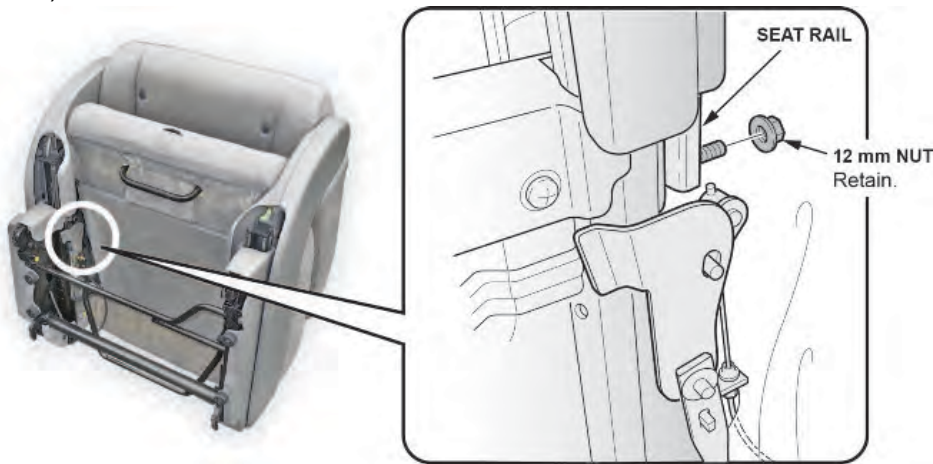
4. Remove the 12 mm nut located on the back of the seat rail (left side second row outer slide rail shown, others are similar).

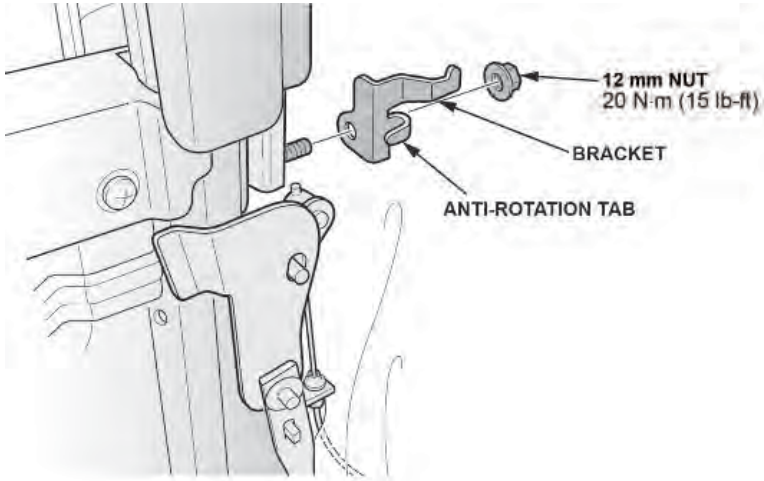
5. Install a bracket from the kit over the stud shown. Make sure the hook part of the bracket faces the back of the seat and the anti-rotation tab contacts the seat rail.

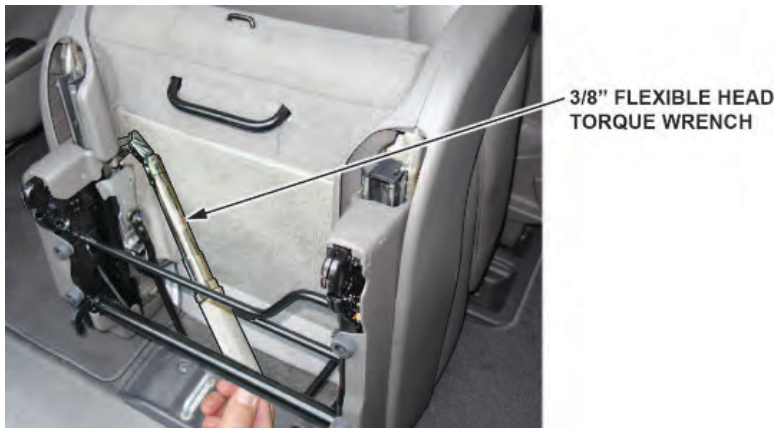
6. Reinstall the original 12 mm nut using a 3/8 in. flexible head torque wrench. Torque the nut to **20 N·m (15 lb-ft)**.

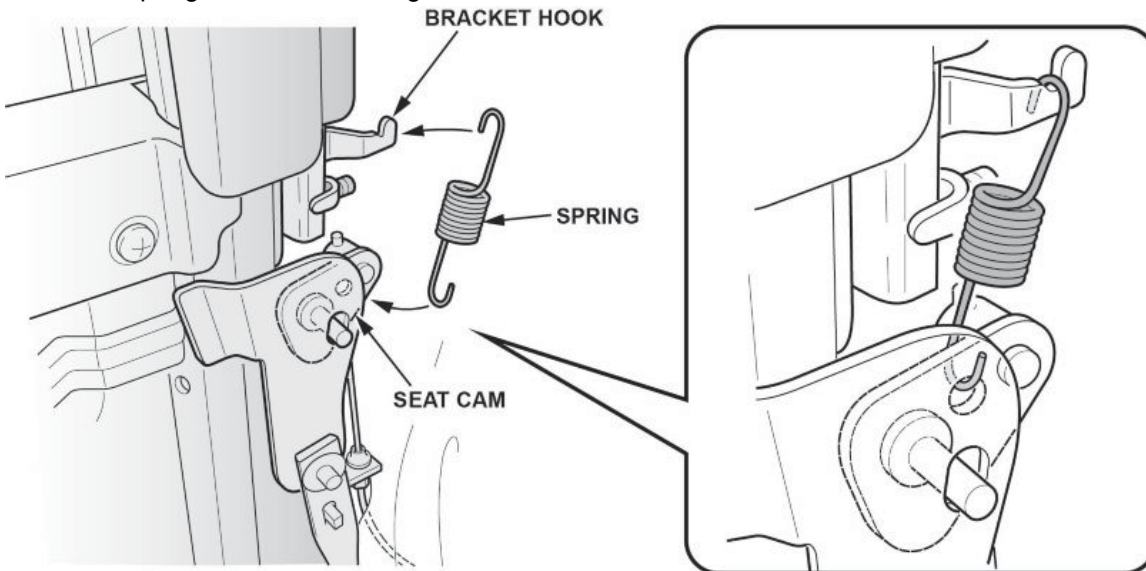
7. Install the spring from the kit through the back of the seat cam as shown.

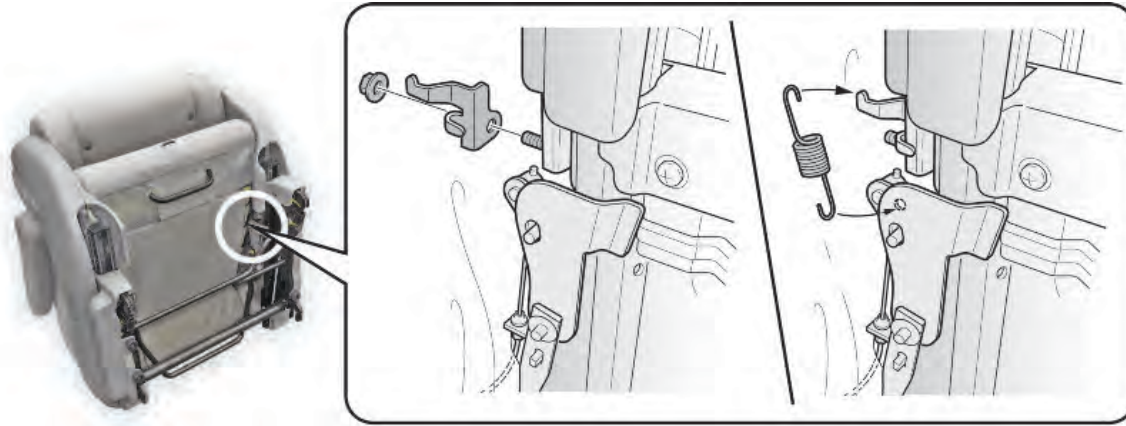
8. Install the other end of the spring onto the bracket hook as shown.

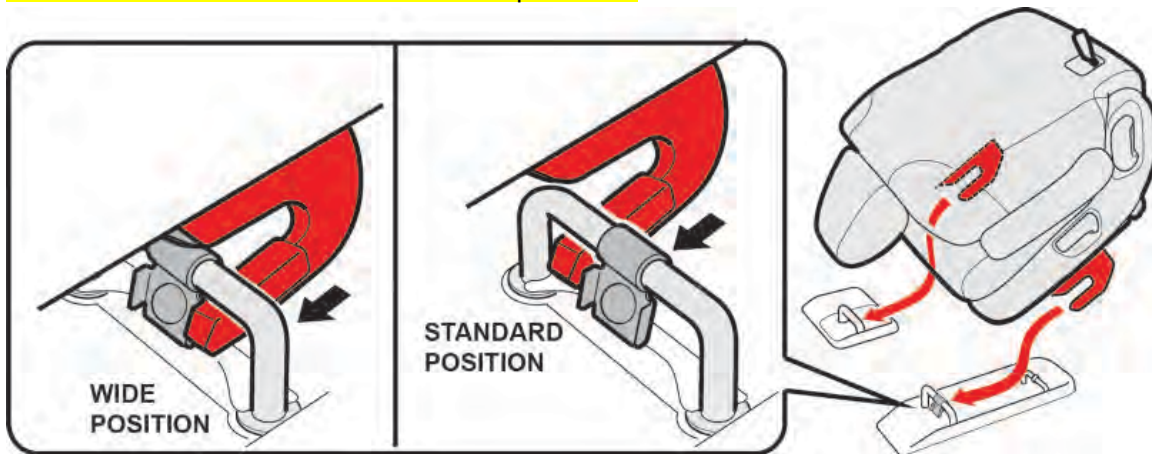
10.1. **With the seat-back folded down and adjusted to the rearmost position, insert the hooks into the floor strikers with the outer hook in the standard or wide position. .**

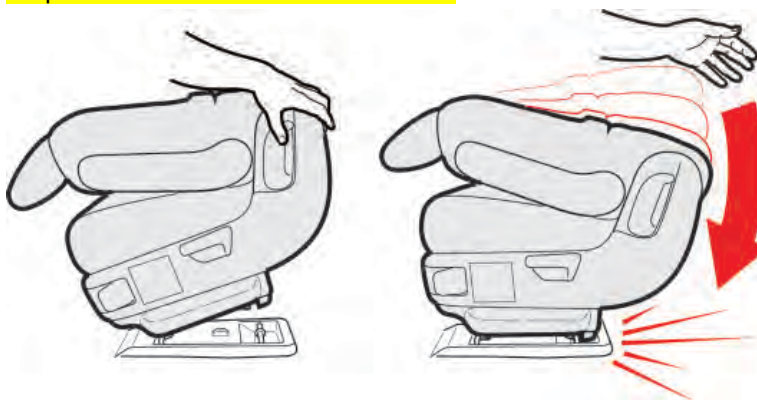
10.2. **After confirming both front hooks are fully inserted into the front strikers, begin to lower the seat then allow it to drop and lock to the rear floor strikers.**

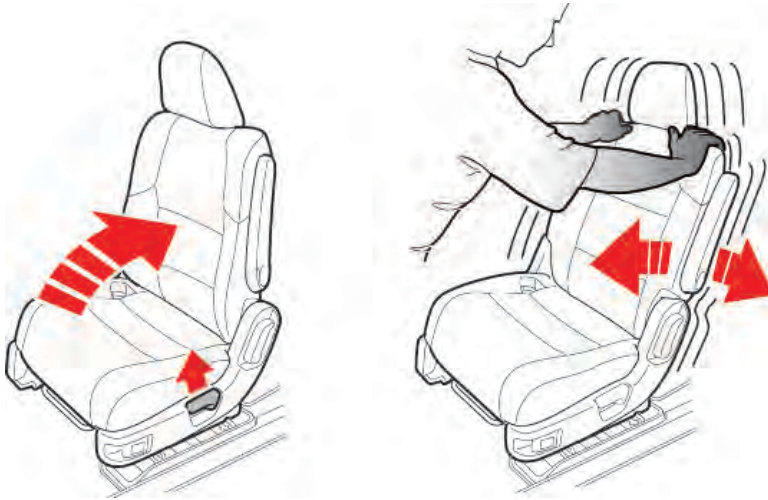
- 10.3. Raise the seat back into an upright position and then rock the seat back and forth and make sure both the inner and outer latches are locked in position.
