J081NAS2

## TECHNICAL BULLETIN

SAFETY RECALL: Autoliv Seatbelt Operation

**INSPECTION PROCEDURE A - F-TYPE (X152):**

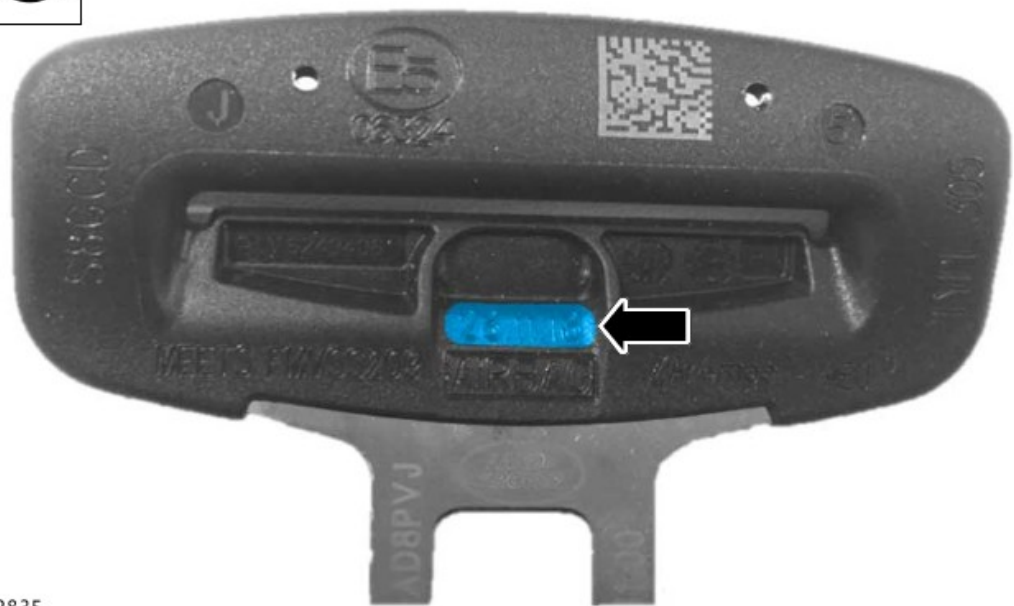
E202835

Record the seatbelt anchor date on the repair order.

4 Repeat steps 1-3 on front row seating right seatbelt anchor.

If both seatbelts do not have one of the listed date codes, release the vehicle.

If either seatbelt has any of listed date codes, **HOLD** the vehicle.
