120/16 ENU AG10

#### AG10 - Replacing Front Side Airbag (Recall Campaign)

Model Line: **911 (991)**

718 (982)

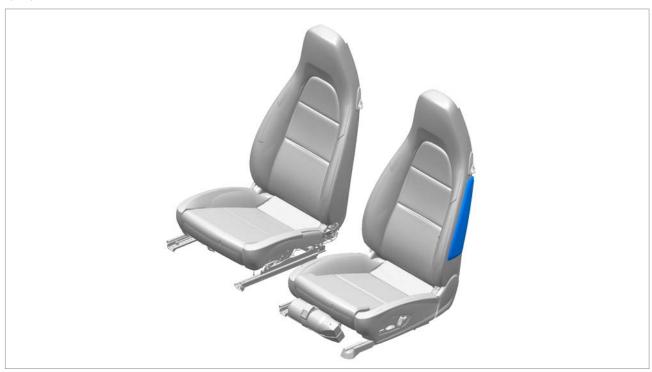
Overview of front side airbag

Work Procedure: 1 Disconnect the battery ⇒ Workshop Manual '2X00IN Work instructions after disconnecting the battery'

- 2 Depending on which campaign scope is assigned to the respective vehicle, carry out:
  - Scope 1 or 4: Replacing front side airbag at the left
  - Scope 2 or 5: Replacing front side airbag at the right
  - Scope 3 or 6: Replacing both front side airbags

For instructions, see ⇒ Workshop Manual '696319 Removing and installing front side airbag'
