**SUBJECT:** RECALL R16YK, TRANSPEC STOP ARM  
Non-Compliance FMVSS 131 – School Bus Pedestrian Safety Devices

**NHTSA Recall Number: 16V-006 School Bus**

SAT-0005-01

### Transpec Stop Arm Blade Assembly Replacement

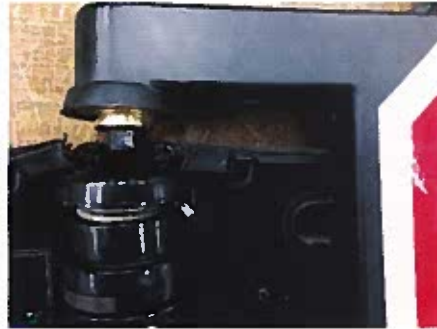
5. Separate the upper end of the blade from the clutch/motor shaft.
