## Followup Notice for Safety Recall 16V-233 (Terex SN618)

# Safety Notification SN618

## Completion Form (XT Lower Boom Tube Inspection)

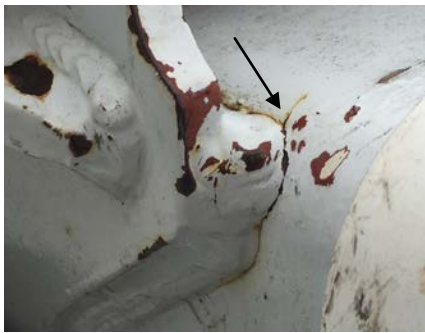
**Crack example**

1. If cracks are noted in the attached SN618 Completion form, you should take the unit out of service and have it repaired immediately by qualified technicians. Any cracks, suspected cracks, or noted deficiencies need to be addressed for the safety of the operator and compliance with ANSI standards and OSHA regulations.

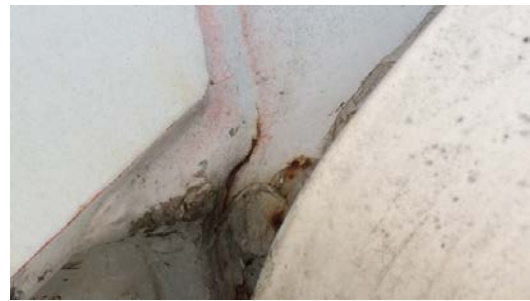
**Paint crack that needs further examination**

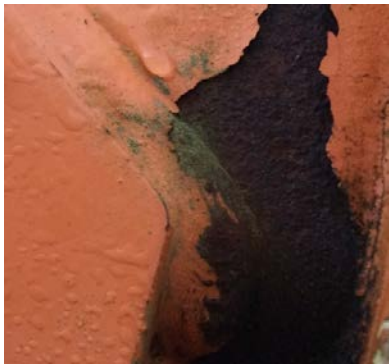
**Rusty area needs cleaning to inspect**

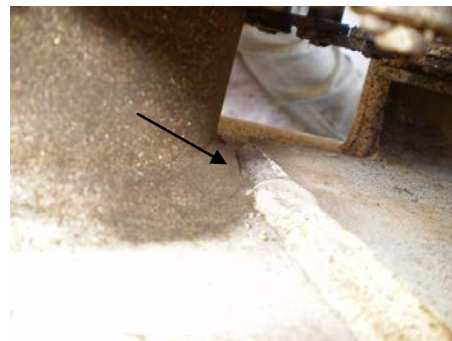
**Crack at pivot inside boom**
